# VOLUNTARY RECALL CAMPAIGN

Classification:	Reference:	Date:
RS23-003A	NTB23-080A	March 6, 2024

## VOLUNTARY SAFETY RECALL CAMPAIGN 2004-2012 ARMADA, TITAN, AND 2004-2009 QUEST; DRIVER AIR BAG COVER

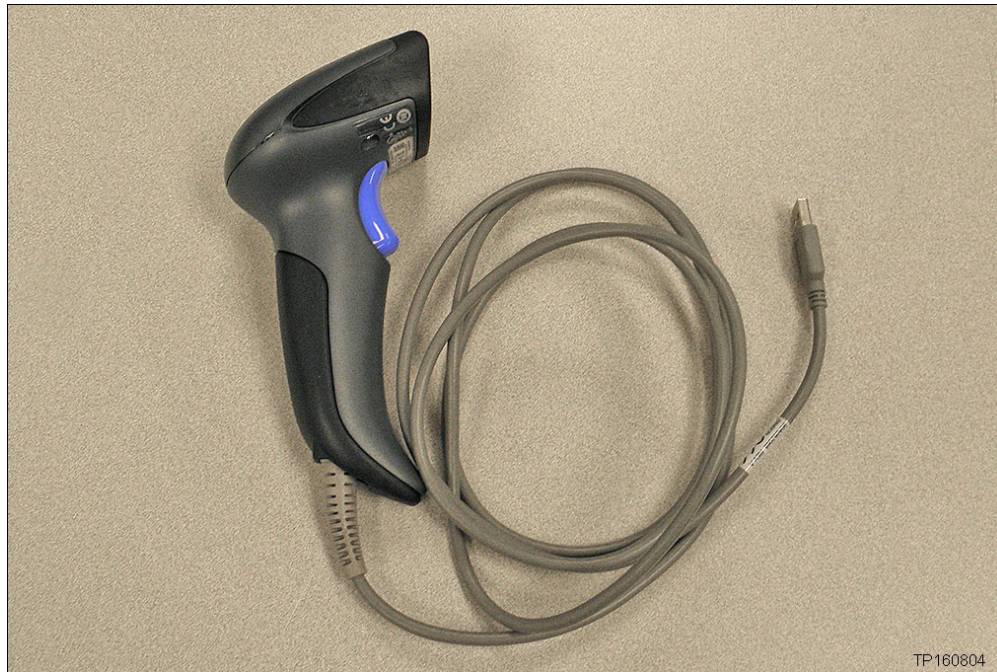
Figure 1

### Quick Scan Tool (J-52352)

- Each dealer has been previously shipped one Quick Scan Tool (J-52352).

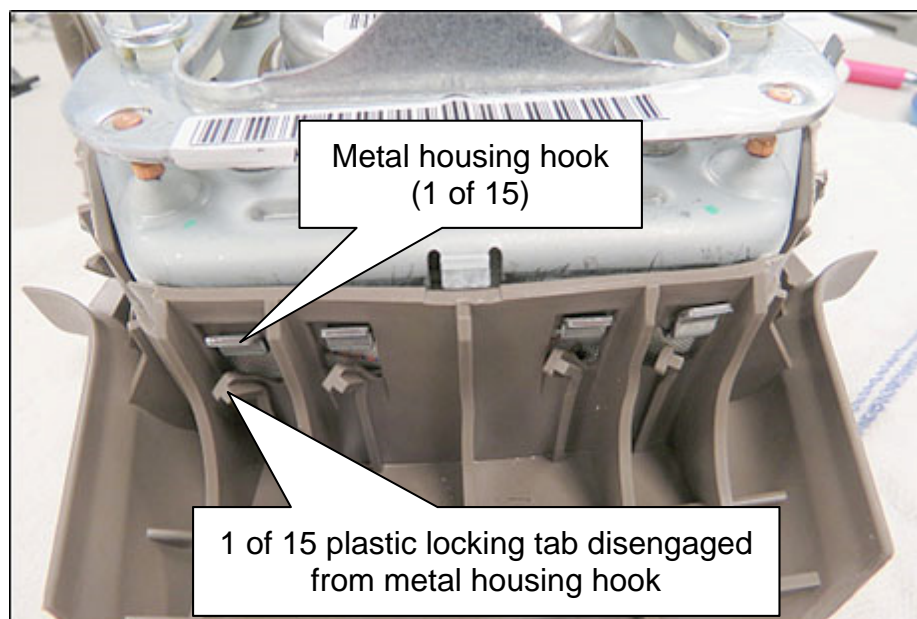
Figure 8

14. Using suitable needle nose pliers, disengage all fifteen (15) Air Bag Cover plastic locking tabs (Figure 8 and Figure 9).
- Rotate each Air Bag Cover plastic locking tab 180 degrees away from each of the metal housing hooks.

**IMPORTANT:** Ensure that the cushion material under each plastic locking tab is not grabbed or twisted by the needle nose pliers.

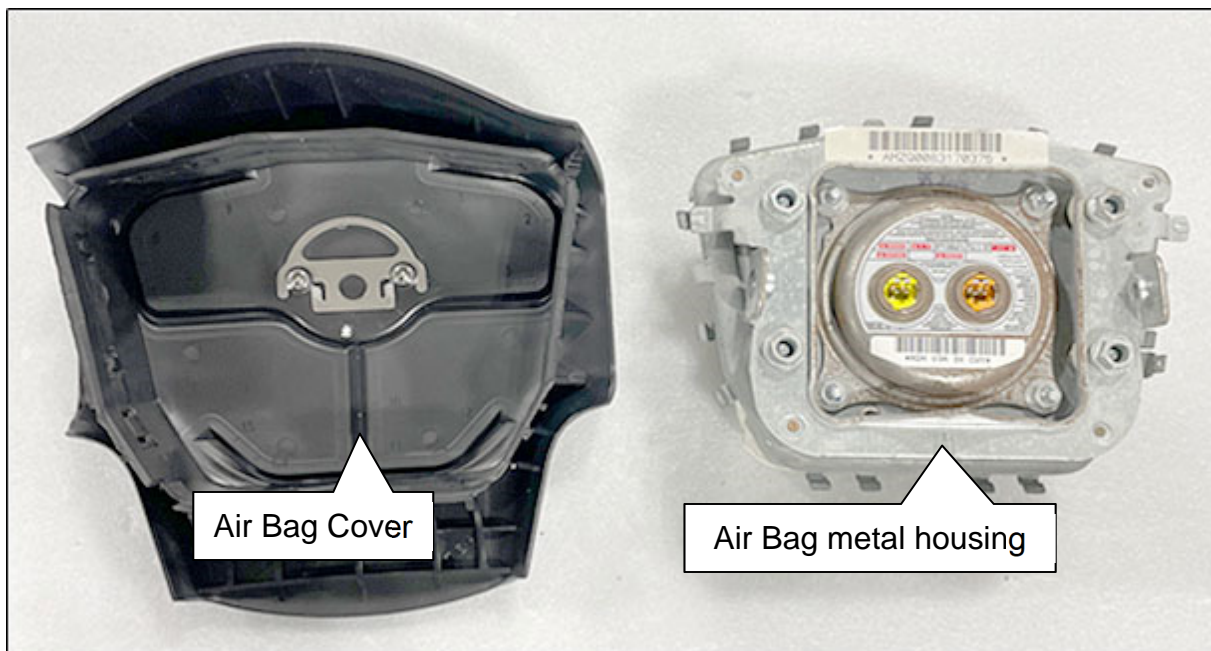
Figure 22

23. On a clean, flat, cloth covered surface, place the new Air Bag Cover face-down (emblem facing down) and the Air Bag metal housing cushion side down (Figure 22).

**IMPORTANT:** Confirm that loose objects or debris do not enter in the Air Bag Cover.

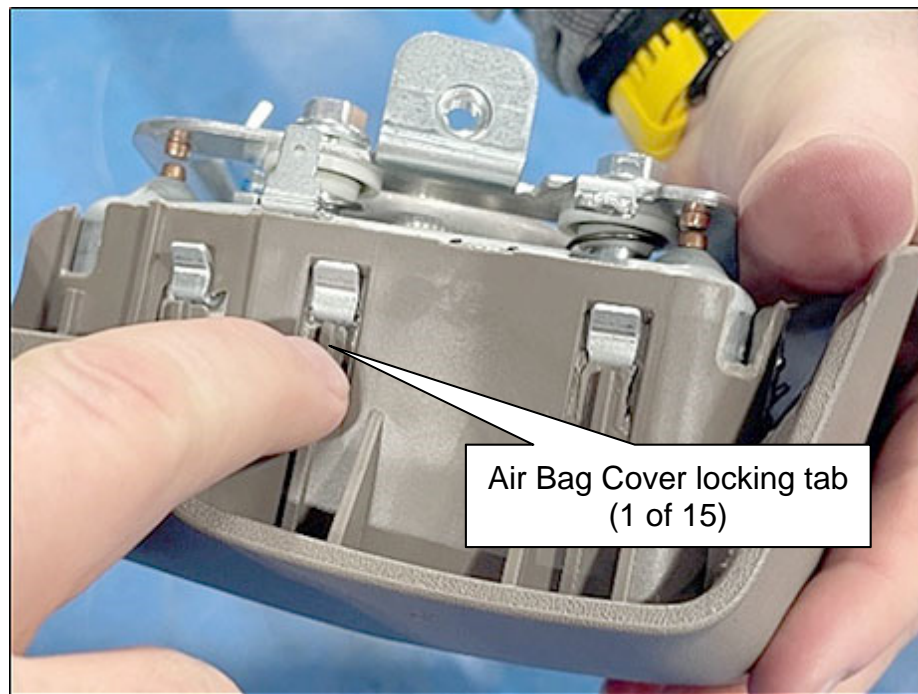
Figure 29

29. If needed, use a finger to push and seat each of the fifteen (15) Air Bag Cover locking tabs under each metal housing hook (Figure 29).

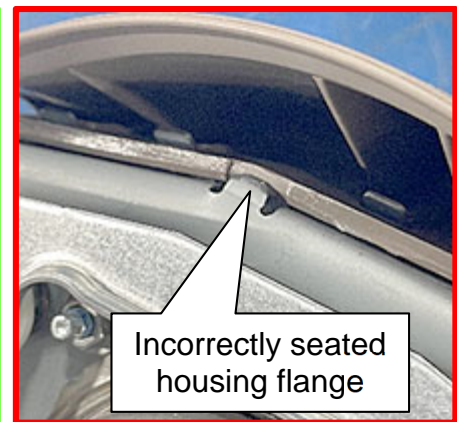
30. Ensure each of the four (4) housing flanges are positioned over the cover-wall edge and the housing corners are seated with no cushion material visible.
- Figure 30 and Figure 31 show an example of one (1) of the four (4) housing flanges seated correctly.
  - Figure 32 is an example of an incorrectly seated housing flange.
