SIB 84 01 23

**RECALL 23V-099: WIRELESS CHARGING TRAY WILL NOT RECOGNIZE DIGITAL KEY REMOVAL**

This Service Information Bulletin (Revision 3) replaces SI B84 01 23 **dated February 2023**.

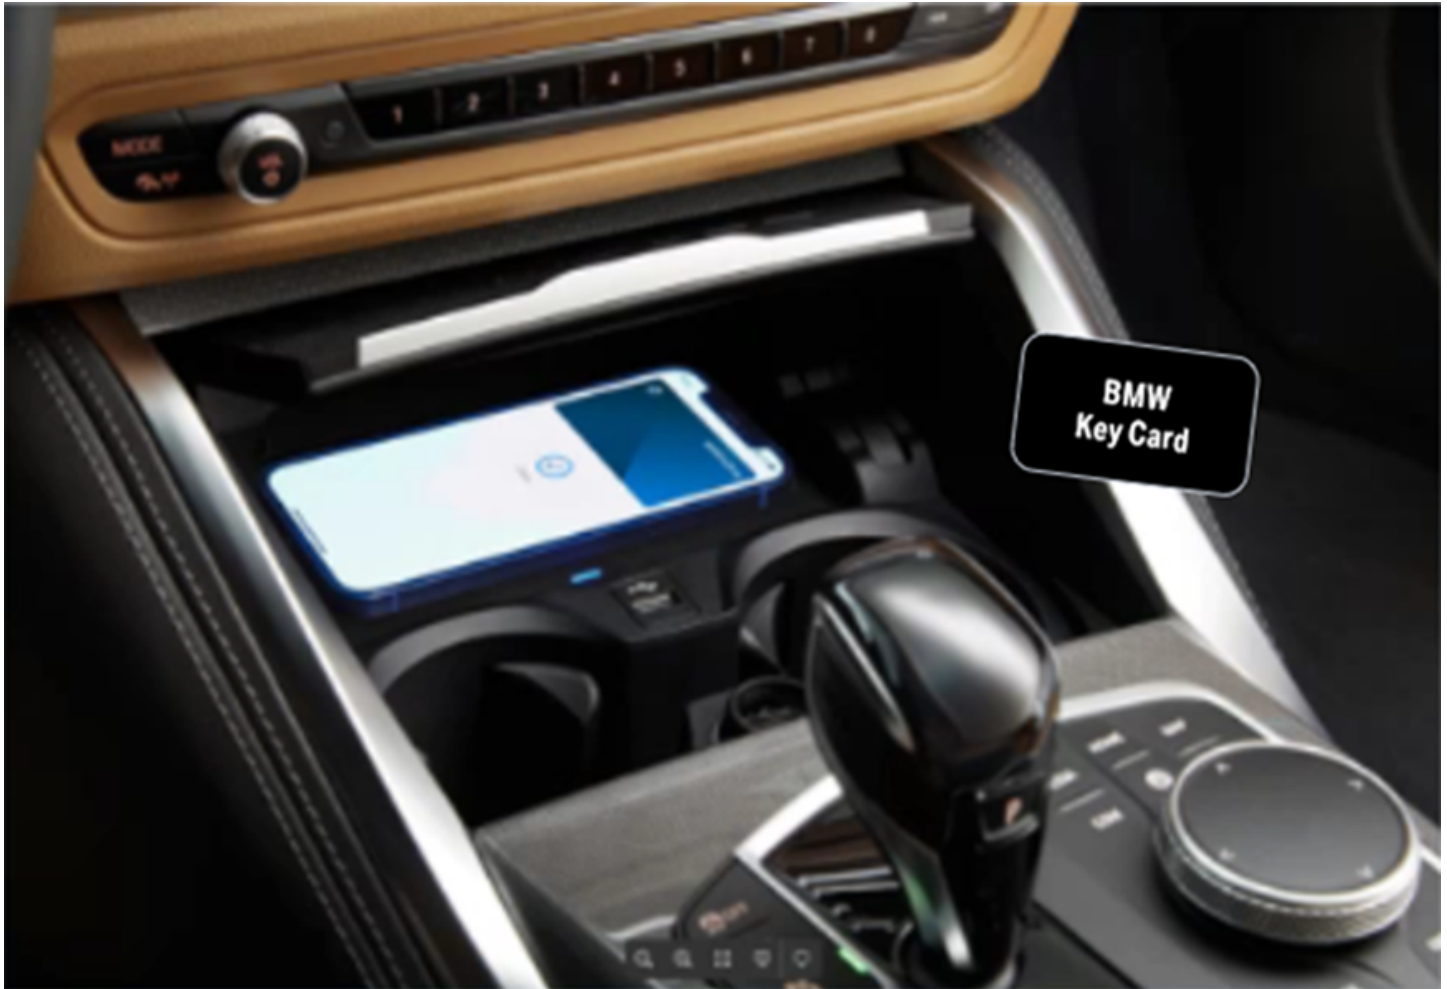
Unfavorable software causes the vehicle to not detect when the digital key (mobile phone/BMW Key Card) is removed from the wireless charging station (WCA). It is still possible to operate the window regulators, sunroof and convertible top for a certain period of time until the vehicle is locked, despite the digital key being removed from the WCA.

Example below: Wireless Charging Tray with either the BMW Key Card or a telephone with the Digital Key activated.

Program the complete vehicle with the correct software. This software will not be available until July 2023. This bulletin will be updated when the software becomes available.

In the interim, BMW has devised a separate temporary procedure listed below to meet federal requirements.

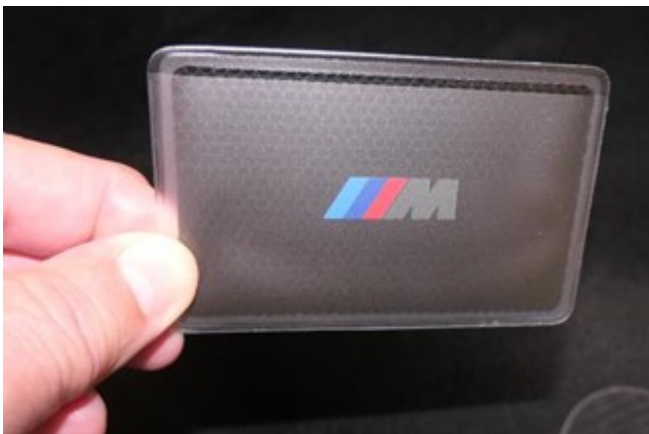
Card for an M model shown; cards for non-M models are similar.

a. Remove the digital key (BMW Key Card) from the vehicle.

b. The current BMW Key Card must be destroyed or damaged, and disposed of.

c. Before vehicle delivery to the customer, the customer must sign the form to confirm that the use of the WCA has been temporarily restricted. The corresponding form is an attachment to this<sup>[1]</sup> SIB and/or included in the vehicle glovebox.
