March 10, 2023

Version 1

Safety Recall: 2019 Insight Front Seat Belt Buckle Repair

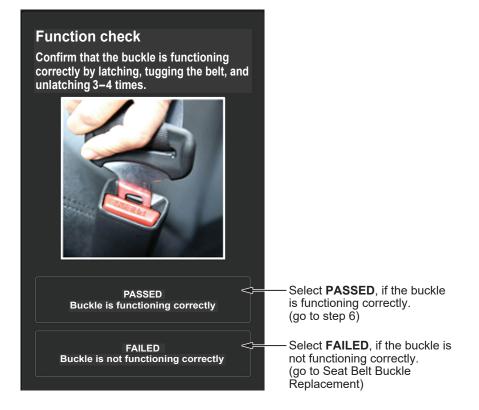
5. Insert the tongue into the buckle and tug on the seatbelt to confirm the buckle is securely latched. Unlatch the buckle and repeat the process **3** to **4** times.

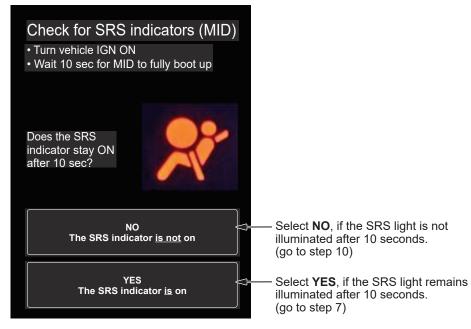
6. Check for an SRS indicator light on in the instrument panel. Press the start button twice to set the power mode to ON and monitor the SRS indicator. The indicator should illuminate and then turn off within **10 seconds**.

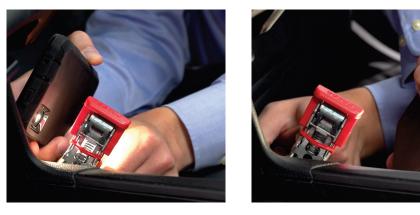
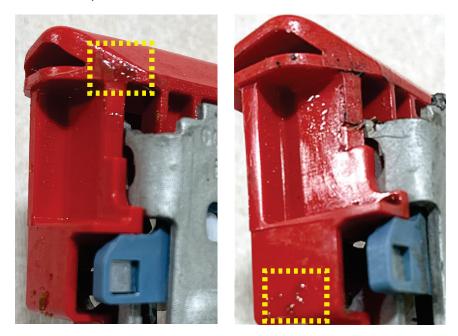
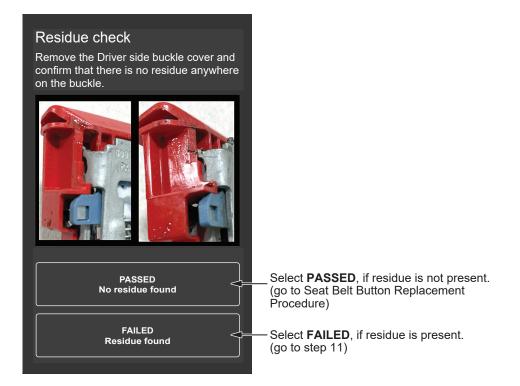
NOTE: Examples of buckles with residue that would cause the buckles to fail the residue check.

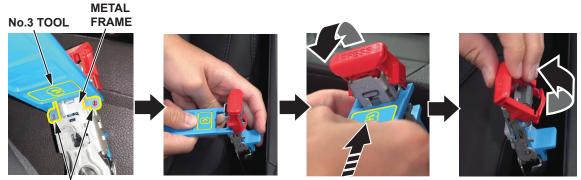
BLUE PLASTIC TABS

While holding the #2 tool, position the #3 tool outside the metal frame and just above the 2 blue plastic tabs.

Push the #3 tool to release the button.

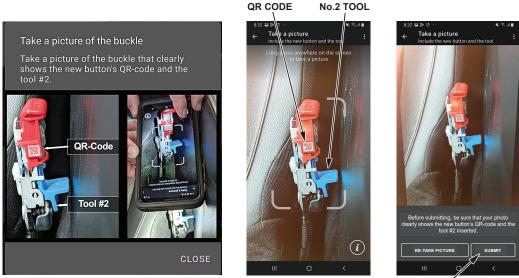
Take a picture of the buckle that clearly shows QR code on the new button, and the #2 tool inserted under the buckle bridge.

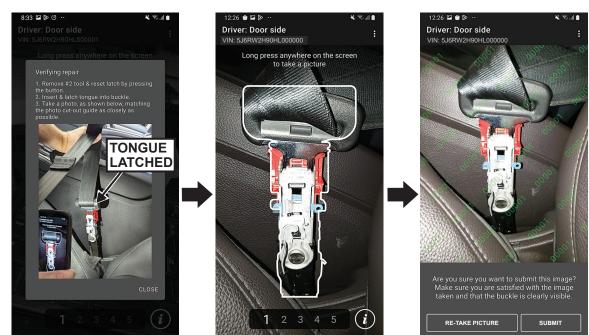
Insert the Seatbelt Tongue into the buckle and confirm it is latched. Pull up on the seatbelt to provide a clear view of the buckle.

Frame the picture using the app's cut-out guide. Long press on the screen to capture the picture.

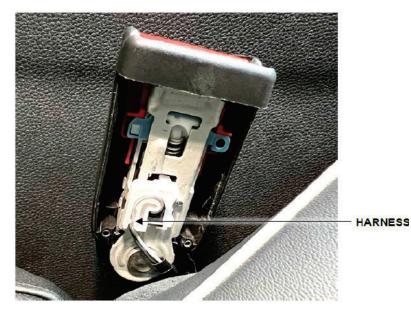
- 6. Final Function Check.
 - Make sure the harness wire is correctly set inside the groove before installing the lower buckle cover.

• Install the buckle cover.

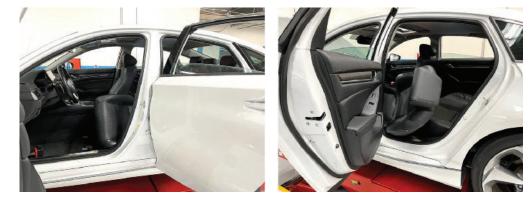
Lift and move the seat back while leaning the seatback into the rear door opening to lay the seat on its side.
 NOTE: To prevent scratching/damaging the center console, do not allow the seat rails to contact the center console.

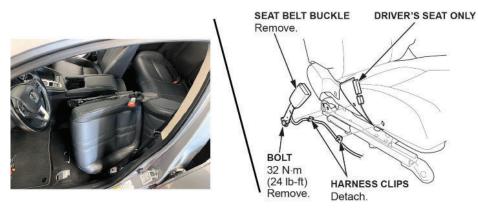
9. With the seat laying on its side, remove the seat belt buckle from the seat frame.

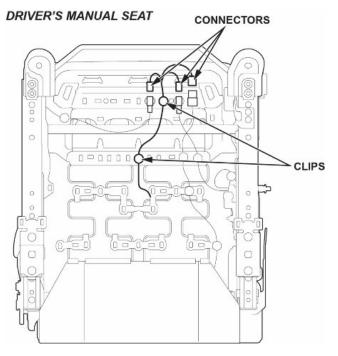
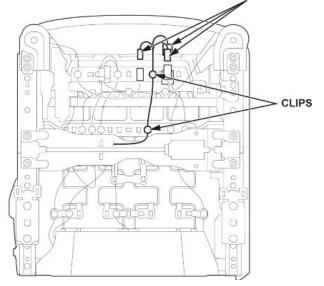
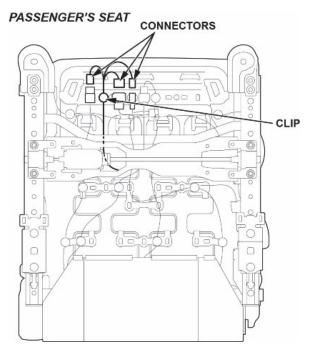
DRIVER'S POWER SEAT

• Detach the harness clip(s) and connector clip(s).

CONNECTORS

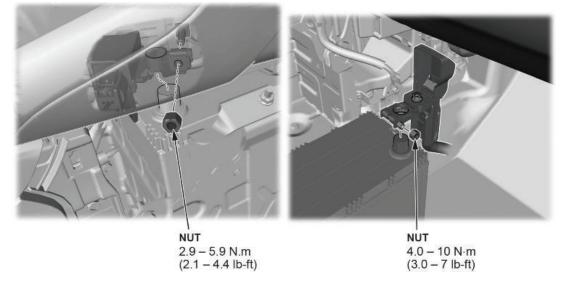
12. Reconnect the cable with the 12 volt battery sensor to the 12 volt battery.

NOTE: To protect the connector battery sensor from damage, do not hold it when installing the terminal.

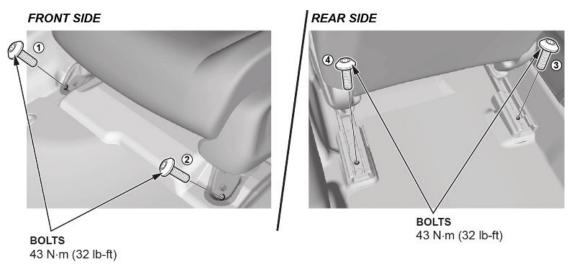
14. Adjust the seat as needed to tighten the bolts to the specified torque in the sequence shown.

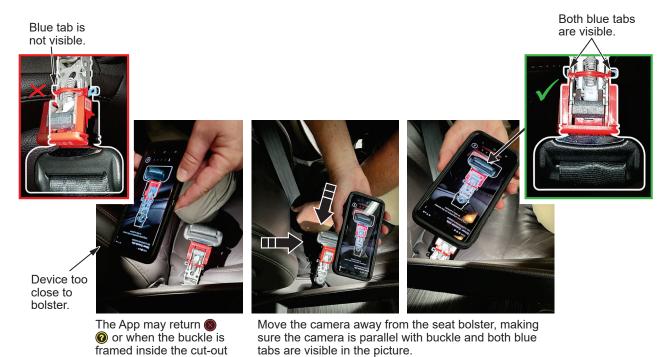
7. Application is unable to verify the repair Picture #3 – G-mass Camera Angle. Some camera angles make it difficult for the application to judge the repair photo. If this occurs, position the camera making sure the camera is parallel with the face of the buckle as shown below. The pictures to the left illustrate a camera angle taken from the side of the buckle. The pictures on the right illustrate a camera angle taken with the camera parallel with and directly in front of the buckle.
