**March 16, 2023**

Version 2

## Safety Recall: 2018–20 Odyssey Front Seat belt Buckle Repair

Supersedes 23-001, dated March 10, 2023, to revise the information highlighted in yellow.

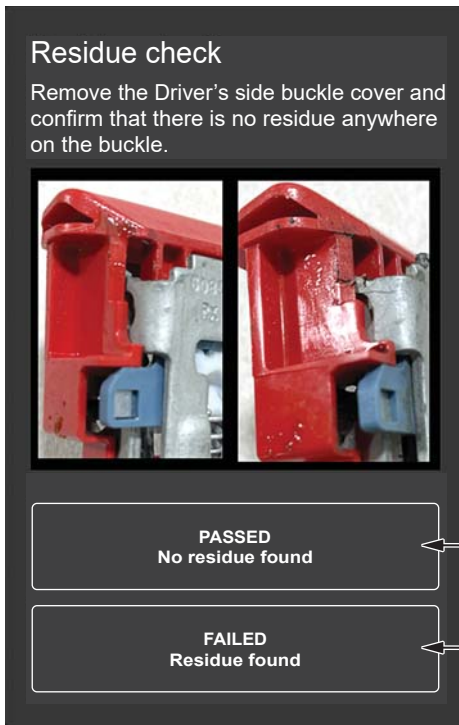
NOTE: Examples of buckles with residue that would cause the buckles to fail the residue check.

Select **PASSED**, if residue is not present.  
(go to Seat Belt Button Replacement Procedure)

Select **FAILED**, if residue is present.  
(go to step 11)

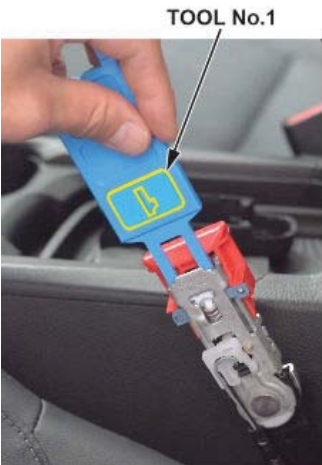
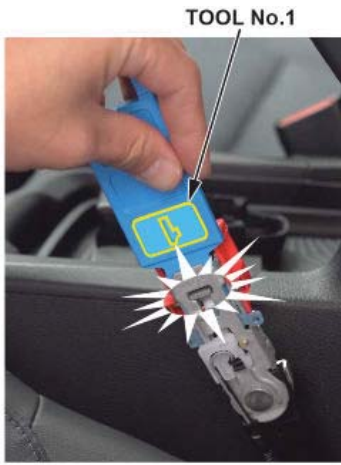
2. Insert the #1 tool into the buckle, listen for a click to confirm the buckle is latched, then remove the tool.

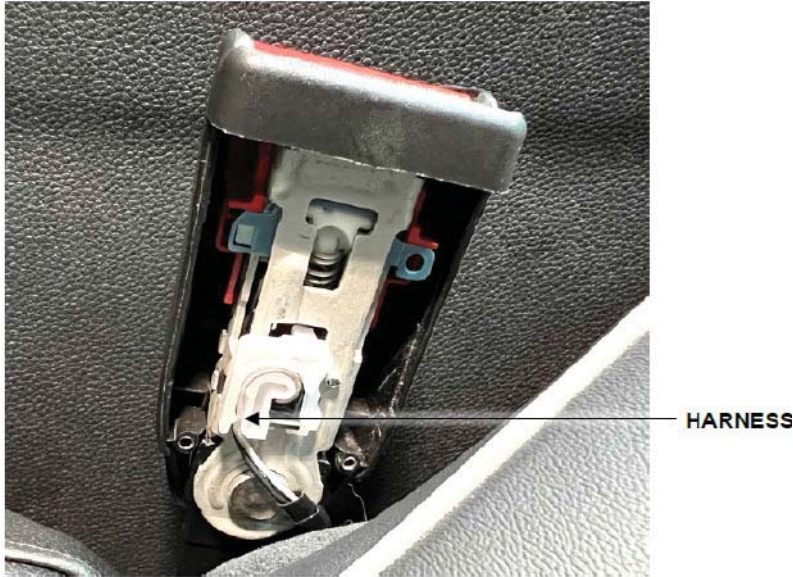
- Make sure the harness wire is correctly set inside the groove before installing the lower buckle cover.

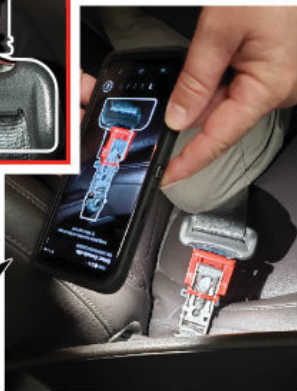
Device too close to bolster.

7. Application is unable to verify the repair Picture #3 – G-mass Camera Angle. Some camera angles make it difficult for the application to judge the repair photo. If this occurs, position the camera making sure the camera is parallel with the face of the buckle as shown below. The pictures to the left illustrate a camera angle taken from the side of the buckle. The pictures on the right illustrate a camera angle taken with the camera parallel with and directly in front of the buckle.
