## Safety Recall: 2019–20 RDX Front Seat Belt Buckle Repair

Due to improper manufacturing of the seat belt buckle channel, the front seat belt buckles may not latch properly. An improperly latched seat belt buckle may not securely restrain occupant(s), increasing the risk of injury to the occupant.

Inspect the seat belt buckle. Replace the button or replace the complete buckle assembly based on the inspection results.

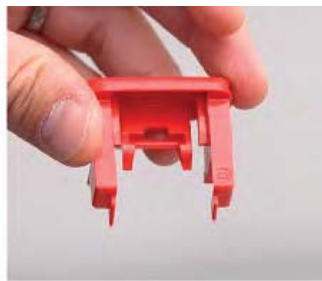
- Using side-cutters, remove the bridge from the old button then discard it.

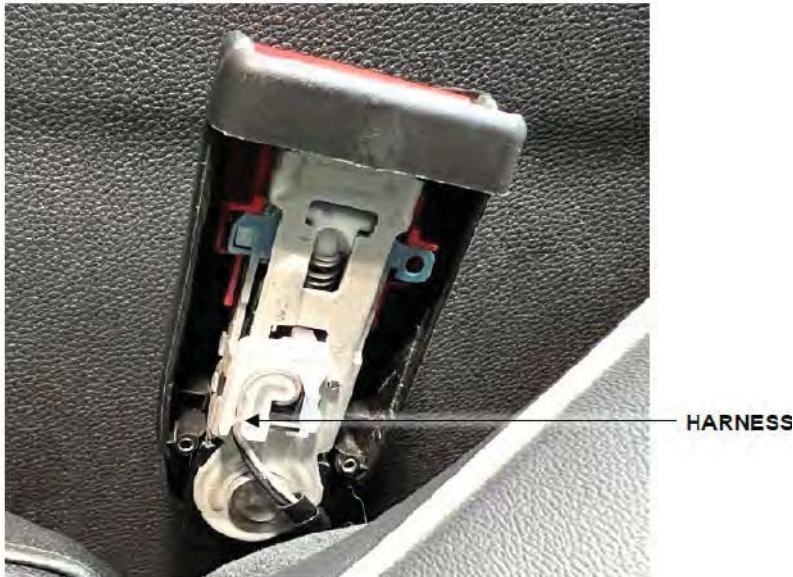
- Make sure the harness wire is correctly set inside the groove before installing the lower buckle cover.

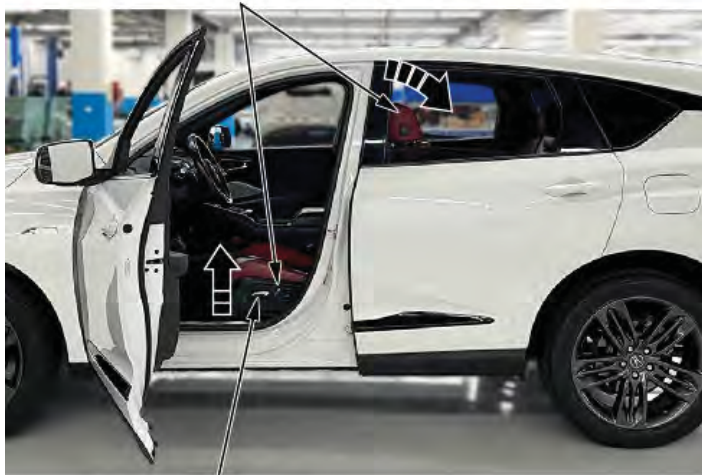
5. Adjust the seat to the rear most position, raise the seat height to the highest position (if equipped) and recline the seat back until the head restraint is behind the B-pillar.

Adjust seat-back angle with head restraint behind B-pillar.

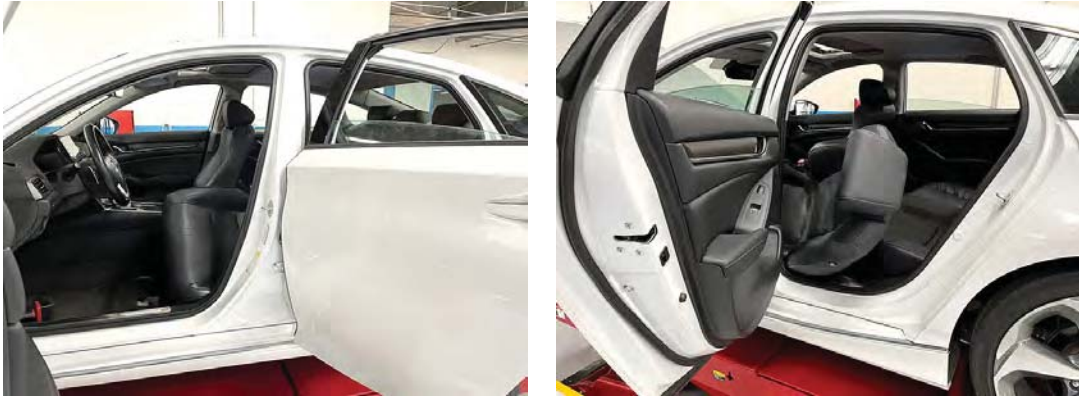
8. Lift and move the seat back while leaning the seatback into the rear door opening to lay the seat on its side.  
NOTE: To prevent scratching/damaging the center console, do not allow the seat rails to contact the center console.
