Safety Recall: 2019–20 RDX Front Seat Belt Buckle Repair

Supersedes 23-005, dated March 16, 2023, to revise the information highlighted in **yellow**.

AFFECTED VEHICLES

Year	Model	Trim	VIN Range
2019–20	RDX	ALL	Check the iN VIN status for eligibility.

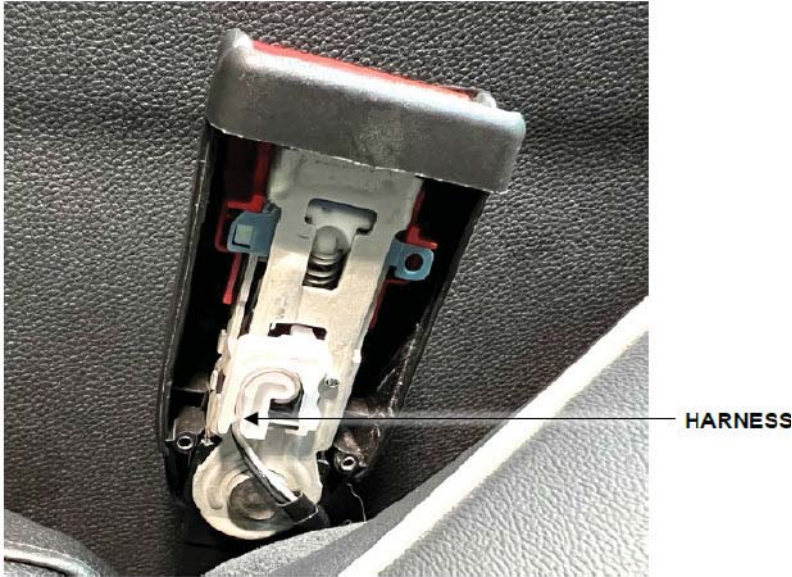
- Make sure the harness wire is correctly set inside the groove before installing the lower buckle cover.

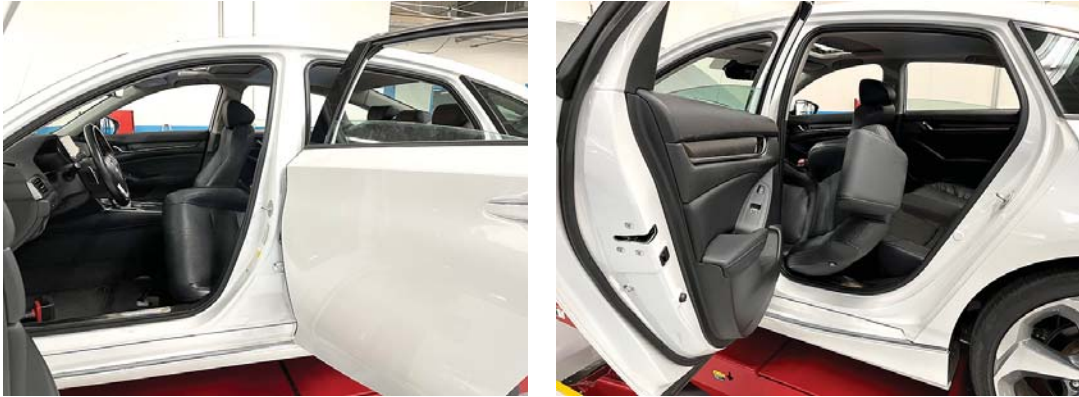
8. Lift and move the seat back while leaning the seatback into the rear door opening to lay the seat on its side.
 NOTE: To prevent scratching/damaging the center console, do not allow the seat rails to contact the center console.

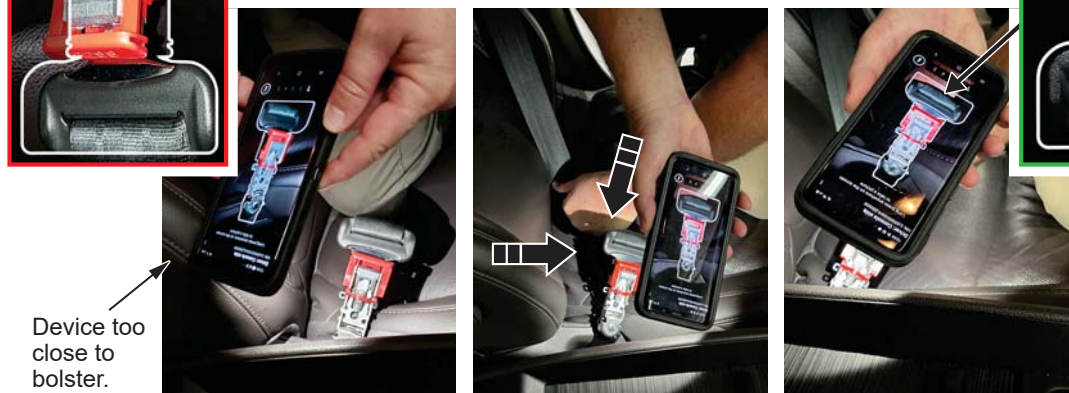
7. Application is unable to verify the repair Picture #3 – G-mass Camera Angle. Some camera angles make it difficult for the application to judge the repair photo. If this occurs, position the camera making sure the camera is parallel with the face of the buckle as shown below. The pictures to the left illustrate a camera angle taken from the side of the buckle. The pictures on the right illustrate a camera angle taken with the camera parallel with and directly in front of the buckle.
