March 24, 2023

Version 3

Safety Recall: 2018–20 Odyssey Front Seat Belt Buckle Repair

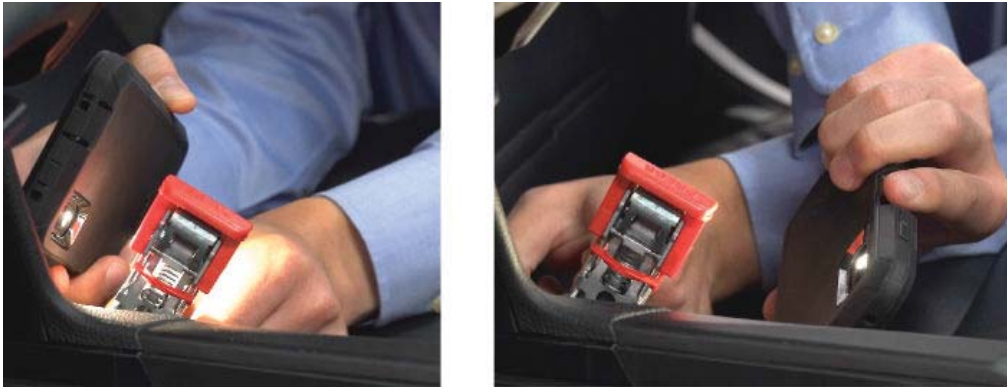
NOTE: Examples of buckles with residue that would cause the buckles to fail the residue check.

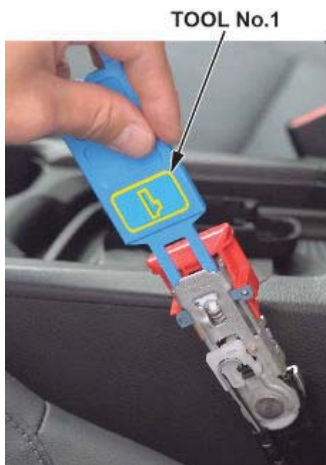
2. Insert the #1 tool into the buckle, listen for a click to confirm the buckle is latched, then remove the tool.

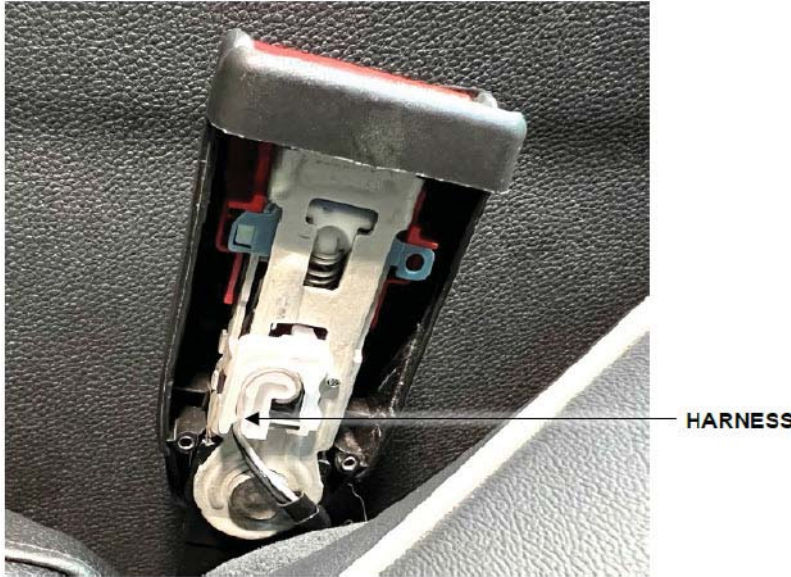
- Make sure the harness wire is correctly set inside the groove before installing the lower buckle cover.

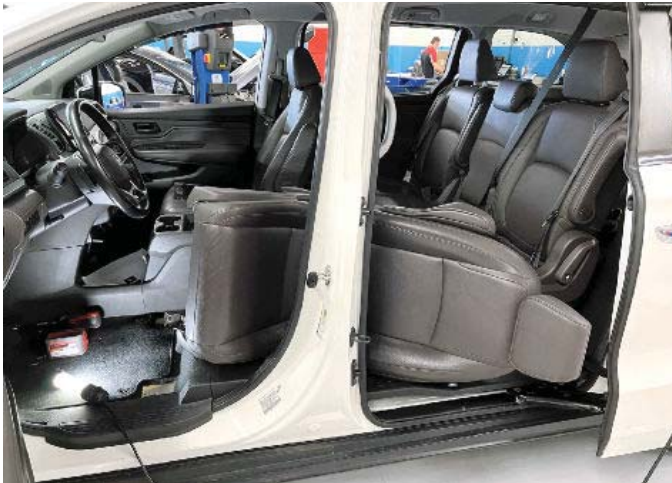
8. Lift and move the seat back while leaning the seatback into the rear door opening to lay the seat on its side.
NOTE: To prevent scratching/damaging the center console, do not allow the seat rails to contact the center console.

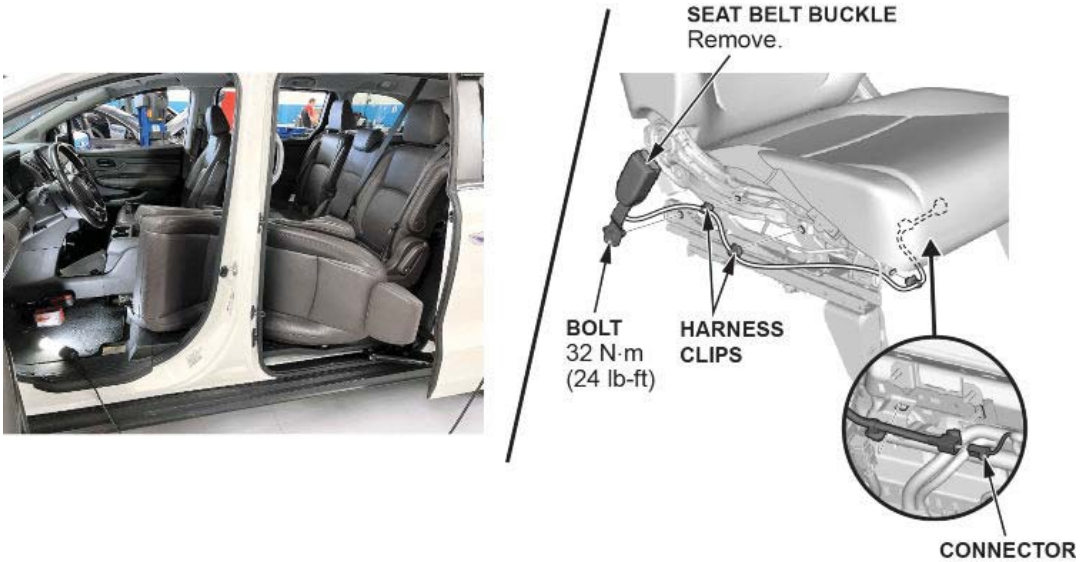
9. With the seat laying on its side, remove the seat belt buckle from the seat frame.
