**March 10, 2023**

Version 1

## Safety Recall: 2018–19 Accord Front Seat Belt Buckle Repair

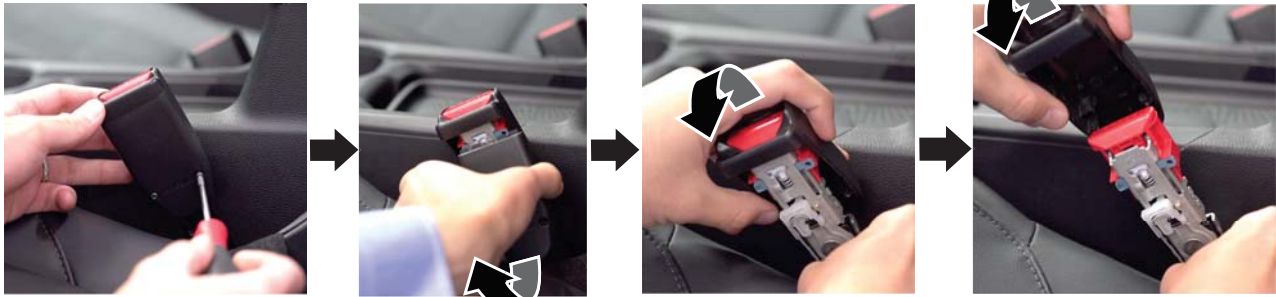
10. Residue check.

Carefully remove the 2 Torx screws from the cover using a T10 Safety Torx Bit.

Remove the cover by gently pulling it away and downward.

Then remove the upper cover by pulling it away and upward.

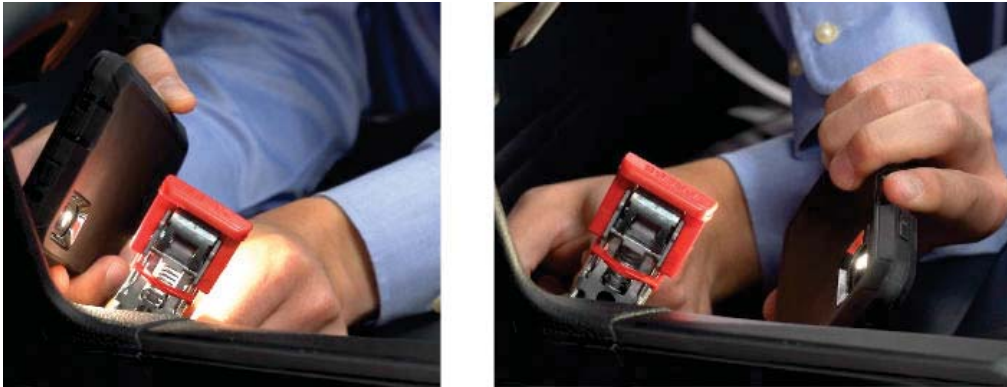
- If equipped, lower the seat to gain better access to the torx screws that secure the cover to the buckle.
- Put the covers and screws in a secure location for installation at a later process.
- The devices flashlight will turn on automatically. Use the flashlight to thoroughly examine the buckle and button, looking for any type of sticky residue that could cause the button to not operate correctly.

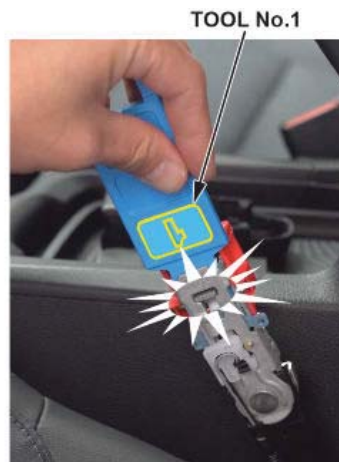
2. Insert the #1 tool into the buckle, listen for a click to confirm the buckle is latched, then remove the tool.

3. Install the #2 tool to secure the G-mass Sensor. The #2 tool MUST BE USED during the button replacement procedure to prevent the G-mass from falling out of place.

#2 TOOL INSTALLED AND SECURING G-MASS

Pull the buckle away from the center console to prevent scratching/damaging the console when installing the #2 tool.

Insert the forks of the tool under the button bridge and slide it upward into place.

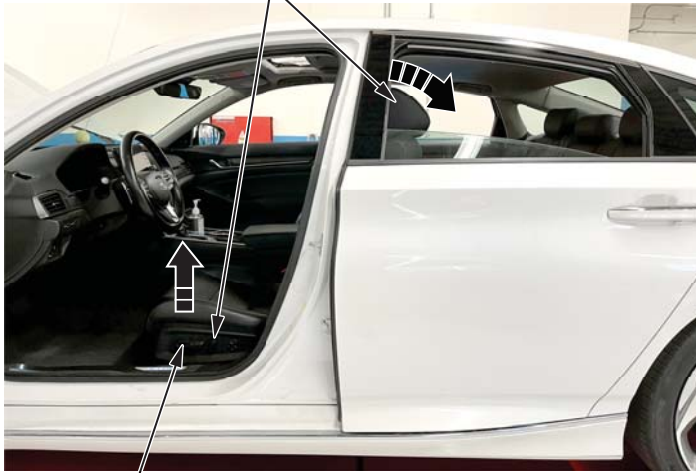
5. Adjust the seat to the rear most position, raise the seat height to the highest position (if equipped) and recline the seat back until the head restraint is behind the B-pillar.

Adjust seat-back angle with  
head restraint behind B-pillar.

Raise seat height to the  
highest position (if equipped)

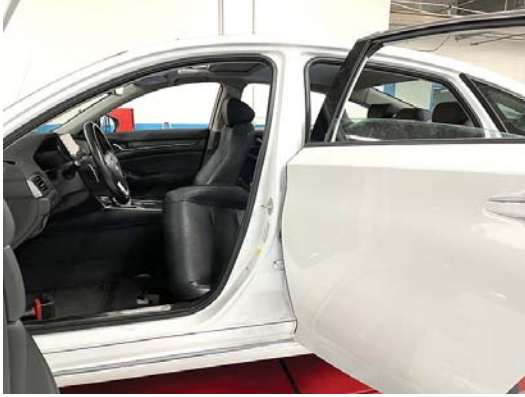
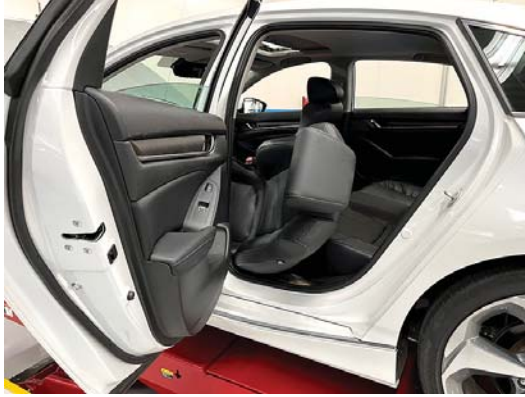
8. Lift and move the seat back while leaning the seatback into the rear door opening to lay the seat on its side.  
NOTE: To prevent scratching/damaging the center console, do not allow the seat rails to contact the center console.
