March 16, 2023

Version 2

Safety Recall: 2019 Insight Front Seat Belt Buckle Repair

Due to improper manufacturing of the seat belt buckle channel, the front seat belt buckles may not latch properly. An improperly latched seat belt buckle may not securely restrain occupant(s), increasing the risk of injury to the occupant.

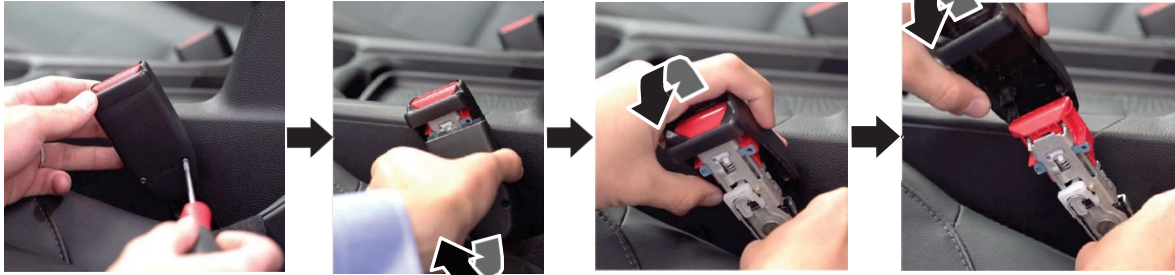
10. Residue check.

Carefully remove the 2 Torx screws from the cover using a T10 Safety Torx Bit.

Remove the cover by gently pulling it away and downward.

Then remove the upper cover by pulling it away and upward.

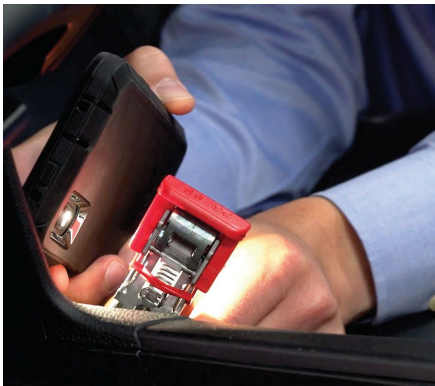
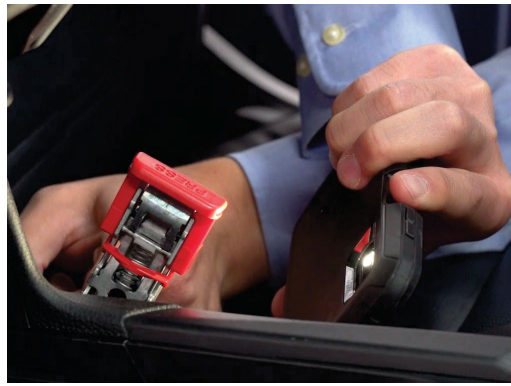
- If equipped, lower the seat to gain better access to the torx screws that secure the cover to the buckle.
- Put the covers and screws in a secure location for installation at a later process.
- The devices flashlight will turn on automatically. Use the flashlight to thoroughly examine the buckle and button, looking for any type of sticky residue that could cause the button to not operate correctly.

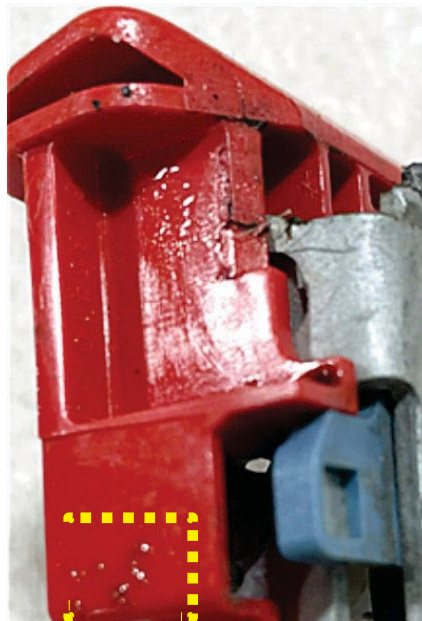
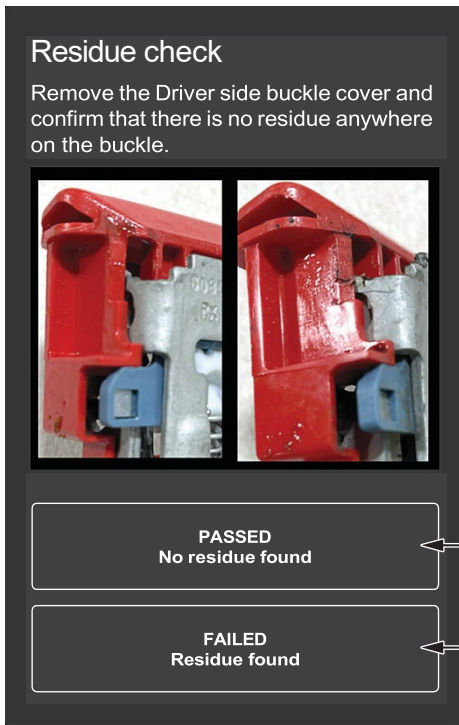
NOTE: Examples of buckles with residue that would cause the buckles to fail the residue check.

Select **PASSED**, if residue is not present.
(go to Seat Belt Button Replacement Procedure)

Select **FAILED**, if residue is present.
(go to step 11)

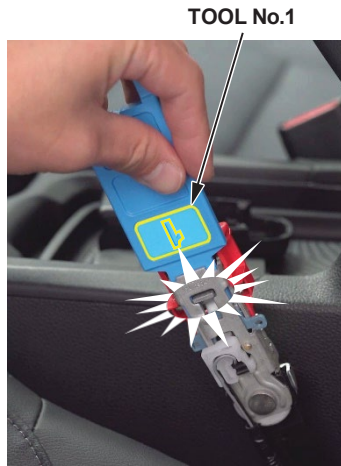
2. Insert the #1 tool into the buckle, listen for a click to confirm the buckle is latched, then remove the tool.

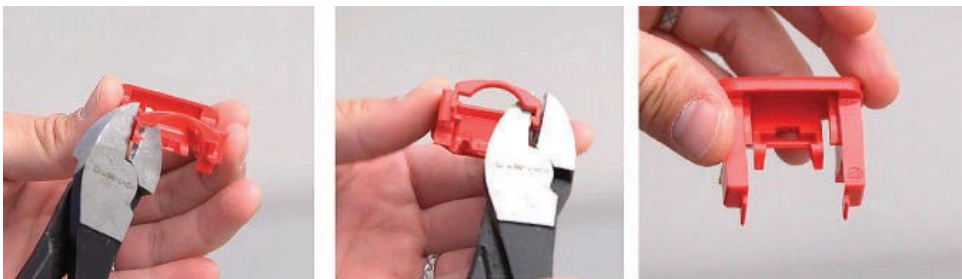
- Using side-cutters, remove the bridge from the old button then discard it.

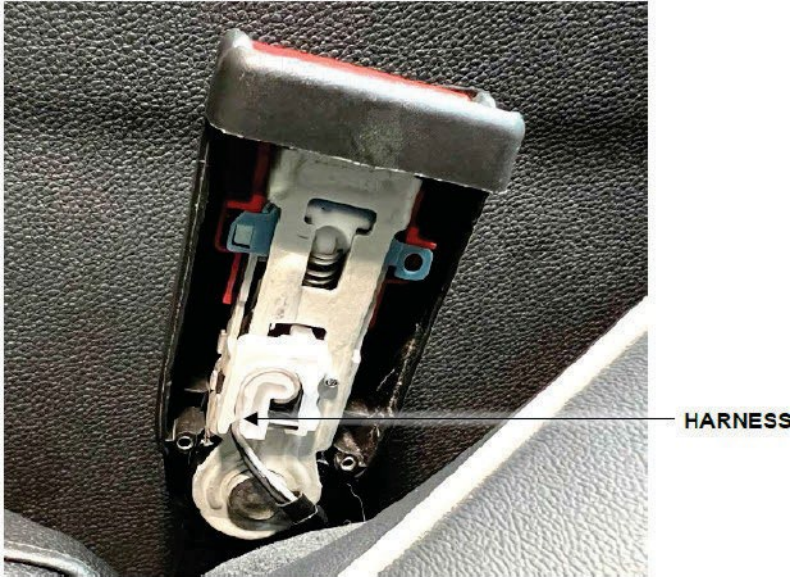
- Make sure the harness wire is correctly set inside the groove before installing the lower buckle cover.

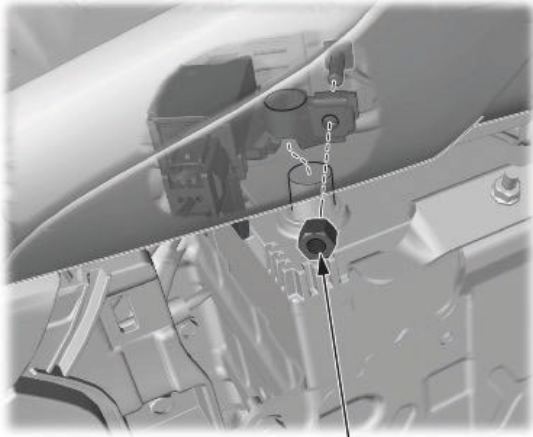
- Keep the driver's door open, and after turning the vehicle to the OFF (LOCK) mode.
- Always disconnect the negative side first.
- To protect the connector from damage, do not hold it when removing the terminal.
- Do not disconnect the 12 volt battery sensor from the cable.
- Wait **3 minutes** before starting work.

NUT
2.9 – 5.9 N.m
(2.1 – 4.4 lb-ft)

NUTS
9.4 N.m (6.9 lb-ft)
