March 24, 2023

Safety Recall: 2017–20 CR-V Front Seat Belt Buckle Repair

Supersedes 23-002, dated March 16, 2023, to revise the information highlighted in **yellow**.

Due to improper manufacturing of the seat belt buckle channel, the front seat belt buckles may not latch properly. An improperly latched seat belt buckle may not securely restrain occupant(s), increasing the risk of injury to the occupant.

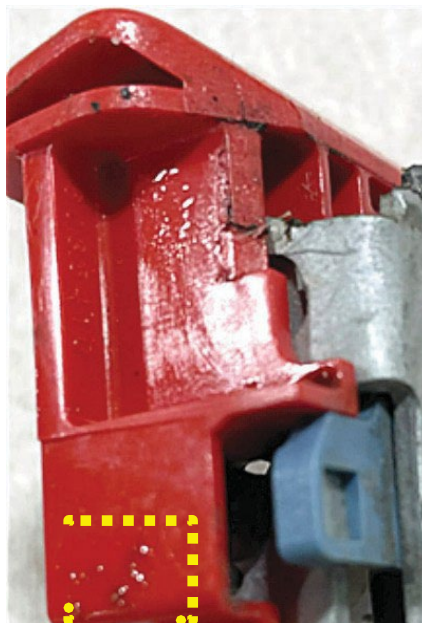
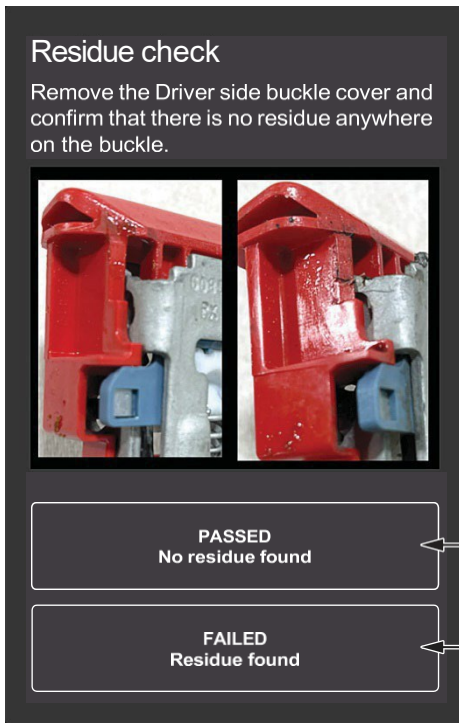
NOTE: Examples of buckles with residue that would cause the buckles to fail the residue check.

Select **PASSED**, if residue is not present.
(go to Seat Belt Button Replacement Procedure)

Select **FAILED**, if residue is present.
(go to step 11)

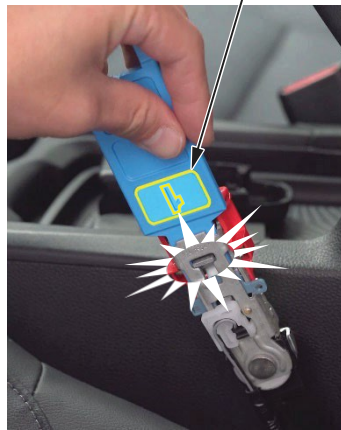
TOOL No.1

3. Install the #2 tool to secure the G-mass Sensor. The #2 tool MUST BE USED during the button replacement procedure to prevent the G-mass from falling out of place.

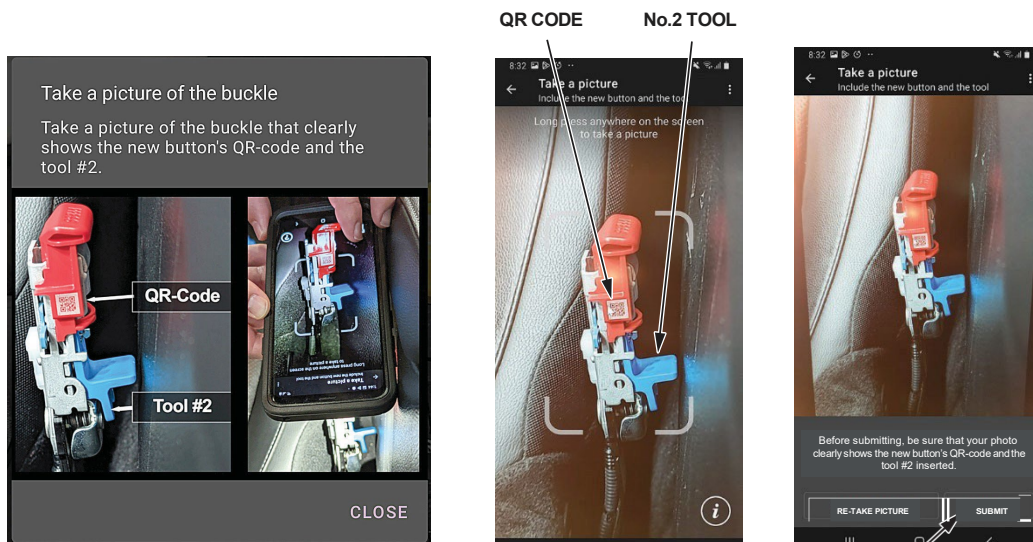
- Take a picture to confirm a new button is installed and the #2 tool was used to secure the G-mass sensor during the button replacement.

NOTE: The #2 tool must be captured in the picture. If the #2 tool is not visible in the picture, the repair will not pass during the technician review and a complete buckle replacement will be required to complete the repair.

Take a picture of the buckle that clearly shows QR code on the new button, and the #2 tool inserted under the buckle bridge.

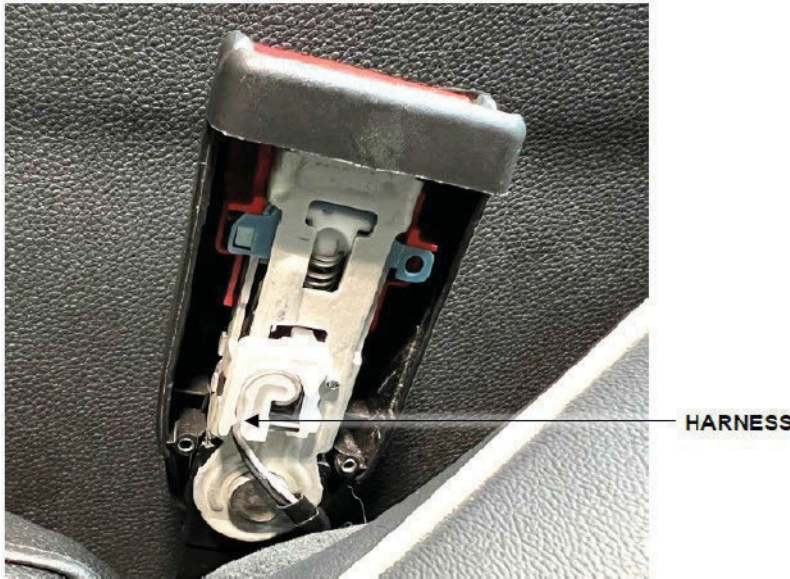
- Make sure the harness wire is correctly set inside the groove before installing the lower buckle cover.

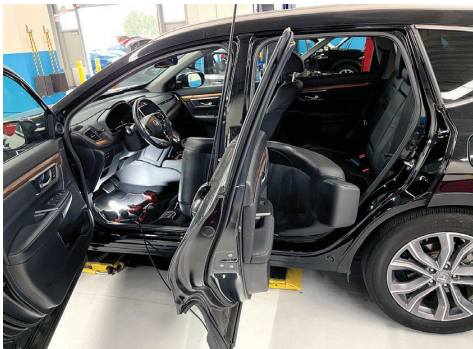
NOTE: To prevent scratching/damaging the center console, do not allow the seat rails to contact the center console.
