## Safety Recall: 2018–19 Accord Front Seat Belt Buckle Repair

Supersedes 23-016 dated March 16, 2023, to revise the information highlighted in **yellow**.

Due to improper manufacturing of the seat belt buckle channel, the front seat belt buckles may not latch properly. An improperly latched seat belt buckle may not securely restrain occupant(s) in position during a collision.

Inspect the seat belt buckle. Replace the button or replace the complete buckle assembly based on the inspection results.

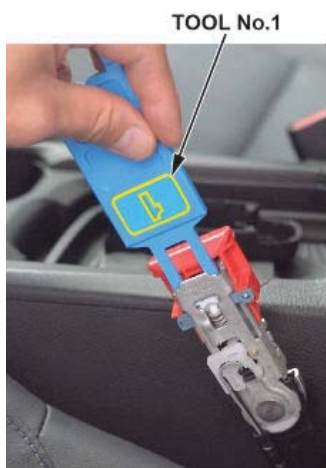
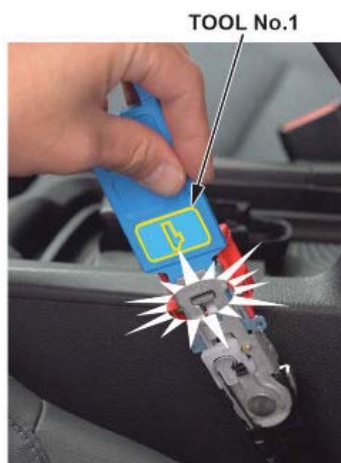
2. Insert the #1 tool into the buckle, listen for a click to confirm the buckle is latched, then remove the tool.

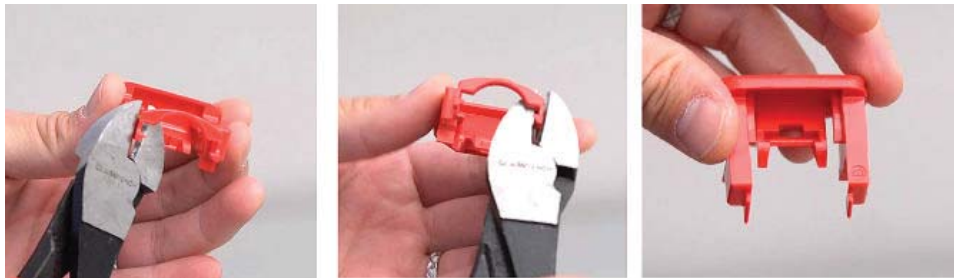
- Using side-cutters, remove the bridge from the old button then discard it.

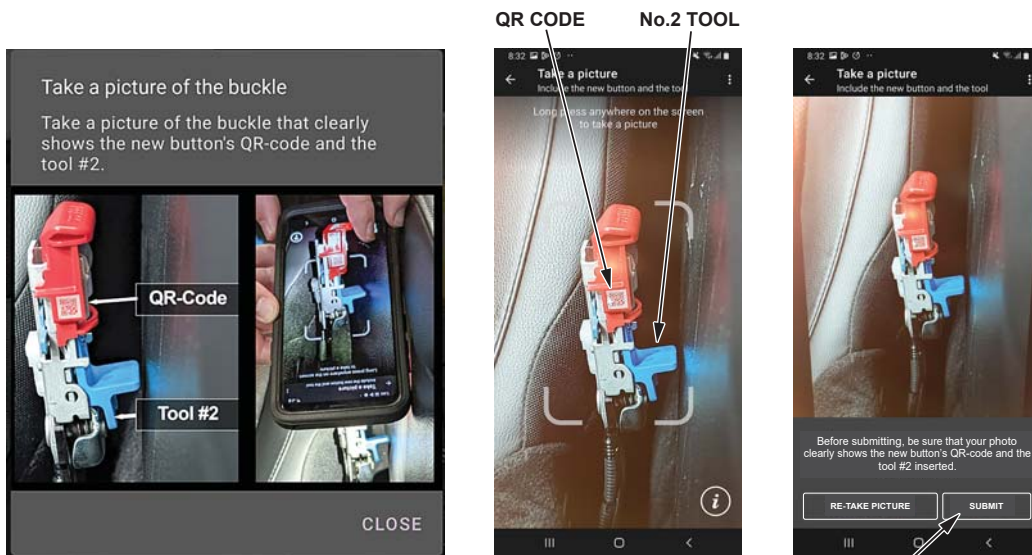
- Take a picture to confirm a new button is installed and the #2 tool was used to secure the G-mass sensor during the button replacement.

**NOTE: The #2 tool must be captured in the picture. If the #2 tool is not visible in the picture, the repair will not pass during the technician review and a complete buckle replacement will be required to complete the repair.**

Take a picture of the buckle that clearly shows QR code on the new button, and the #2 tool inserted under the buckle bridge.

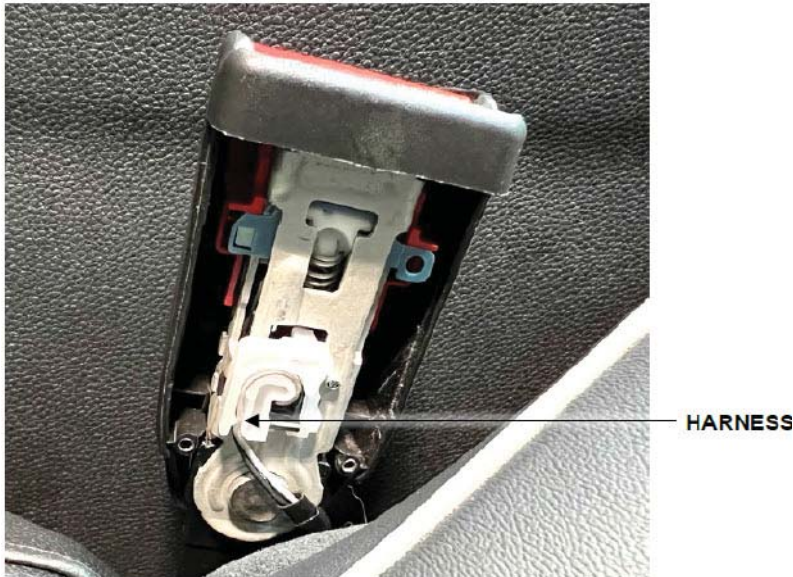
- Make sure the harness wire is correctly set inside the groove before installing the lower buckle cover.

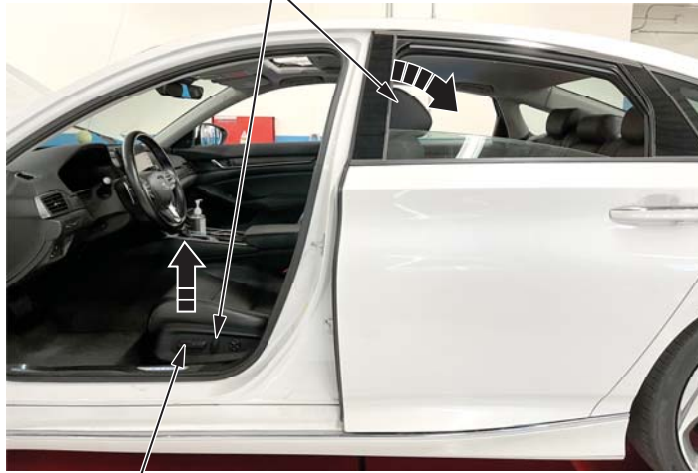
5. Adjust the seat to the rear most position, raise the seat height to the highest position (if equipped) and recline the seat back until the head restraint is behind the B-pillar.

Adjust seat-back angle with  
head restraint behind B-pillar.

Raise seat height to the  
highest position (if equipped)

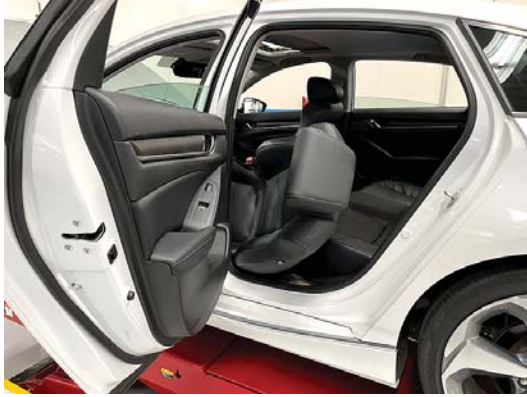
8. Lift and move the seat back while leaning the seatback into the rear door opening to lay the seat on its side.  
NOTE: To prevent scratching/damaging the center console, do not allow the seat rails to contact the center console.

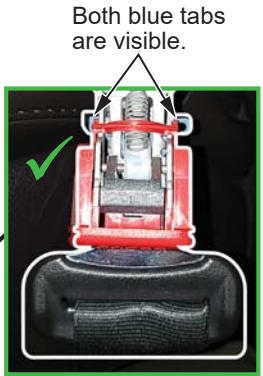
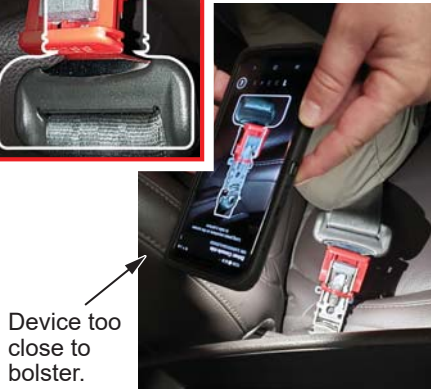
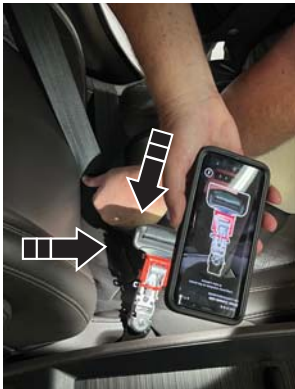
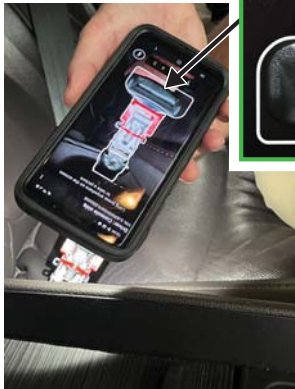
7. Application is unable to verify the repair Picture #3 – G-mass Camera Angle. Some camera angles make it difficult for the application to judge the repair photo. If this occurs, position the camera making sure the camera is parallel with the face of the buckle as shown below. The pictures to the left illustrate a camera angle taken from the side of the buckle. The pictures on the right illustrate a camera angle taken with the camera parallel with and directly in front of the buckle.

The App may return ❌ or when the buckle is framed inside the cut-out guide...
