Safety Recall: 2019–20 RDX Front Seat Belt Buckle Repair

Supersedes 23-005, dated March 10, 2023, to revise the information highlighted in **yellow**.

Due to improper manufacturing of the seat belt buckle channel, the front seat belt buckles may not latch properly. An improperly latched seat belt buckle may not securely restrain occupant(s), increasing the risk of injury to the occupant.

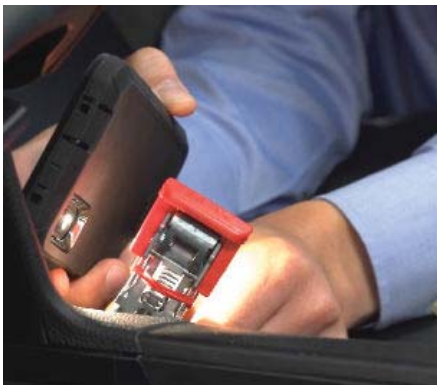
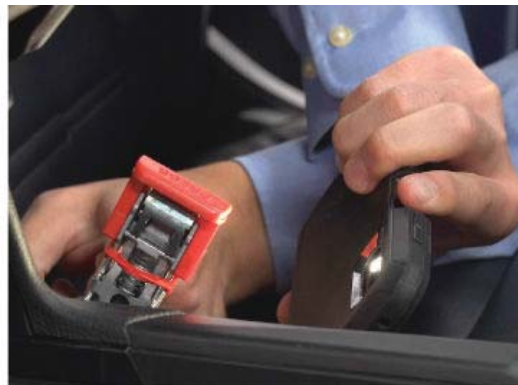
NOTE: Examples of buckles with residue that would cause the buckles to fail the residue check.

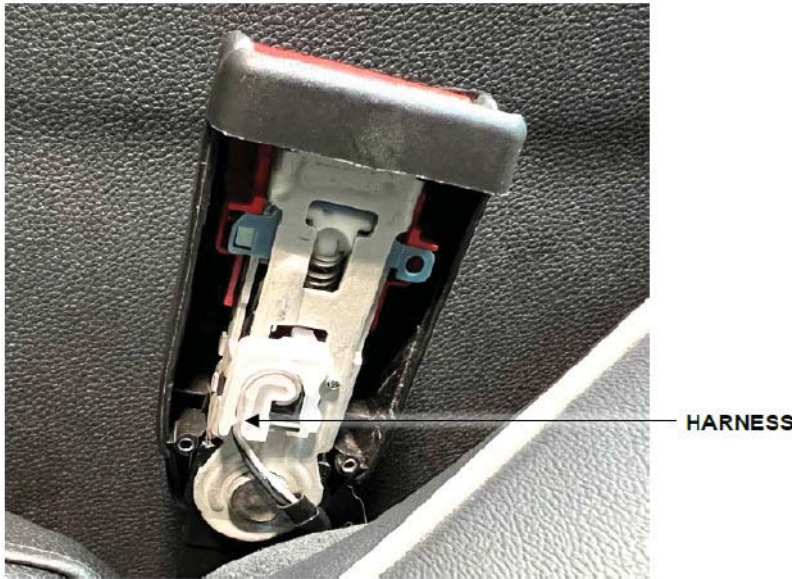
- Make sure the harness wire is correctly set inside the groove before installing the lower buckle cover.
