## Safety Recall 28A / NHTSA 23V-191 Frame Stud

#### 2020-2022 (JL) Jeep® Wrangler

### Subject

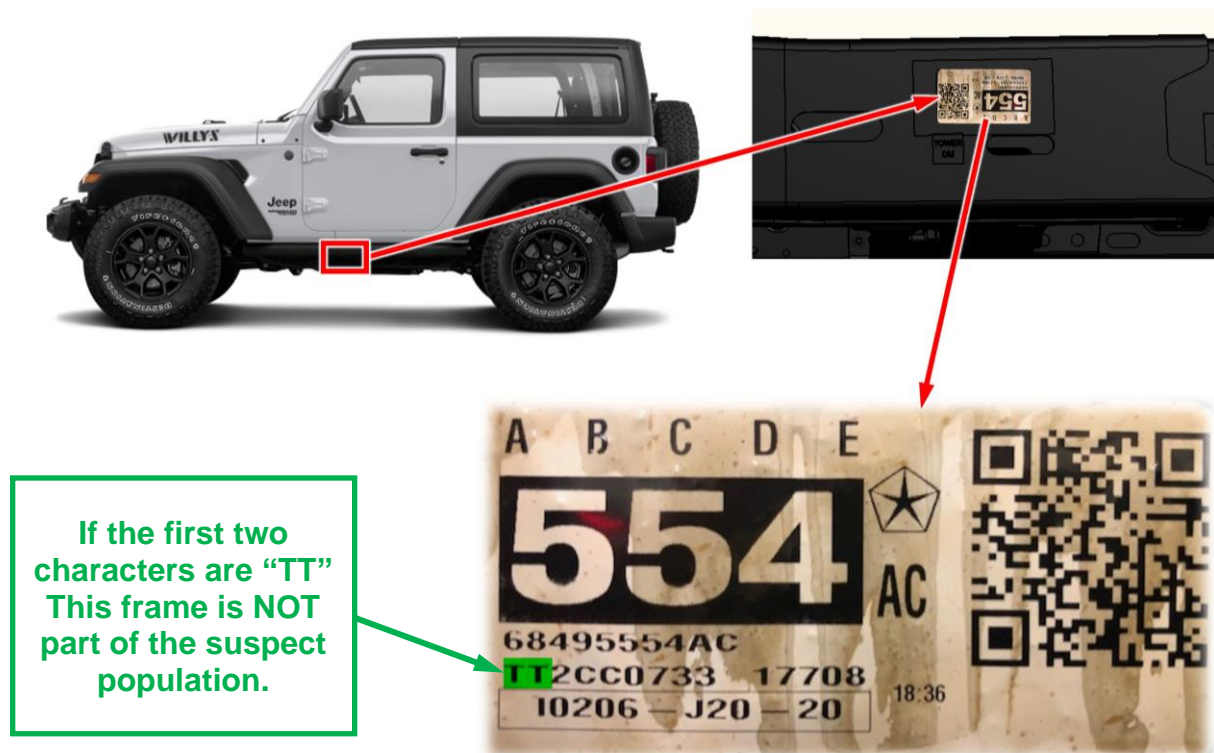
**Figure 1 – Front Reinforcement Crossmember**

1. Look for a label on the driver side frame rail just rearward of the door hinges.
2. If the label looks like (Figure 1) and is readable not missing or covered over by an aftermarket coating material, then read the label as instructed in (Figure 1).
3. If the label does NOT look like (Figure 1) or is unreadable, missing, or covered over by an aftermarket coating material, then proceed to **Section B. Frame Stud Inspection.**

4. What were the first two characters on the label as instructed in (Figure 1).
  - First two characters were "TT" – No further action required. Claim the appropriate inspection LOP and return vehicle to customer.
  - First two characters were some other combination of characters - Proceed to **Section B. Frame Stud Inspection.**
