Safety Recall

N232404980 Driver Front Airbag Inflator May Rupture

Release Date: February 2025

Revision: 03

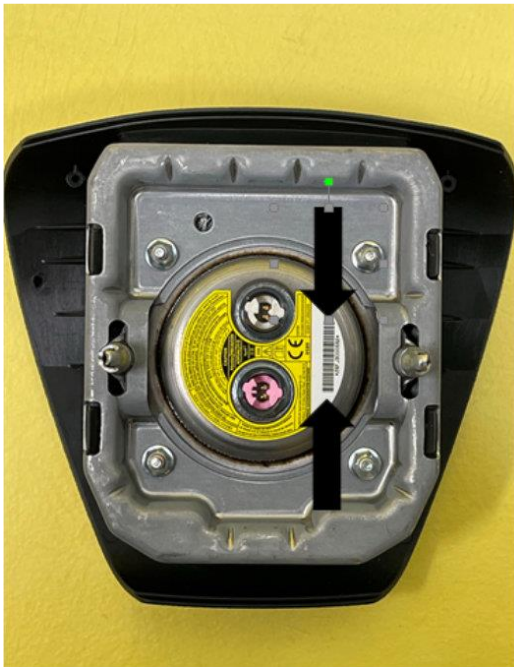
6524631

Important: (TECHNICIAN and WARRANTY ADMINISTRATOR) SERIAL NUMBER RECORDING REQUIREMENT. The replacement steering wheel airbag serial number must be captured by the technician and recorded on the job card. The Warranty Administrator **MUST** enter the serial numbers in GWM (Global Warranty Management) or in DMS (Dealer Management System). Enter the serial number of the **replacement airbag** in the 'Labor Operation Dependency Code' field per the screen shown.

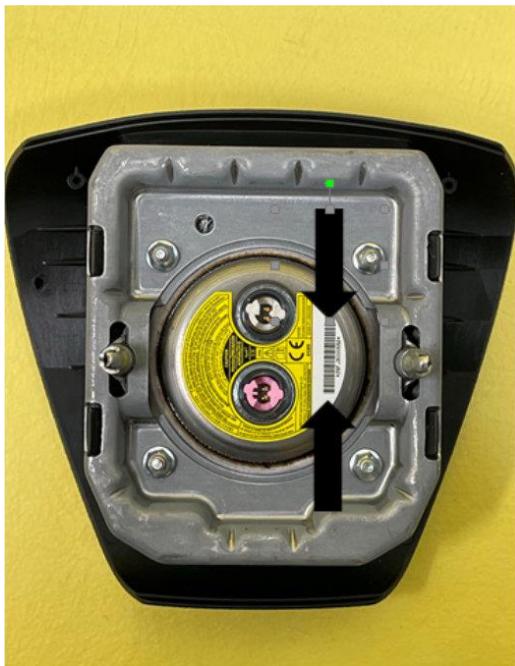
6524631

Note: DO NOT SCAN THE QR CODE ON THE SIDE OF THE AIRBAG MODULE. SCAN THE INFLATOR SERIAL NUMBER BARCODE ON THE BACK OF THE AIRBAG MODULE AS PICTURED ABOVE.

Note: Scanning the Inflator Serial Number Barcode will not populate all fields within the CSMT app. THE REMAINING FIELDS ARE NOT REQUIRED FOR THIS FIELD ACTION.

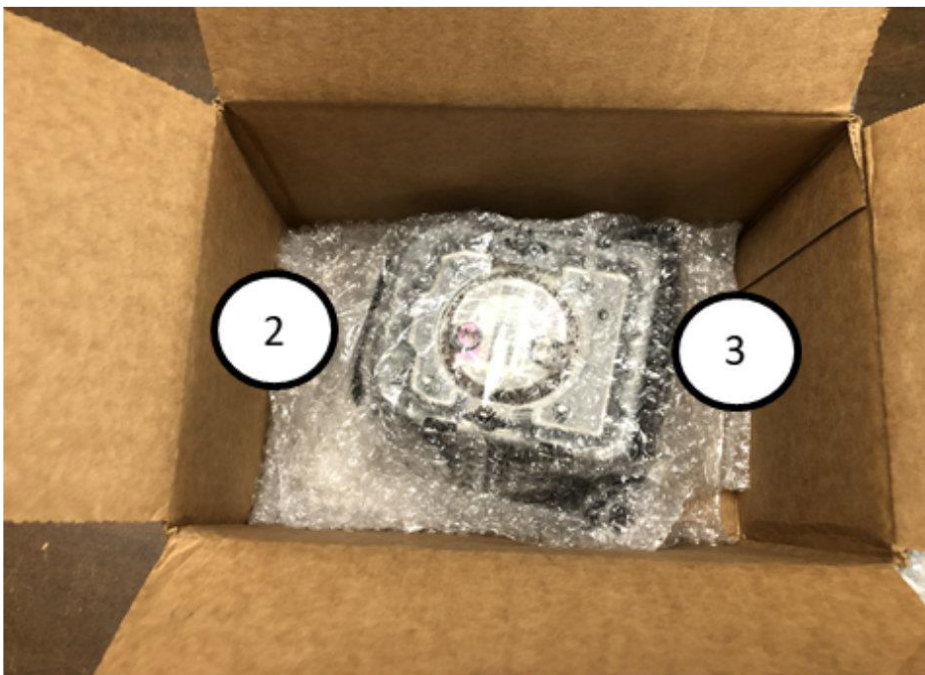
1. Confirm the original box is not damaged, allowing it useable to return ship. If a new box is required contact: scfieldaction.14305@rxo.com for a replacement box. There should be enough bubble wrap that the part will not shift during transport.

2. Wrap the airbag module in the bubble wrap from the original packaging.
3. Place the airbag module in the center of the box on top of bubble wrap.

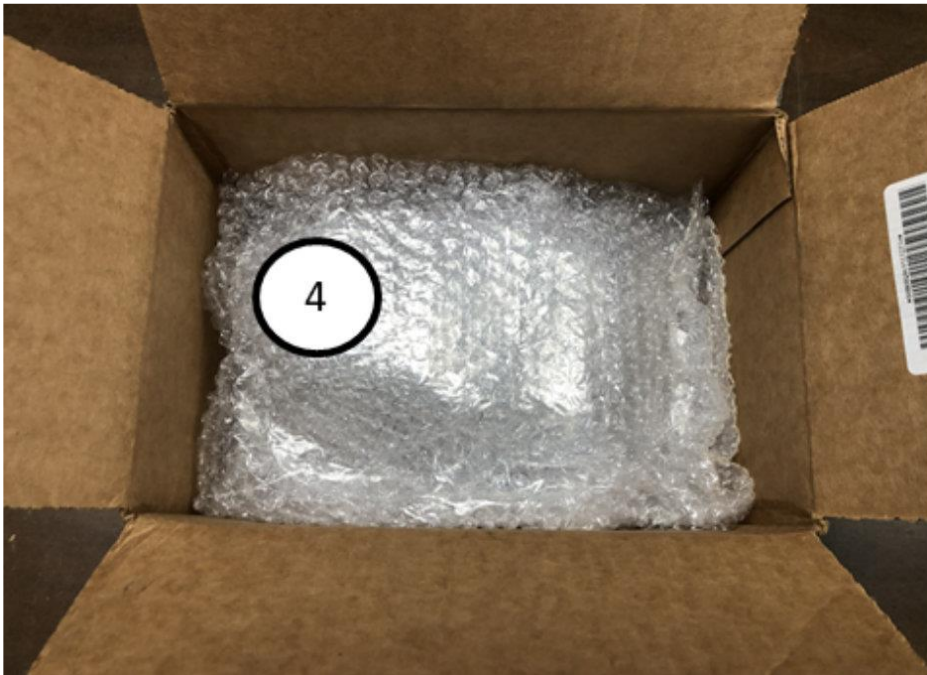
6543373

4. Place original bubble wrap around the airbag module to prevent movement inside the box.

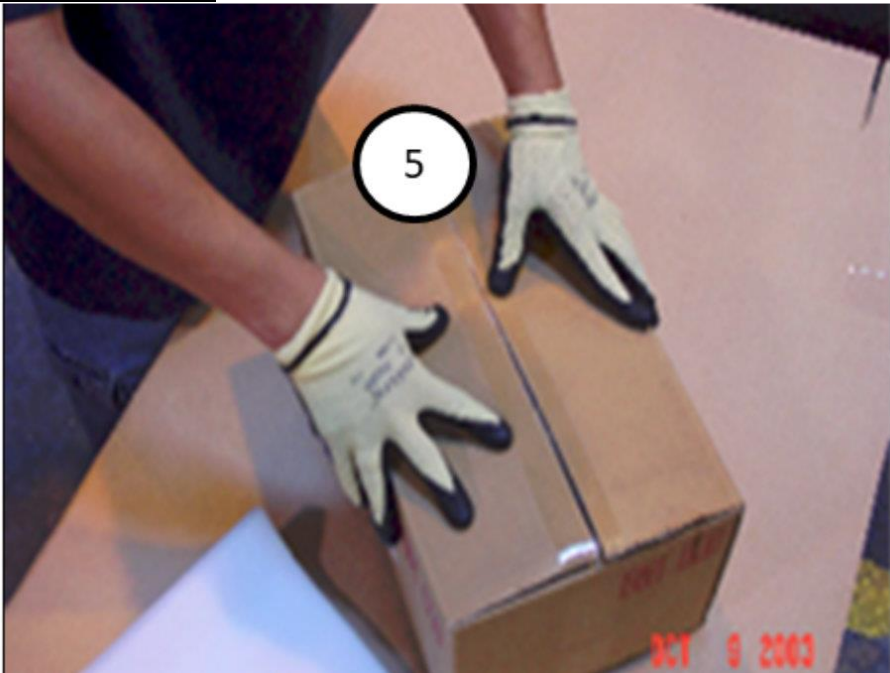
6543374

5. Use box sealing tape.
- Confirm flaps are flush prior to taping.

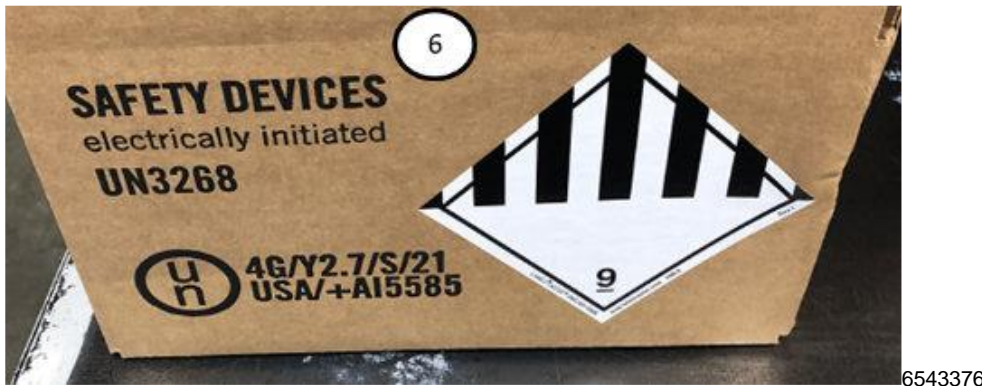
6. Compliance checks on box

- Confirm UN Specification number is in the upright position.
- DO NOT COVER “Up Arrows” and “Handle with Care” Markings.
- DO NOT COVER UN Package specification markings.
- Confirm the Class 9 label is not damaged or covered.

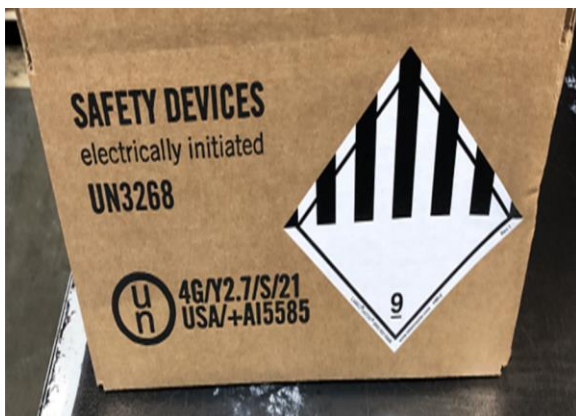
6787550

- Confirm box is in an acceptable condition. Box should have no visible signs of damage and should be capable of withstanding additional transportation.

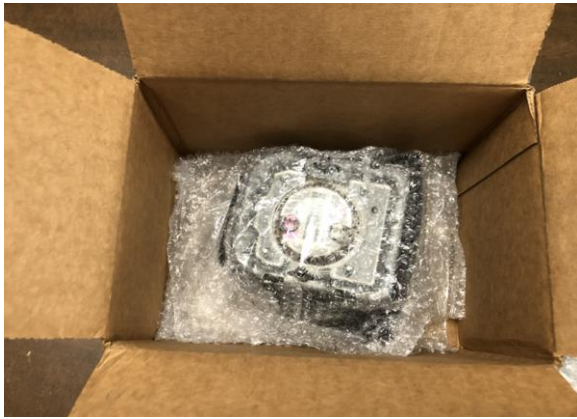
6787552

- Place the undeveloped airbag inflator or module in the “cradle” of the box insert.

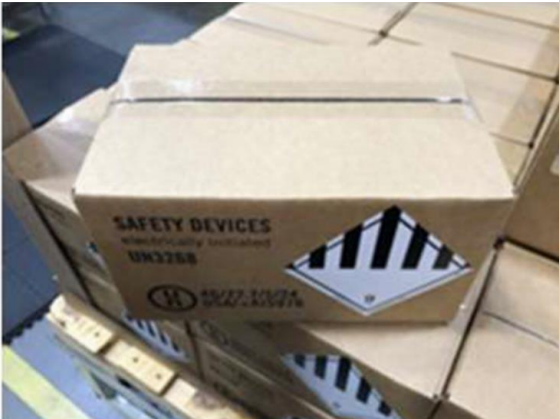
6787553

- Close the top box flaps using a piece of shipping tape to fully and securely close the box.

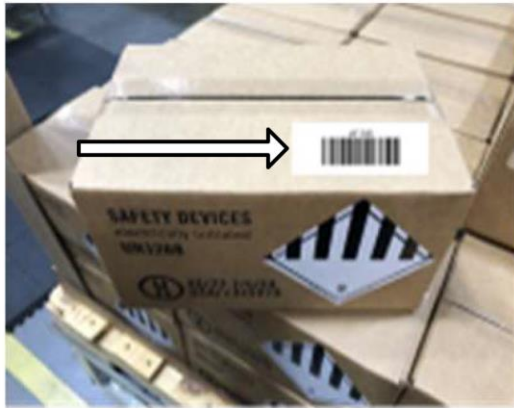
6787556

- Cut and affix the printed “New Leaf Label” to each box as shown in the above graphic. DO NOT COVER THE CLASS 9 MARKING.

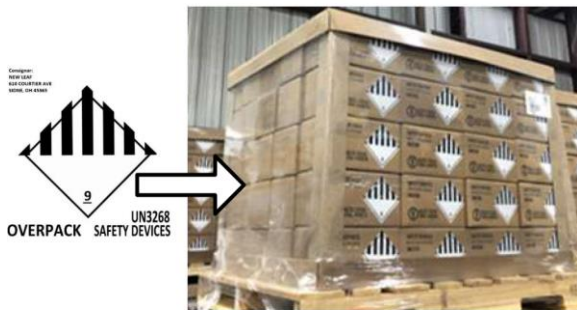
6787558

- Arrange the airbag modules on a pallet in acceptable condition as the above graphic illustrates.
 - 20 boxes per layer – 5 rows / 4 boxes in each row per layer.
 - 5 layers total per pallet (100 Boxes).
- Shrink-wrap the boxes to the pallet.
- Affix the over-pack label and pallet label on the side of the pallet. DO NOT PLACE THESE LABELS ON THE TOP OF THE PALLET.
- If 100 boxes have not been accumulated within a 2-week period, ship a partial pallet, ensuring proper label placement and packaging.
