INSTRUCTIONS TO PERFORM REMEDY FOR RECALL 175

Models Affected:

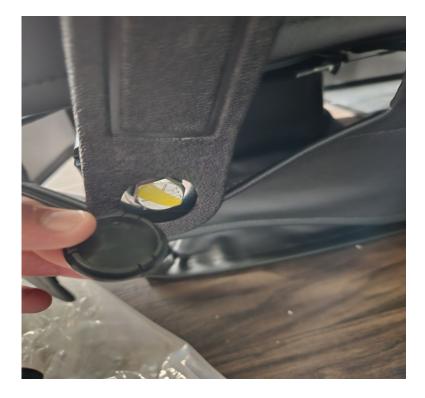
1. Remove caps from two inner seatbelt buckles attached to front seat pedestals with flat blade screwdriver or pry tool.

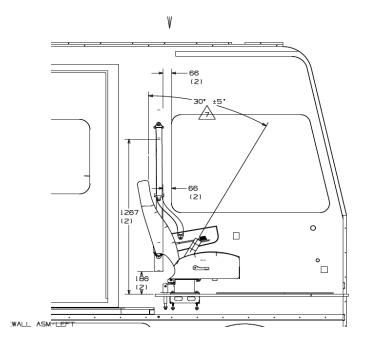
2. Ensure 30-degree angle for each seat belt buckle is met. Loosen bolt under cap and correct angle if required.

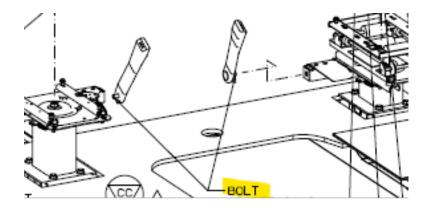
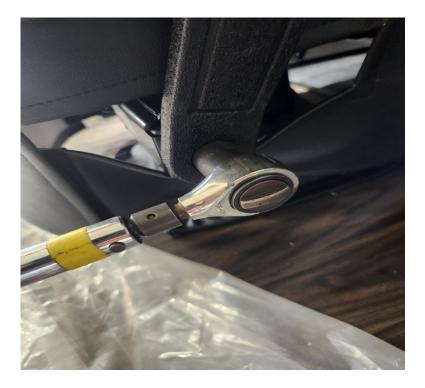
3. Torque bolt under each cap to 45+/-3.5 Nm (33+/-3 ft-lb)

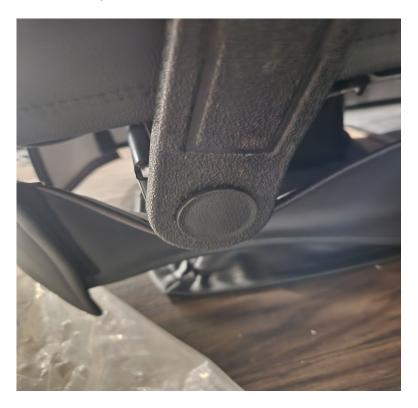
5. Reinstall caps.
