## August 21, 2024 – Added Vehicles are in Open or Prelim Letter Status

## Safety Recall 6023G – 2016-2021 CX-3 Repair Procedure

### A. VEHICLE INSPECTION PROCEDURE – AND PREPERATION FOR REPAIR

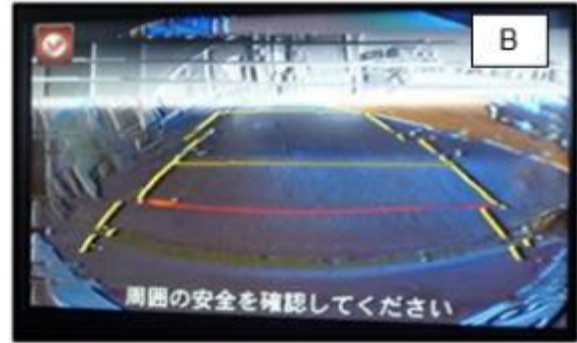
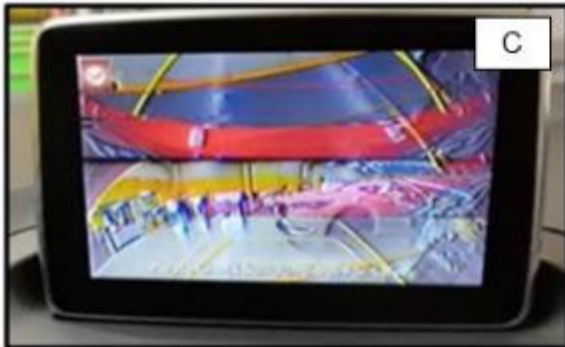
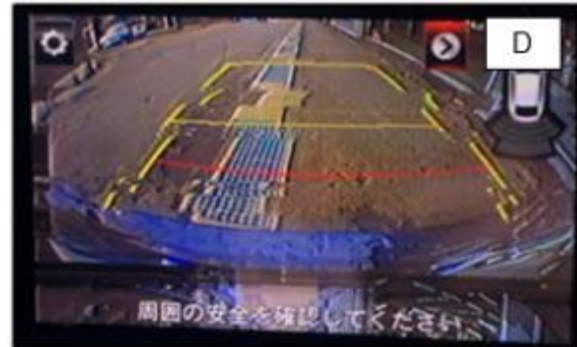
IMAGE DISTORTION THAT IS ACCEPTABLE FOR REPLACEMENT OF THE REAR CAMERA. THE REAR CAMERA MUST BE REPLACED IN THE CONDITIONS BELOW.

| A | Image has noise and distortion |
| B | Lines appear distorted |
| C | Scrolling or split image |
| D | Edges are distorted |
| E | No image is displayed |

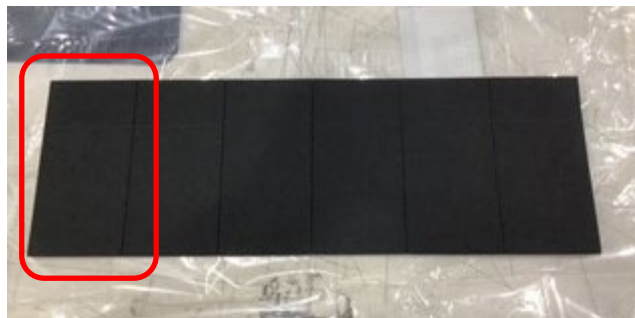
4. Install only one foam pad from kit part # B6Y1-66-1A3. Return any remaining pads to your parts department for use on a future vehicle.

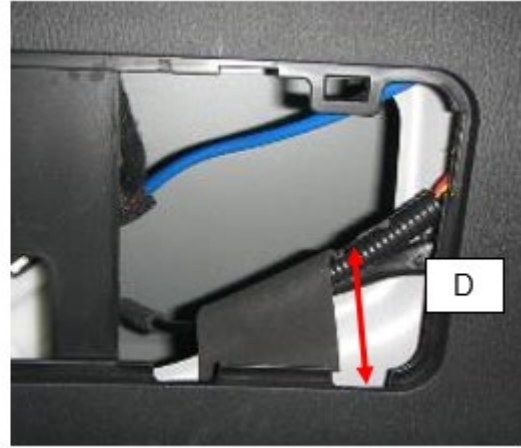
5. Fold the Foam seal to reveal 1.3" (35 mm) of the pad sheet and remove 1/3 of the paper from one side.
6. Stick the 1/3 Foam seal to the front of the liftgate panel. Then, fold over and stick the remaining 2/3 of the Foam pad to the back side. This will bundle the rear camera wiring harness together with the license plate light's wiring harness to the liftgate panel.

**NOTE:** There should be very little tension on rear camera and license plate wires after pad installation (E in second figure below).

| B | 2" (50 mm) |
| C | 6" (100 mm) |
| D | Stick 1/3 of the pad on the front side of the body panel, then fold over. <b>DO NOT WRAP THE PAD VERY TIGHT AGAINST THE BODY EDGE, THE WIRES MUST BE SECURE AND FLEXIBLE.</b> |

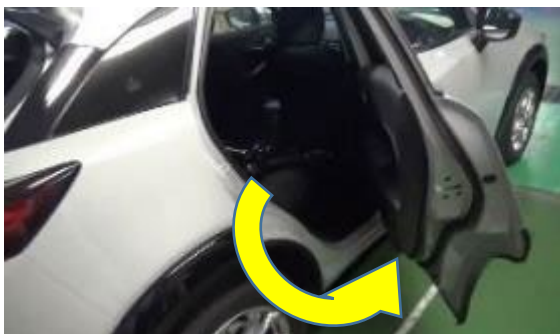
1. **Technician A:** Switch the ignition to ON twice (no engine running). Move the gearshift into (R) Reverse, place your foot on the brake pedal and set the parking brake. Confirm that the rear view image is displayed on the center display.

**Technician B:** Open one rear door (RH - right or LH - left door). This is to reduce air resistance when raising and lowering the liftgate. Raise and lower the liftgate 5 times from the top position with both hands.

If the lift gate does not open while in (R) Reverse, put it in (P) Park range once to open the lift gate, then place in (R) again and repeat raising and lowering the liftgate.

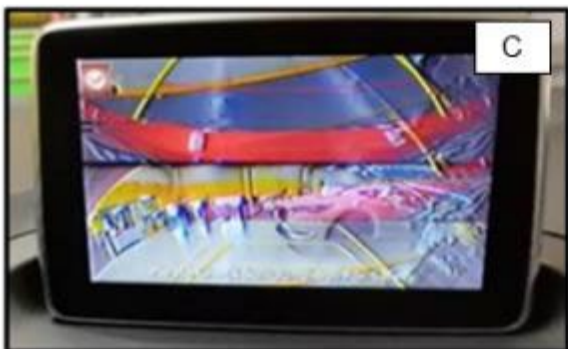
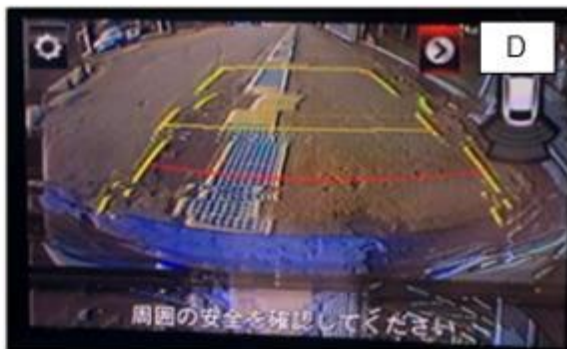
2. Technician A – Watch the display for a flickering or distorted image while Technician B raises and lowers the liftgate 5 times. If the image appears similar to A through D – STOP! AND PROCEED to [REPAIR PROCEDURE 2 – REAR CAMERA REPLACEMENT](#).

| A | Image has noise and distortion |
| B | Lines appear distorted |
| C | Scrolling or split image |
| D | Edges are distorted |
| E | No image is displayed |

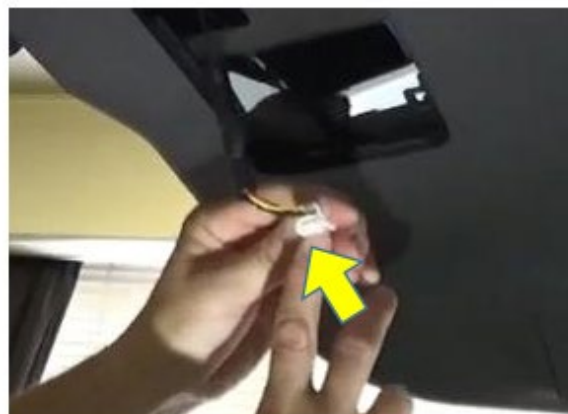
1. Make sure the vehicle is in (P) Park and switch the ignition to OFF.
2. Disconnect the negative battery cable.
3. Remove the rear camera according to the workshop manual [REAR MOUNT CAMERA REMOVAL/INSTALLATION](#) - *Carefully remove all rear camera connectors by pushing the connector tabs from bottom to top (BELOW – A).*

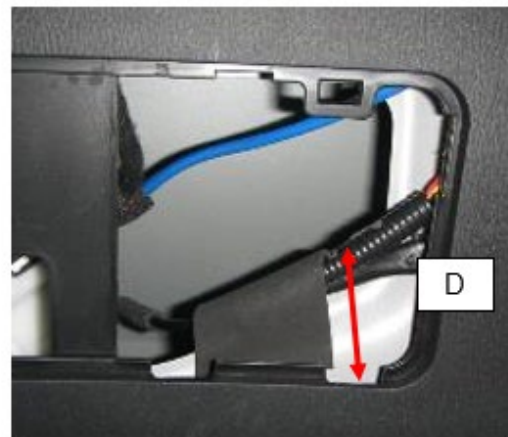
3. Install only one foam pad from the recall parts kit. If you were not sent a recall parts kit (rear camera and 1 pad) then use one pad from B6Y1-66-1A3 and return any remaining pads to your parts department for use on a future vehicle.
4. Fold the Foam seal to reveal 1.3" (1/3 OR 35 mm) of the pad sheet and remove 1.3" (1/3 OR 35 mm) of the paper from one side.
5. Stick the 1/3 Foam seal to the front of the liftgate panel. Then, fold over and stick the remaining 2/3 of the Foam pad to the back side. This will bundle the rear camera wiring together with the license plate light's wiring harness to the liftgate panel.

**NOTE:** There should be very little tension on rear camera and license plate wires after pad installation (E in second figure below).

| B | 2" (50 mm) |
| C | 6" (100 mm) |
| D | Stick 1/3 of the pad on the front side of the body panel, then fold over – <b>DO NOT WRAP THE PAD VERY TIGHT AGAINST THE BODY EDGE, THE WIRES MUST BE SECURE AND FLEXIBLE.</b> |

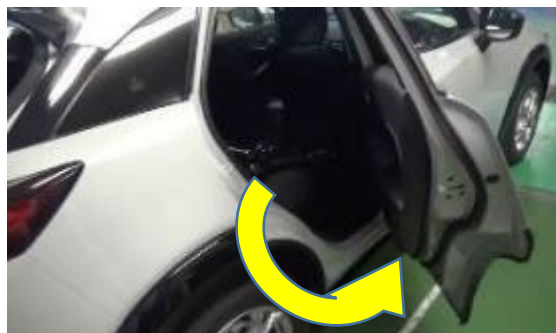
- Technician A:** Switch the ignition to ON twice (no engine running). Move the gearshift into (R) Reverse, place your foot on the brake pedal and set the parking brake. Confirm that the rear view image is displayed on the center display.

**Technician B:** Open one rear door (RH - right or LH - left door). This is to reduce air resistance when raising and lowering the liftgate. Raise and lower the liftgate 5 times from the top position with both hands.

If the lift gate does not open while in (R) Reverse, put it in (P) Park range once to open the lift gate, then place in (R) again and repeat raising and lowering the liftgate.

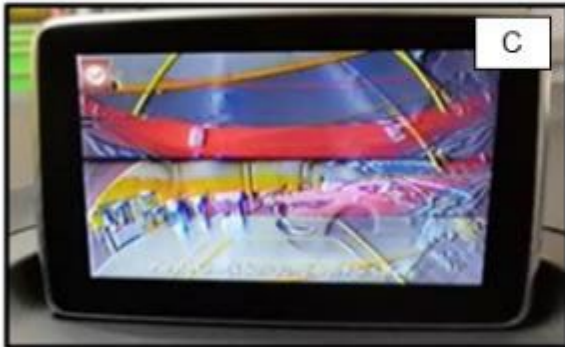
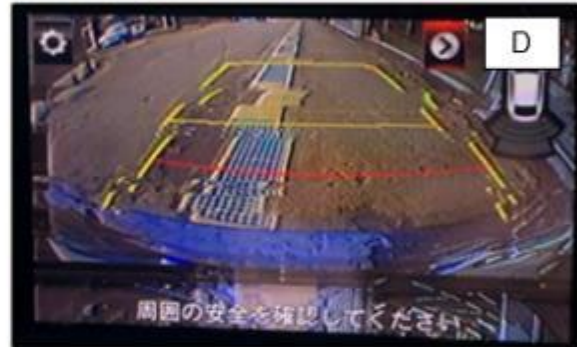
7. Technician A – Watch the display for a flickering or distorted image while Technician B raises and lowers the liftgate 5 times. If the image appears similar to A through D – STOP! AND PROCEED to [REPAIR PROCEDURE 2 – REAR CAMERA REPLACEMENT](#).

| A | Image has noise and distortion |
| B | Lines appear distorted |
| C | Scrolling or split image |
| D | Edges are distorted |
| E | No image is displayed |
