Recall 6023G Rear Camera Recall Job Aid - Repair Calculator	
<i>GOOGLE SHEETS OR EXCEL - MACROS MUST BE ENABLED</i>

## Safety Recall 6023G – 2016-2021 CX-3 Repair Procedure

### A. VEHICLE INSPECTION PROCEDURE – AND PREPERATION FOR REPAIR

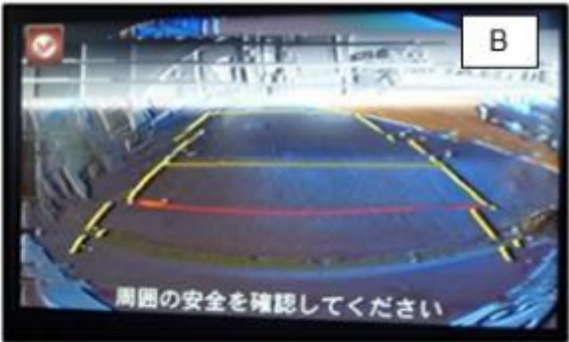
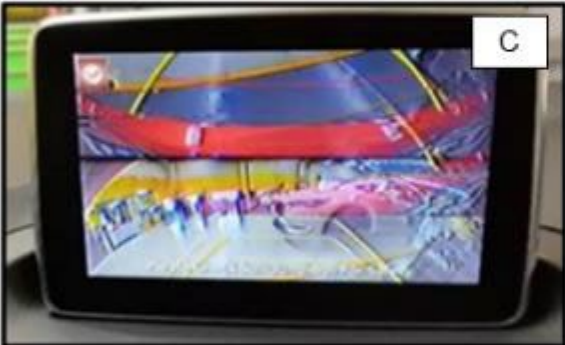
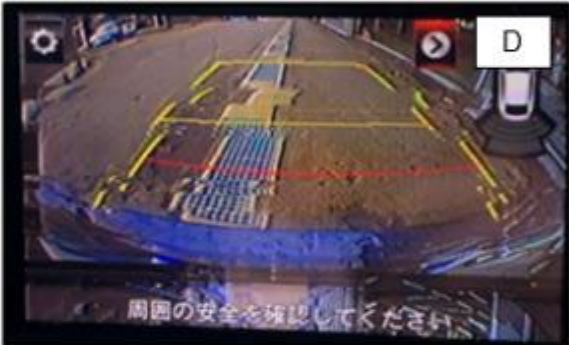
IMAGE DISTORTION THAT IS ACCEPTABLE FOR REPLACEMENT OF THE REAR CAMERA. THE REAR CAMERA MUST BE REPLACED IN THE CONDITIONS BELOW.

A	Image has noise and distortion
B	Lines appear distorted
C	Scrolling or split image
D	Edges are distorted
E	No image is displayed

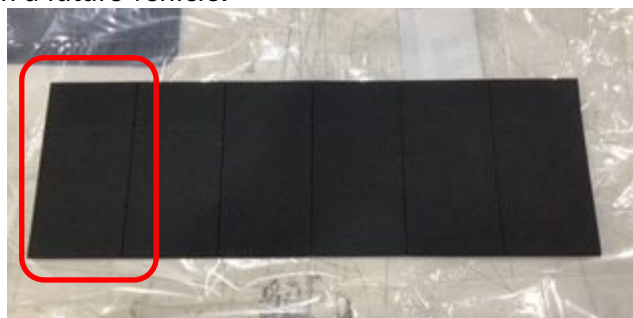
4. Install only one foam pad from kit part # B6Y1-66-1A3. Return any remaining pads to your parts department for use on a future vehicle.

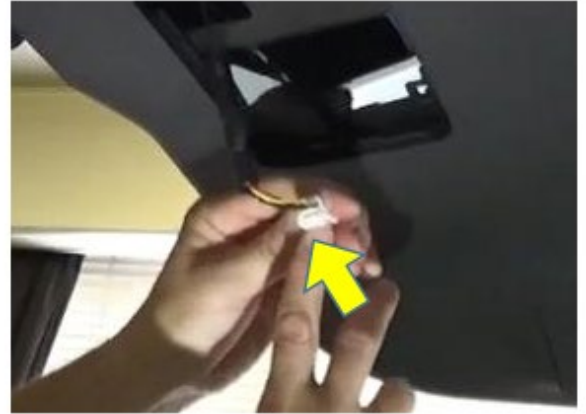
1. Make sure the vehicle is in (P) Park and switch the ignition to OFF.
2. Disconnect the negative battery cable.
3. Remove the rear camera according to the workshop manual [REAR MOUNT CAMERA REMOVAL/INSTALLATION](#) - *Carefully remove all rear camera connectors by pushing the connector tabs from bottom to top (BELOW – A).*

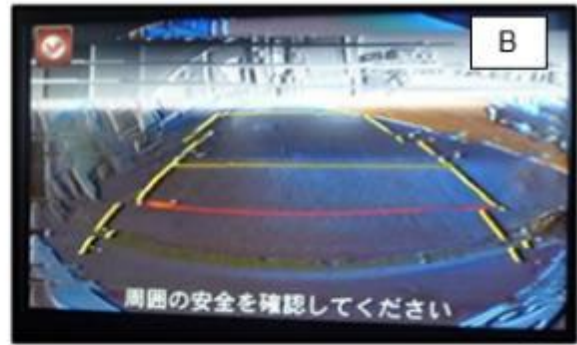
7. Technician A – Watch the display for a flickering or distorted image while Technician B raises and lowers the liftgate 5 times. If the image appears similar to A through D – STOP! AND PROCEED to [REPAIR PROCEDURE 2 – REAR CAMERA REPLACEMENT](#).

A	Image has noise and distortion
B	Lines appear distorted
C	Scrolling or split image
D	Edges are distorted
E	No image is displayed
