March 26, 2025 - Clarified camera repair guidelines

Safety Recall 6023G – 2016-2021 CX-3 Repair Procedure

A. VEHICLE INSPECTION PROCEDURE – AND PREPERATION FOR REPAIR

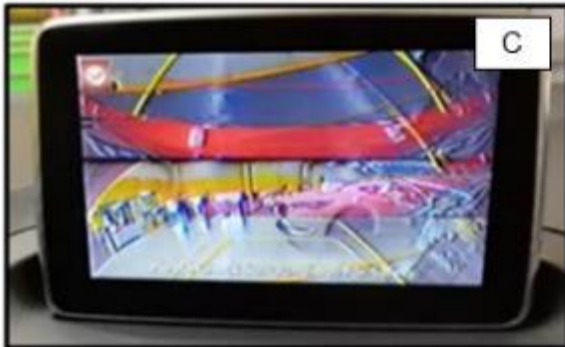
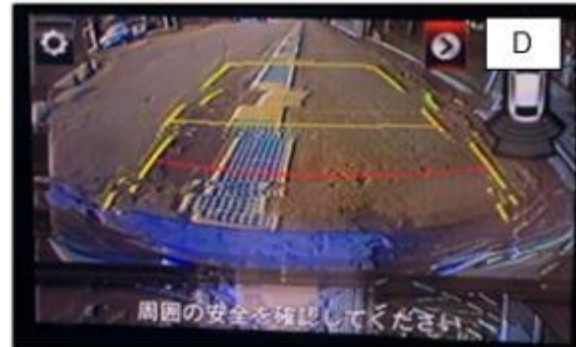
IMAGE DISTORTION THAT IS ACCEPTABLE FOR REPLACEMENT OF THE REAR CAMERA. THE REAR CAMERA MUST BE REPLACED IN THE CONDITIONS BELOW.

A	Image has noise and distortion
B	Lines appear distorted
C	Scrolling or split image
D	Edges are distorted
E	No image is displayed

1. Push the Start button twice, ignition to ON position (engine is not running).
2. Set the parking brake
3. While in the driver seat, place your foot on the brake pedal and move the gear selector to (R) Reverse
Look at the rear camera image (SEE NEXT PAGE FOR EXAMPLES):
 1. If not distorted or flickering, proceed to [REPAIR PROCEDURE 1 – FOAM PAD INSTALLATION](#)
 2. If the image is distorted or flickering as on page 4, proceed to [REPAIR PROCEDURE 2 – REAR CAMERA REPLACEMENT.](#)

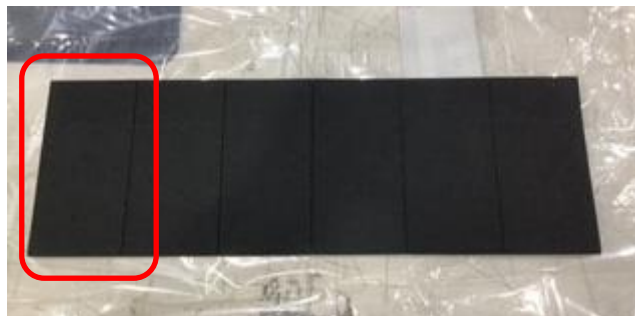
4. Install only one foam pad from kit part # B6Y1-66-1A3. Return any remaining pads to your parts department for use on a future vehicle.

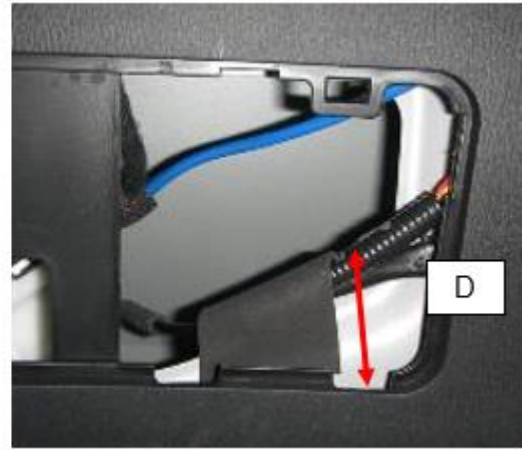
B	2" (50 mm)
C	6" (100 mm)
D	Stick 1/3 of the pad on the front side of the body panel, then fold over. DO NOT WRAP THE PAD VERY TIGHT AGAINST THE BODY EDGE, THE WIRES MUST BE SECURE AND FLEXIBLE.

A	Liftgate panel
B	Camera wiring harness and license plate light harness
C	Foam seal
D	The Foam pad will be in the middle of the service hole
E	There should be very little tension on these wires

5. Fold the Foam seal to reveal 1.3" (35 mm) of the pad sheet and remove 1/3 of the paper from one side.

6. Stick the 1/3 Foam seal to the front of the liftgate panel. Then, fold over and stick the remaining 2/3 of the Foam pad to the back side. This will bundle the rear camera wiring harness together with the license plate light's wiring harness to the liftgate panel.

NOTE: There should be very little tension on rear camera and license plate wires after pad installation (E in second figure below).

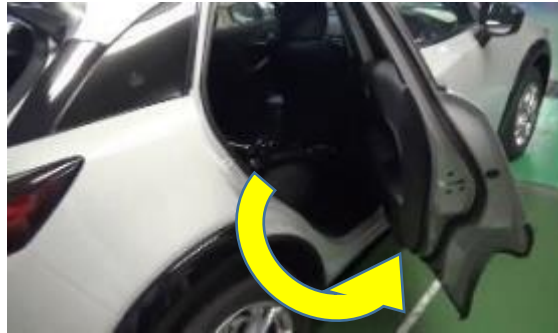
1. **Technician A:** Switch the ignition to ON twice (no engine running). Move the gearshift into (R) Reverse, place your foot on the brake pedal and set the parking brake. Confirm that the rear view image is displayed on the center display.

Technician B: Open one rear door (RH - right or LH - left door). This is to reduce air resistance when raising and lowering the liftgate. Raise and lower the liftgate 5 times from the top position with both hands.

If the lift gate does not open while in (R) Reverse, put it in (P) Park range once to open the lift gate, then place in (R) again and repeat raising and lowering the liftgate.

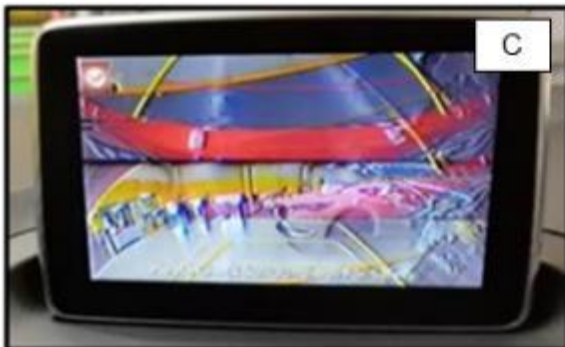
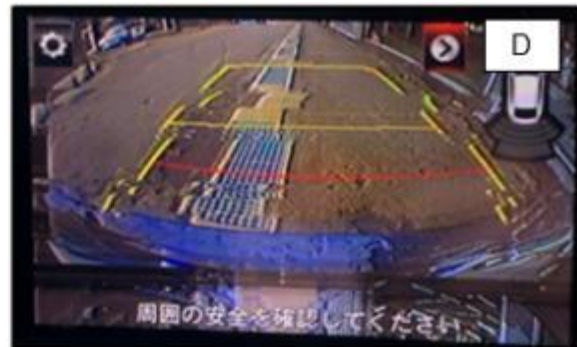
2. Technician A – Watch the display for a flickering or distorted image while Technician B raises and lowers the liftgate 5 times. If the image appears similar to A through D – STOP! AND PROCEED to [REPAIR PROCEDURE 2 – REAR CAMERA REPLACEMENT](#).

A	Image has noise and distortion
B	Lines appear distorted
C	Scrolling or split image
D	Edges are distorted
E	No image is displayed

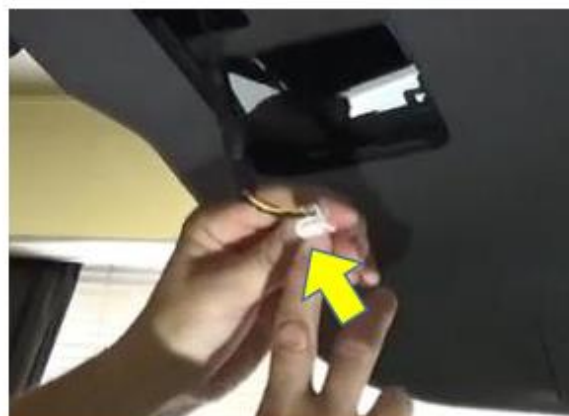
1. Make sure the vehicle is in (P) Park and switch the ignition to OFF.
2. Disconnect the negative battery cable.
3. Remove the rear camera according to the workshop manual [REAR MOUNT CAMERA REMOVAL/INSTALLATION](#) - *Carefully remove all rear camera connectors by pushing the connector tabs from bottom to top (BELOW – A).*

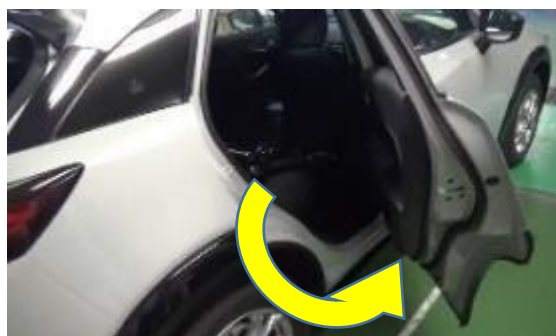
1. **Technician A:** Switch the ignition to ON twice (no engine running). Move the gearshift into (R) Reverse, place your foot on the brake pedal and set the parking brake. Confirm that the rear view image is displayed on the center display.

Technician B: Open one rear door (RH - right or LH - left door). This is to reduce air resistance when raising and lowering the liftgate. Raise and lower the liftgate 5 times from the top position with both hands.

If the lift gate does not open while in (R) Reverse, put it in (P) Park range once to open the lift gate, then place in (R) again and repeat raising and lowering the liftgate.

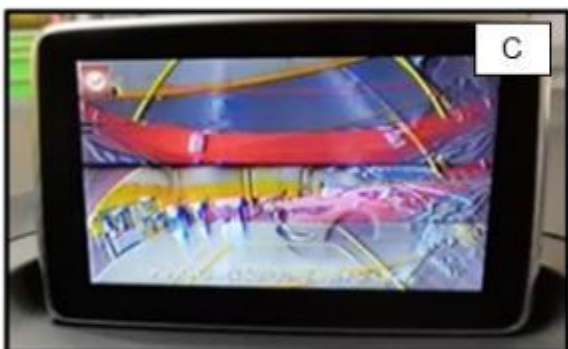
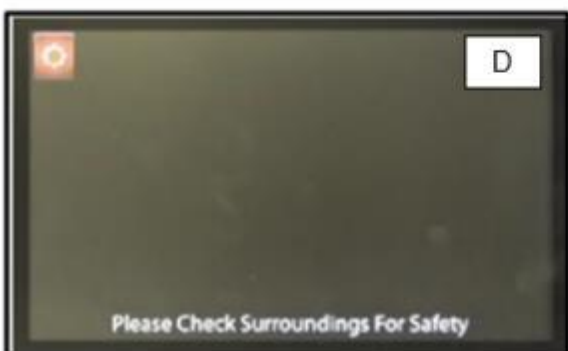
2. Technician A – Watch the display for a flickering or distorted image while Technician B raises and lowers the liftgate 5 times. If the image appears similar to A through D – STOP! AND PROCEED to [REPAIR PROCEDURE 2 – REAR CAMERA REPLACEMENT](#).

A	Image has noise and distortion
B	Lines appear distorted
C	Scrolling or split image
D	Edges are distorted
E	No image is displayed
