APB2 – Checking High-Volt Battery and Replacing if Necessary (Stop Delivery / Recall Campaign)

Model Line: **Taycan (Y1A / Y1B / Y1C)**

Concerns: **High-volt battery**

Action: Check high-volt battery and replace it depending on the test result.

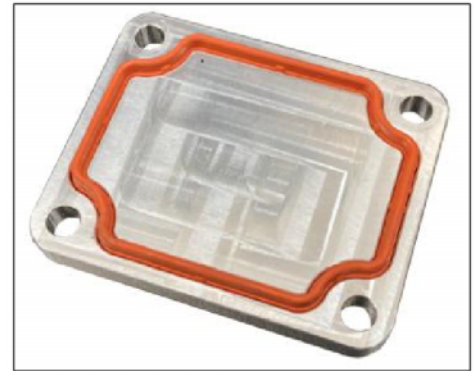
Adapter plate

Special test adapters (one adapter plate and one adapter plug each) are required to check the high-voltage battery for leaks.

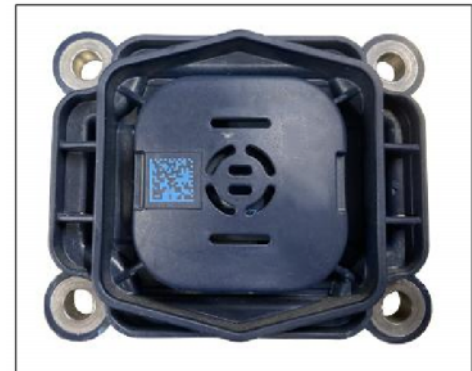
Pressure valve

The pressure release valve and fastening screws cannot be reused and must be replaced.

Before assembling the adapter plate (before the pressure test) and before assembling the pressure valve (after performing the pressure test), the frame of the high-voltage battery must be cleaned with isopropanol in the contact surface area of the seal.
