SIB 61 22 23

RECALL 23V-644: WIPER LINKAGE

E-Series	Model Description	Production Date
G70	7 Series Sedan	October 13, 2022 – January 26, 2023

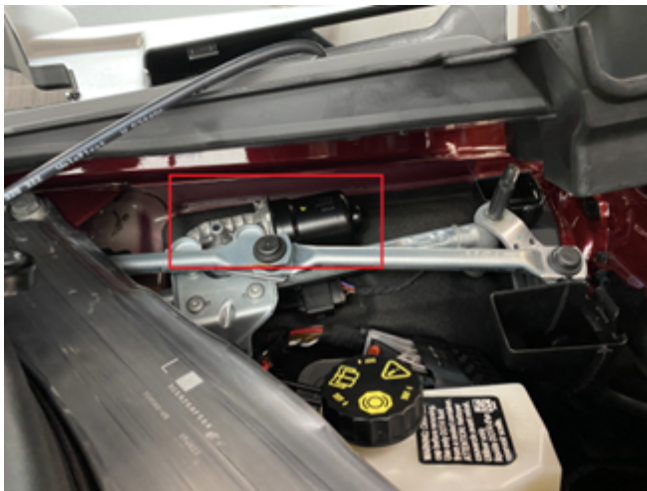
4. Remove the driver side wiper arm following the repair instructions **“Removing and installing/replacing both windshield wiper arms 61 61 100 | REP-REP-P-6161100-G70 – V.1”** (detach wiper arm with special tool **0 493 441 (61 6 060)** when necessary.)

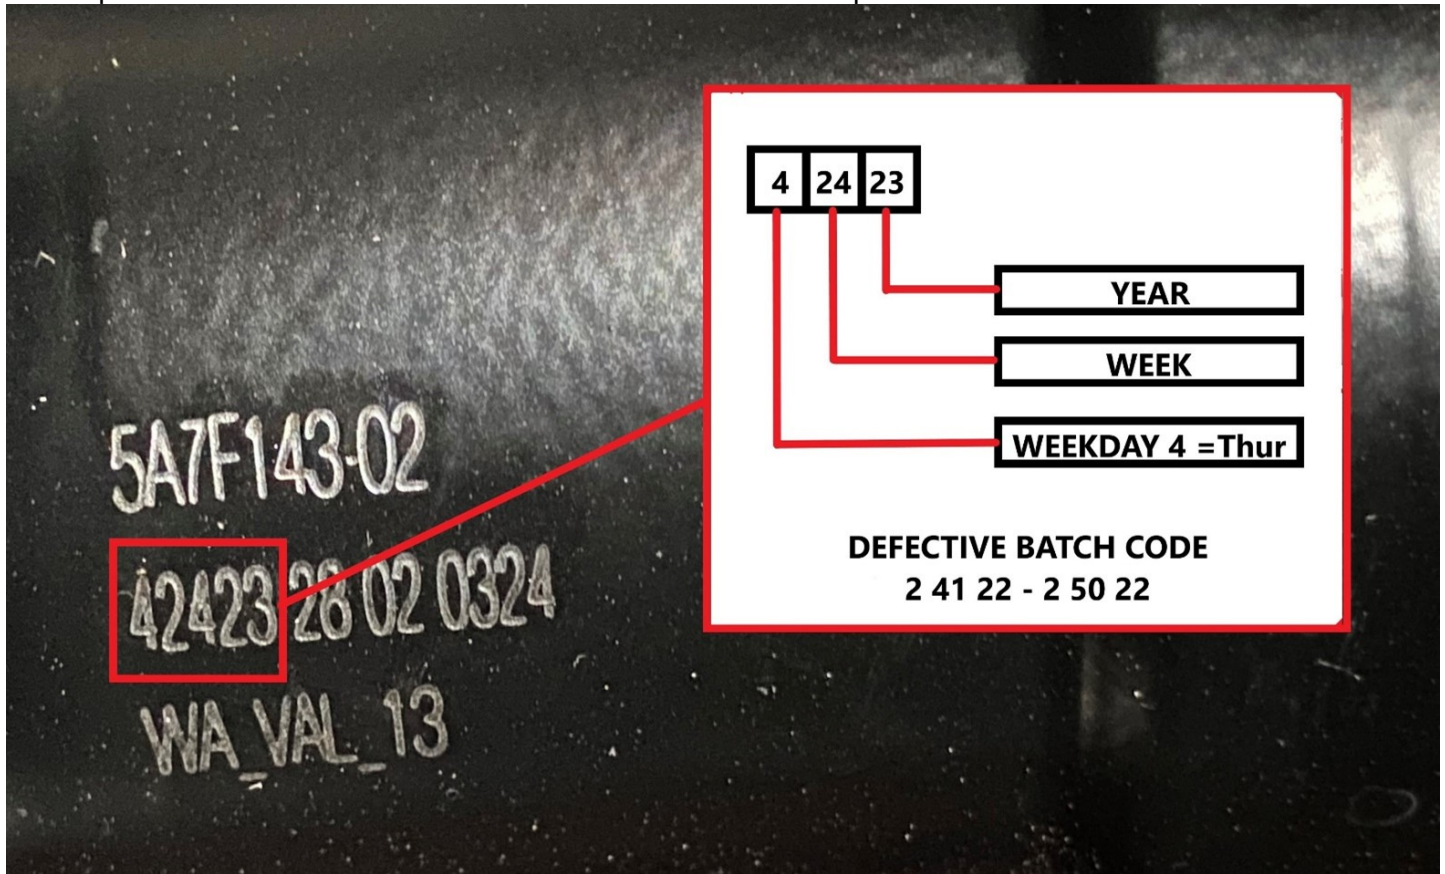
6. Compare the defective batch code and dates of the installed wiper motor.

7. When the batch code falls under the affected dates (from **2 41 22** to **2 50 22**), the wiper linkage must be replaced. Refer to repair instructions **“Replace the console for the windshield wiper system 61 61 271 | REP-REP-P-6161271-G70 - V.3”** available with ISTA 4.40.5X.
