Safety Recall: 2016–20 MDX Connecting Rod Bearing

Supersedes 24-001, dated February 21, 2024, to revise the information.

AFFECTED VEHICLES

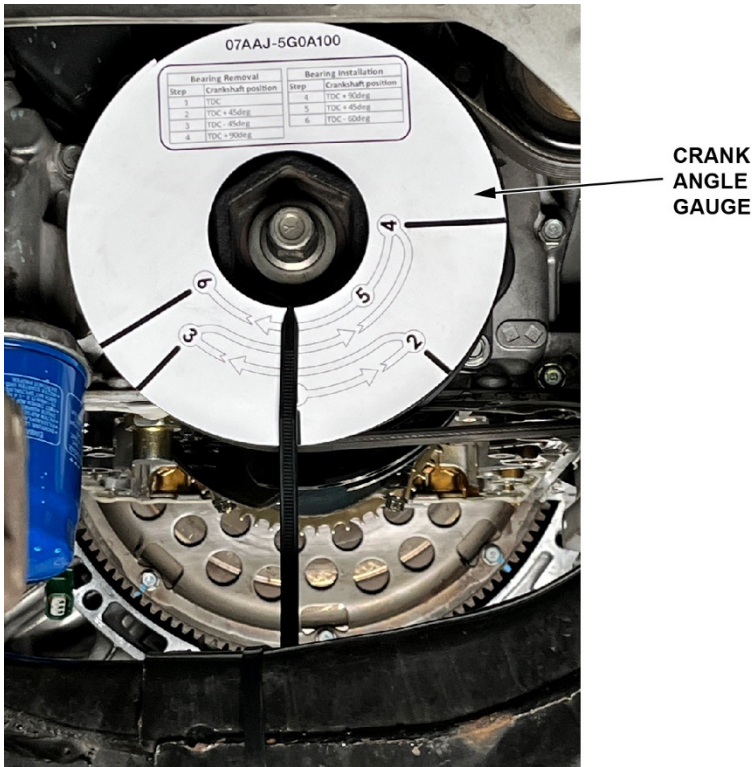
30. Make sure the **cylinder 1** is at TDC, (**position #1**).
