Remedy available for
 2021-2023 (JL) Jeep Wrangler PHEV

SYMPTOM DESCRIPTION

REPAIR TO BE PERFORMED

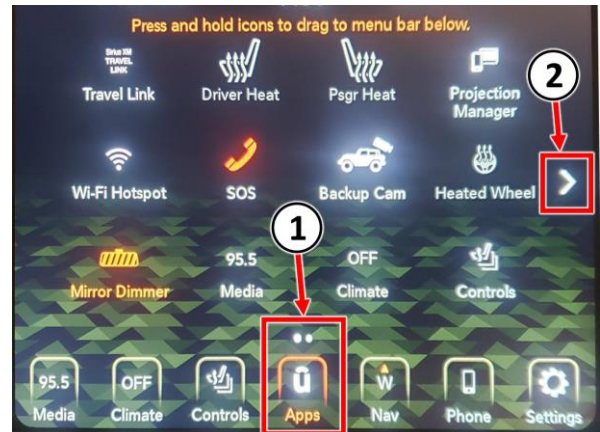
Figure 1 – Apps Display Screen

1. Select “Apps” then “Hybrid Electric” on the display (Figure 1).
2. Scroll through screens until locating the “Hybrid Electric” app. (Figures 1 and 2).
3. Select “Hybrid Electric” app (Figure 2).

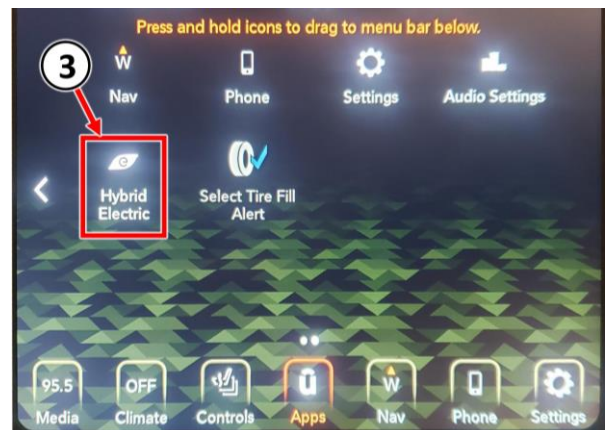
Figure 2 – Apps Display Screen

3. Select “Hybrid Electric” app (Figure 2).

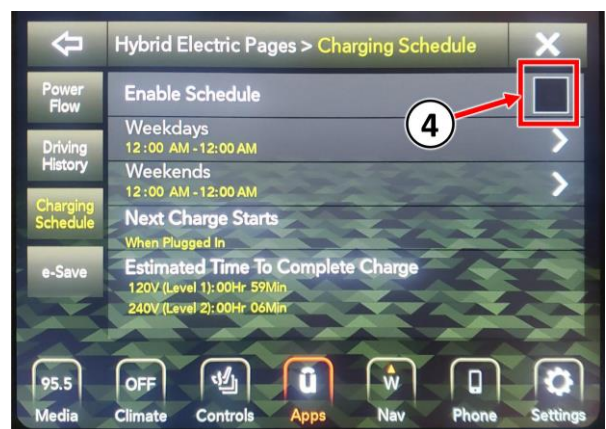
Figure 3 – Apps Display Screen

4. Verify the “Check Mark” is NOT selected in the “Enable Schedule” box (Figure 3).

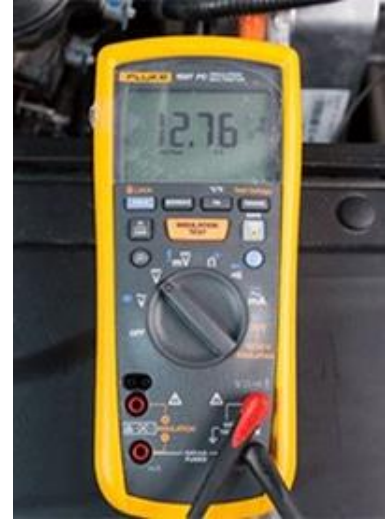
Figure 5 – Multi Meter

7. Use of an insulation tester such as the Fluke Meter, Multi 126-1587 is recommended for PHEV circuit testing. Perform the multi-meter functionality tests per the manufacturer's directions. If at any point during the procedure, the multi-meter settings are changed, or the probes are repositioned in the meter, verification with a known good power source must be repeated (Figure 5).

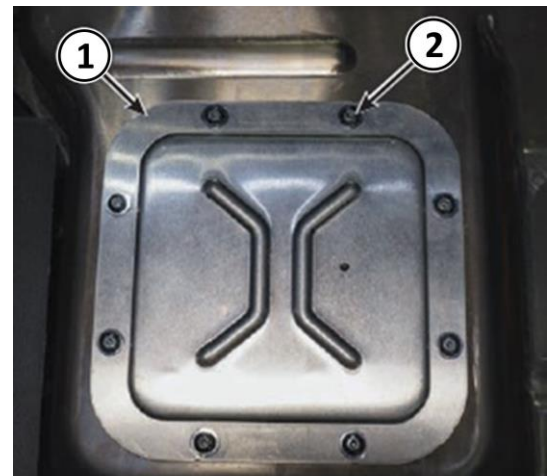
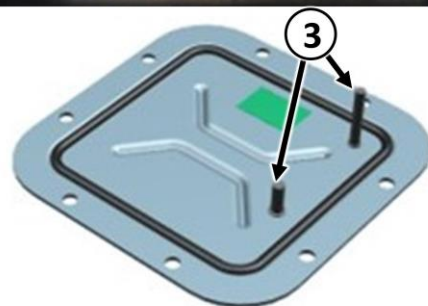
Figure 6 – Test Point Access Cover

8. The high voltage service test points access cover is located on the battery pack, under the drivers side rear seat cushion.
9. Remove the Torx screws (2) from the high voltage service test points access cover (1) (Figure 6).

10. Carefully remove the test points access cover and set in a protected location so that the cover plate alignment and HVIL pins (3) are not damaged (Figure 6).

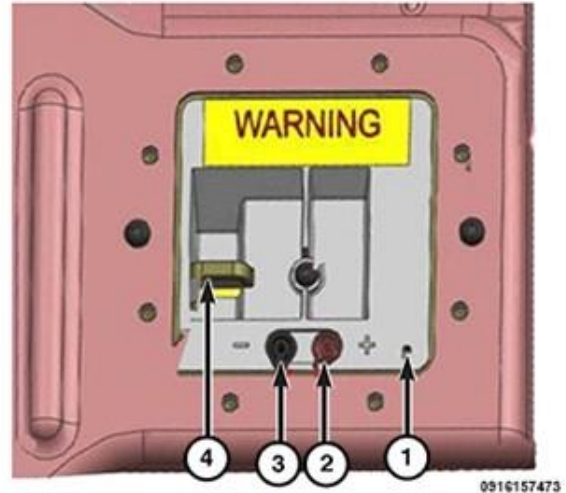
Figure 7 – HV Battery Test Points

- 1 - Internal HVIL Switch
- 2 - High Voltage (+) Test Port
- 3 - High Voltage (-) Test Port
- 4 - Service Lockout Loop

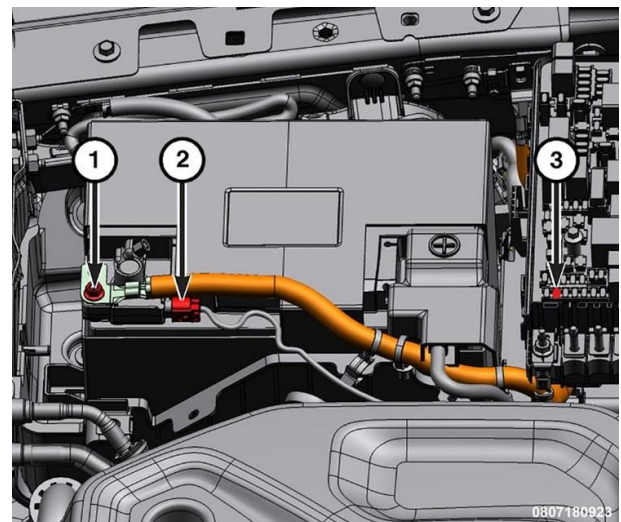
Figure 8 – 12-Volt Battery

- 1 - Battery Negative Cable Nut
- 2 - IBS Wire Harness Connector

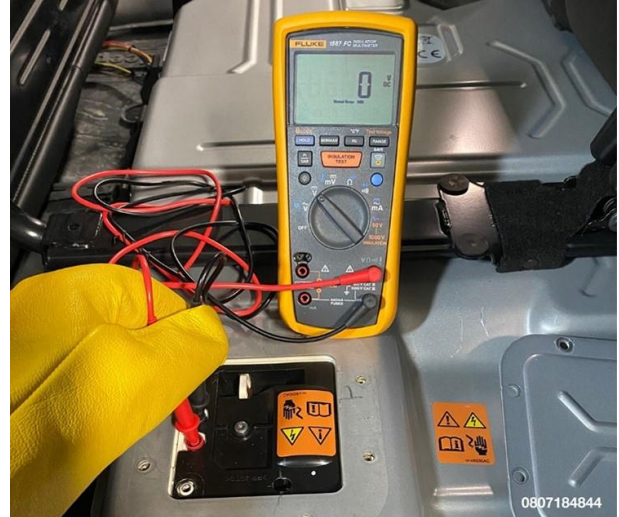
Figure 9 – HV Battery Test Points

15. Using the Fluke multi-meter, measure the voltage at the high voltage positive and high voltage negative test points as follows (Figure 9):
- Measure for voltage between the positive and negative high voltage test points.
 - Measure for voltage between positive test point and chassis ground.
 - Measure for voltage between negative test point and chassis ground.

16. The voltage reading should be near 0 volts for each measurement. (Some residual voltage may be present, up to 2.0 volts may be normal).
- If the voltage measured is below 2 volts, it is safe to work on the high voltage components with the exception of the high voltage battery internal components.

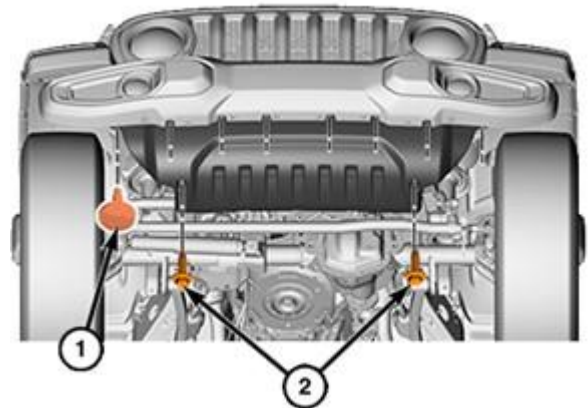
Figure 10 – Air Dam Fasteners

17. Loosen the cap on the high voltage cooling reservoir.
18. Raise and support the vehicle.
19. Remove the eight push pin fasteners from the front air dam (1) (Figure 10).
20. Remove the bolts (2) (Figure 10).
21. Remove the air dam (1) (Figure 11).
22. Remove the support and lower the vehicle.

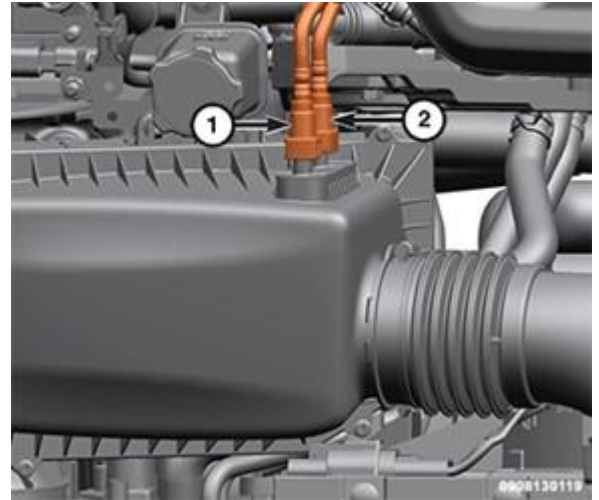
Figure 12 – Air Cleaner Cover

23. Disconnect the vacuum boost hose quick coupling (1) from the air cleaner body cover (Figure 12).

24. Disconnect the fuel vapor purge hose quick coupling (2) from the air cleaner body cover (Figure 12).

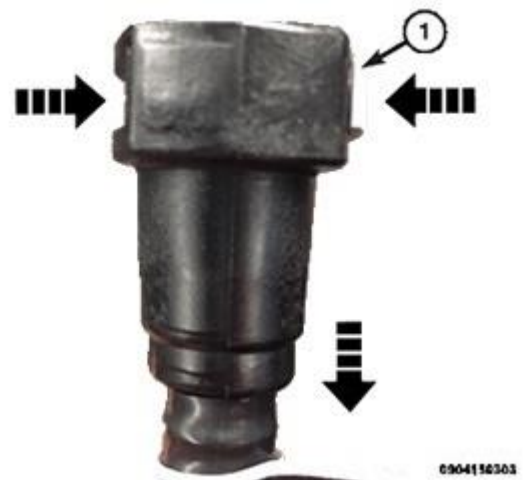
Figure 13 – Hose Connections

- Push in and hold both sides of the grey release (1) on the quick coupling (Figure 13).
- Pull the quick coupling away from air cleaner body cover.

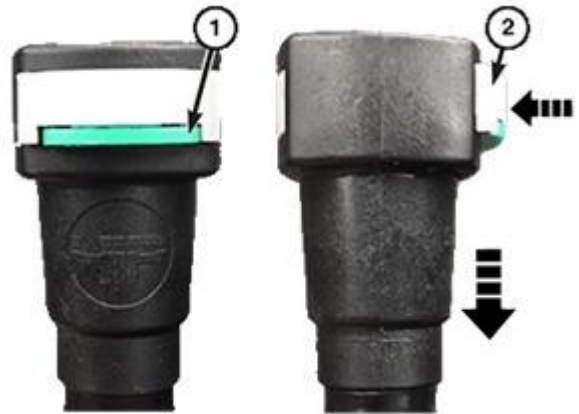
Figure 14 – Hose Connections

- Do not press on the green anti-tampering feature (1) (Figure 14).
- Push in and hold only the side of the release (2) with the green anti-tampering feature and pull the quick coupling away from air cleaner body cover.

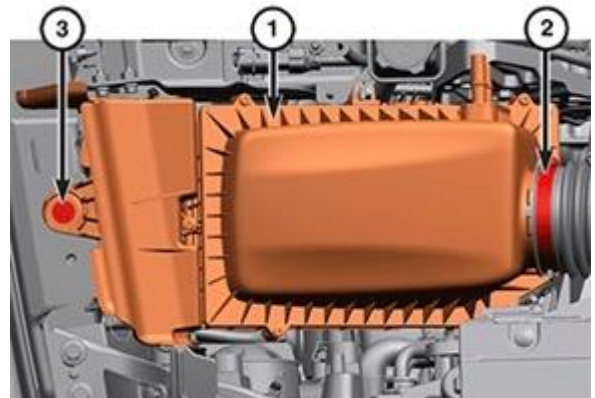
Figure 15 – Air Cleaner

25. Loosen the clean air hose band clamp (2) (Figure 15).

26. Remove the bolt (3) (Figure 15).

27. Disengaging the air cleaner body (1) from the two lower rubber grommets and from the clean air hose (Figure 15).

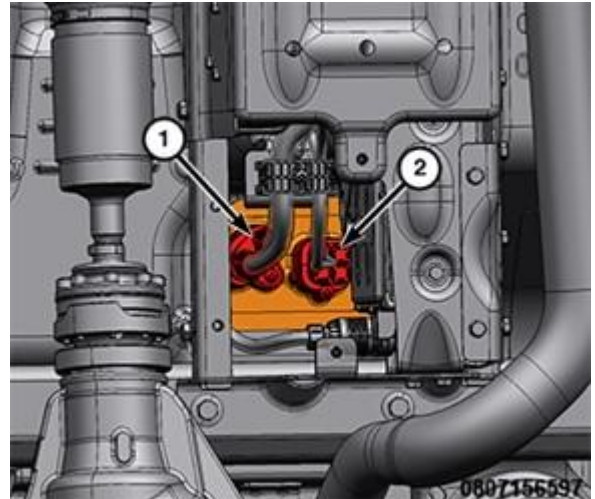
Figure 18 – HV Battery Wiring Connectors

33. Disconnect the HV wire harness connectors (1) and (2) from the HV battery (Figure 18).

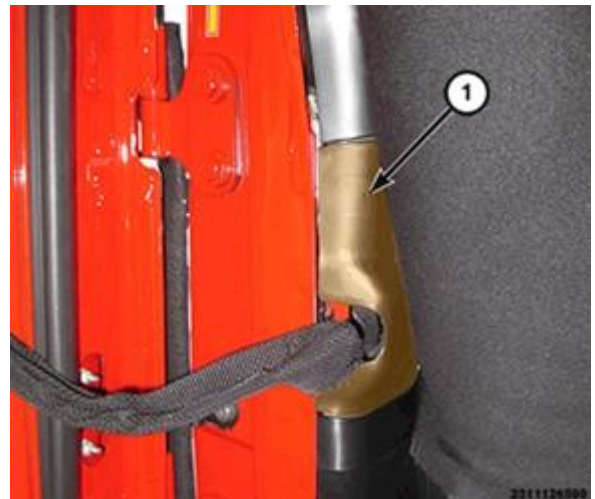
Figure 19 – B-pillar Trim Cover

35. Remove the support and lower the vehicle.
36. Using a trim stick, release and remove the B-pillar trim cover (1) (Figure 19).

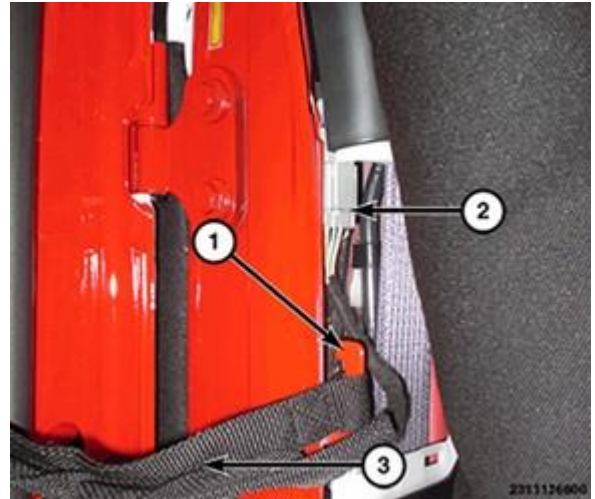
Figure 20 – Harness to Support Bracket

37. Disconnect the wire harness connector (2) and release the door tether from the support bracket (1) (Figure 20).

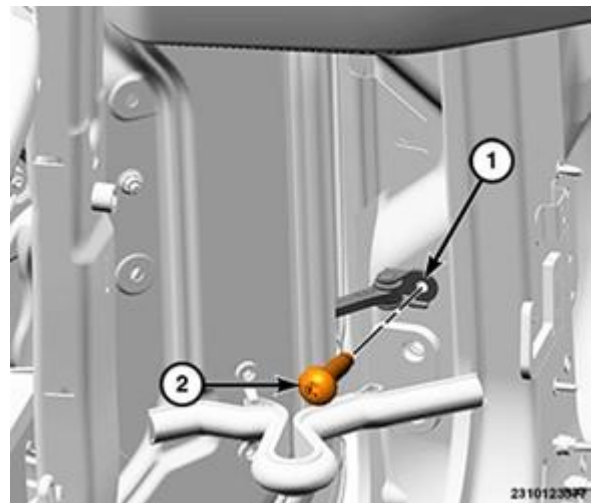
Figure 21 – Door Check Bolt

38. Remove the bolt (2) securing the door check (1) (Figure 21).

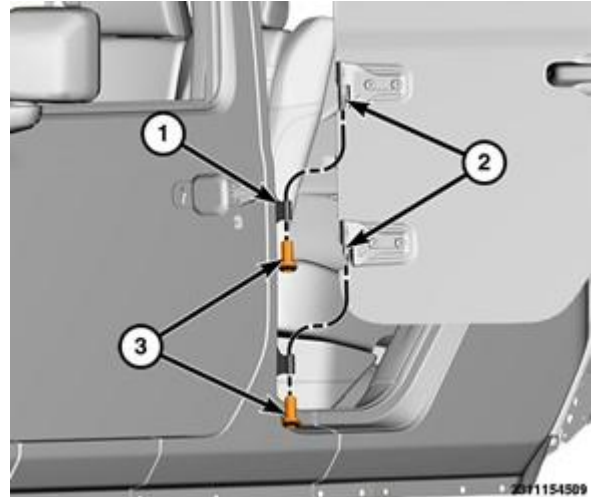
Figure 22 – Hinge Pin Nuts

- 39. Remove the nuts (3) and lift the door up off hinges (1) and remove (Figure 22).
- 40. Raise the rear seat cushion.

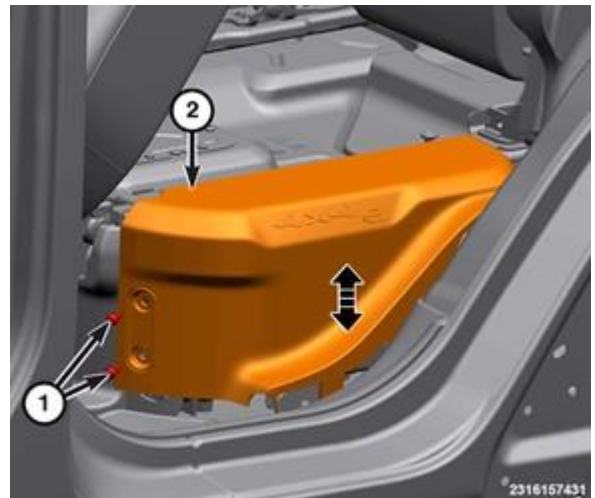
Figure 23 – HV Battery Side Trim

- 41. Remove the fasteners (1) from the side high voltage battery trim panels (2) (Figure 23).
- 42. Using a trim stick or equivalent, remove the high voltage trim panel upward to release the retainers and remove the trim panel. Repeat for the passenger side.
- 43. Lower the rear seat cushion.

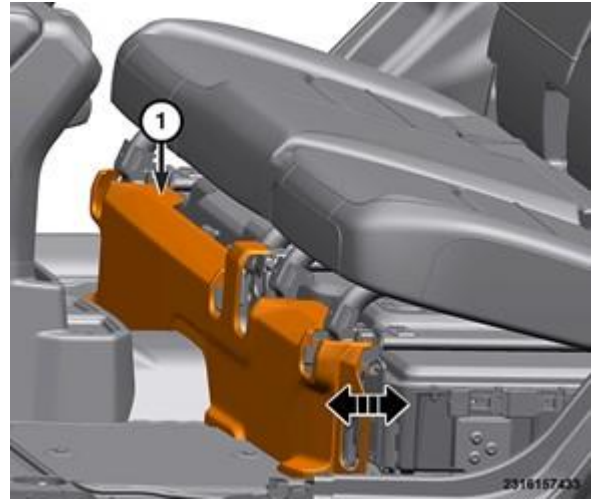
Figure 24 – HV Battery Front Trim

44. Using a trim stick or equivalent, release the retainers from the front high voltage battery closeout and remove from vehicle (Figure 24).

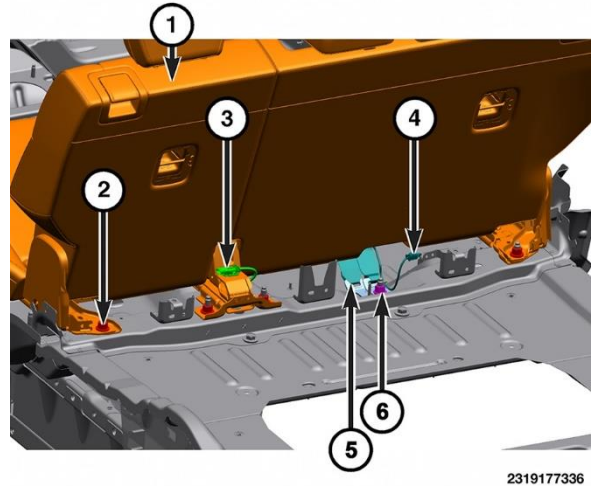
Figure 26 – Rear Seat Components

- 46. Disconnect the wire harness connectors, if equipped (4) (Figure 26).
- 47. Remove the nut for the center seat belt anchor (6). Remove the seat belts from the floor stud (Figure 26).
- 48. Remove the rear seat fasteners (2) at the rear of the seat (Figure 26).

| 3 - Wire Harness Connector | 6 - Center Seat Belt Anchor nut |

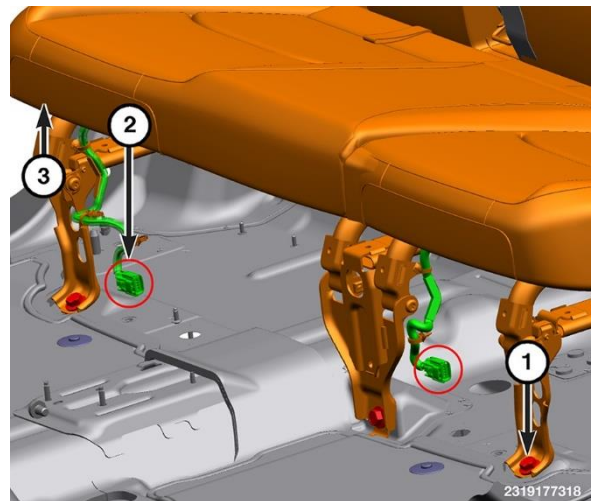
Figure 27 – Rear Seat Components

- 49. Disconnect the wire harness connectors (2), if equipped (Figure 27).
- 50. Remove the bolts (1) at the front of the rear seat (Figure 27).

- 1 - Rear Seat Bolts
- 2 - Wire Harness Connectors
- 3 - Rear Seat

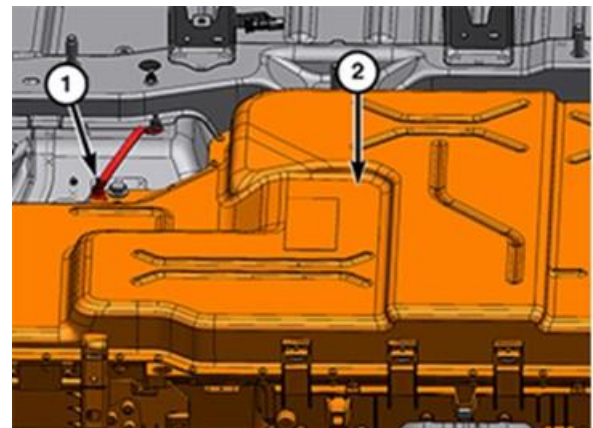
Figure 29 – HV Battery Fastener and Ground Cable

- 53. Remove the fastener (1) and the chassis ground cable from the HV battery (2) (Figure 29).

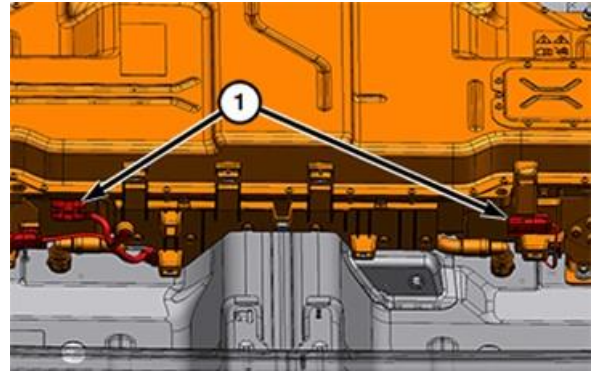
Figure 30 – HV Wire Harness Connectors

54. Disconnect the HV wire harness connectors (1) (Figure 30).

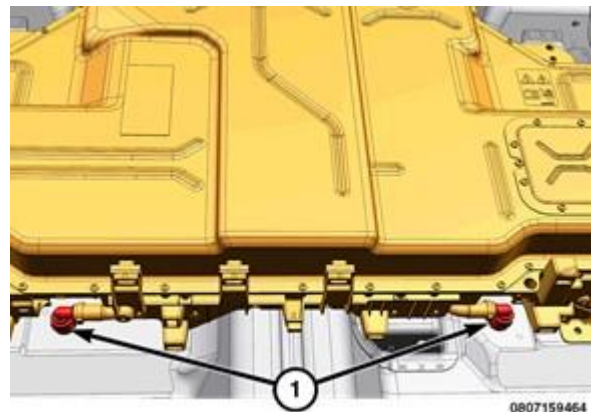
Figure 31 – HV Battery Coolant Connectors

55. Disconnect and plug the HV battery coolant line connectors (1) (Figure 31).

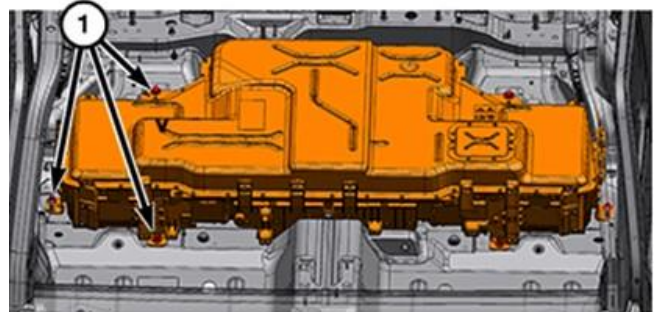
Figure 32 – HV Battery Bolts

56. Remove the bolts (1) securing the HV battery to the vehicle (Figure 32).

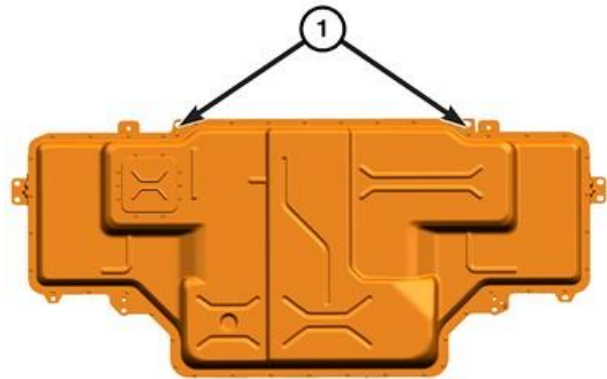
Figure 33 – Support Mounting Holes

57. Install two Eyebolt, 10mm 2035203080 with the nuts to the front support mounting holes (1) (Figure 33).

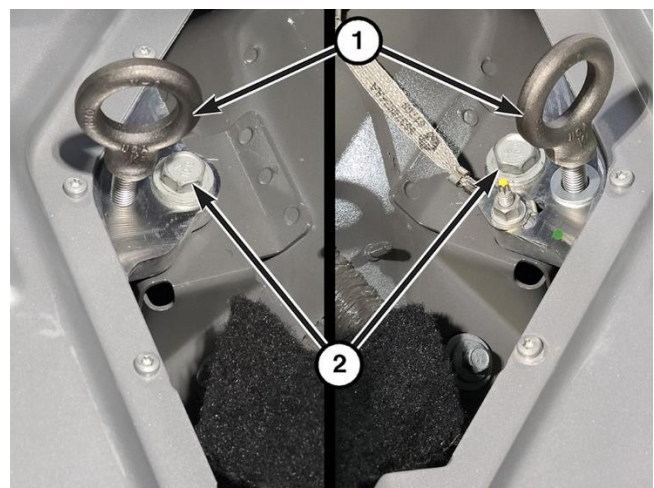
Figure 34 – Eyebolt Installation

58. Thread the other two Eyebolt, 10mm 2035203080 (1) into the threaded holes next to the HV battery pack mounting bolt holes (2) on the rear side of the HV battery pack (Figure 34).

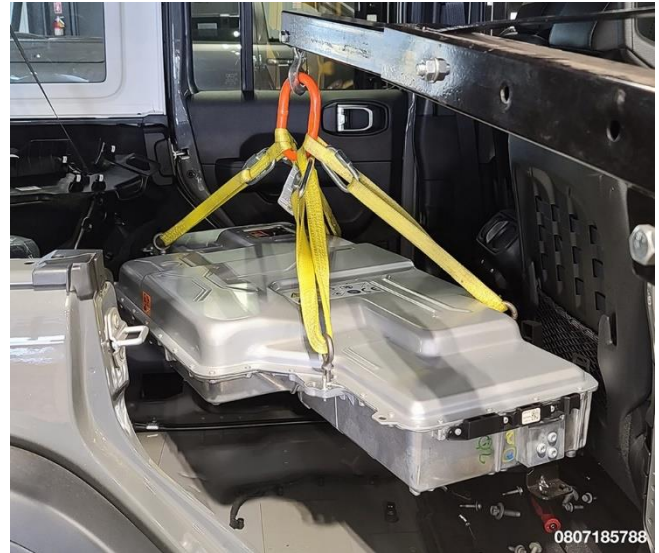
Figure 35 – Lift Straps

59. Connect the Lift Straps, HV Battery 2035200080 to the eyebolts and the lifting device. Adjust the straps so that the battery will be level during lifting as shown in the picture (Figure 35).

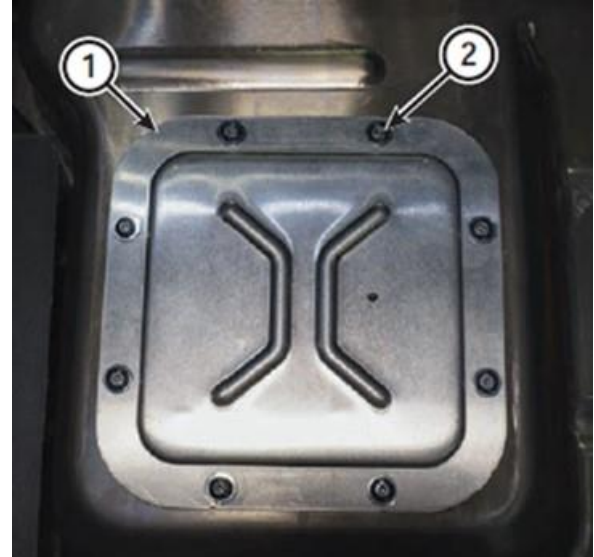
Figure 36 – Test Point Access Cover

93. Remove the M6 Torx screws from the high voltage service test points access cover (Figure 36).
94. Carefully remove the test points access cover and set in a protected location such that the cover plate alignment and HVIL pins are not damaged (Figure 36).

99. Install the test points access cover (1) to the battery pack and securely tighten the eight M6 Torx screws (2), identified with blue circles (Figure 36).
100. Remove the cover, connect the negative battery cable to the IBS and tighten the fastener (1) to 10N·m (7 ft. lbs.) (Figure 40).
101. Install the F09 (5 amp) IDCM fuse (3) in the Power Distribution Center (PDC) (Figure 40).
102. Connect the IBS harness connector (2) (Figure 40).
103. Using the scan tool, delete any DTCs that may have set due to the IDCM fuse being removed. Turn the key OFF and wait 2 minutes,
104. Use the scan tool and flash program the BPCM with the latest software.
105. Use the scan tool and perform the "Enable Contactor for Service" procedure in BPCM.

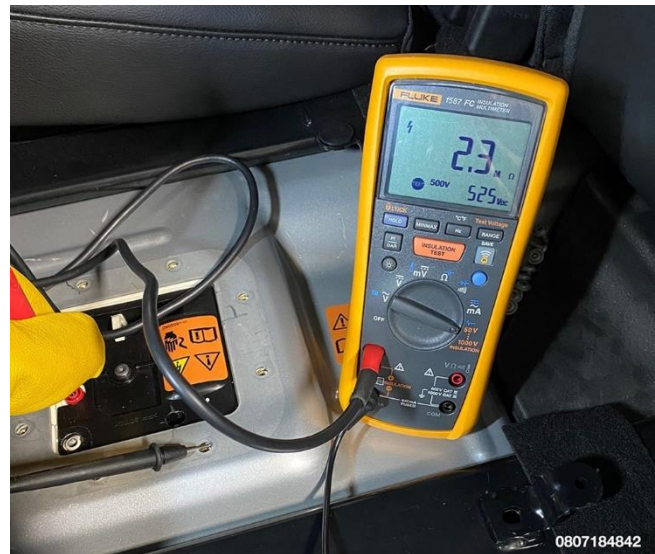
Figure 37 – Measure and Record Isolation Resistance Between HV Positive Test Point and Chassis Ground

95. Using the Meter, Multi 126-1587 measure and record the isolation resistance between the high voltage positive test point and chassis ground (Figure 37).

97. Isolation resistance should be 2.3 Mohms (+/- .2). If the measured isolation resistance is outside of this range, a loss of isolation condition exists within the high voltage circuitry. **Do not continue the High Voltage Power Up procedure until the condition causing the loss of isolation is corrected.**

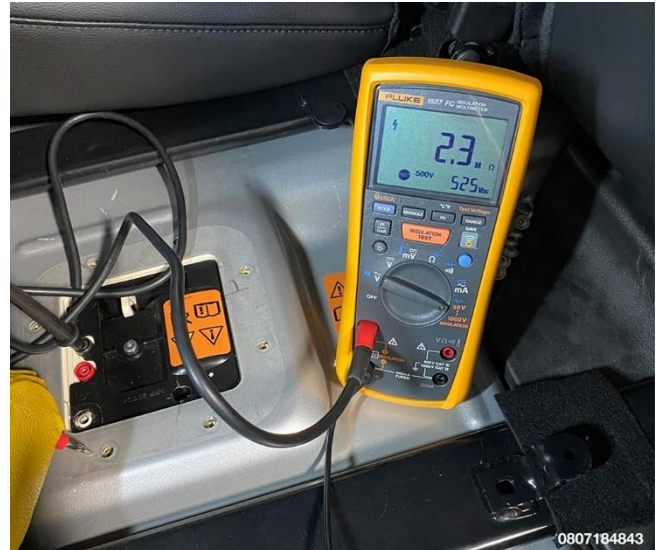
Figure 38 – Measure and Record Isolation Resistance Between HV Negative Test Point and Chassis Ground

96. Using the Meter, Multi 126-1587 measure and record the isolation resistance between the high voltage negative test point and chassis ground (Figure 38).

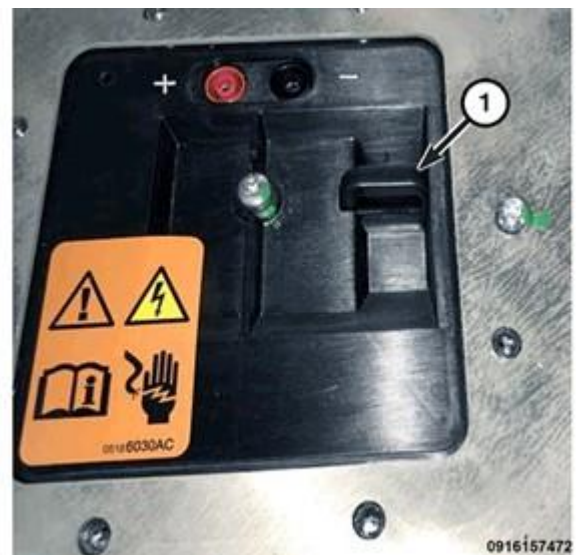
Figure 39 – Service Lockout Loop

98. If required, remove the lockout-tagout padlock from the service lockout loop (1) (Figure 39).
