SAFETY RECALL
 NORTH AMERICA
High Voltage Battery

Reference: B9A / NHTSA 23V-787

FCA US LLC

Remedy available for
 2021-2024 (JL) Jeep Wrangler PHEV

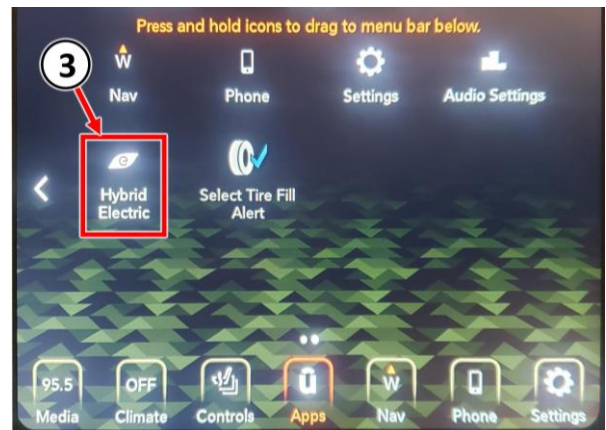
Figure 2 – Apps Display Screen

3. Select “Hybrid Electric” app (Figure 2).

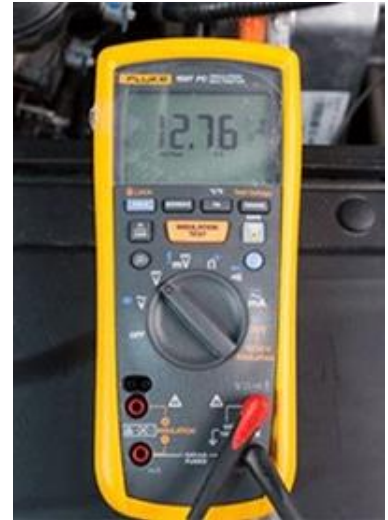
Figure 5 – Multi Meter

7. Use of an insulation tester such as the Fluke Meter, Multi 126-1587 is recommended for PHEV circuit testing. Perform the multi-meter functionality tests per the manufacturer's directions. If at any point during the procedure, the multi-meter settings are changed, or the probes are repositioned in the meter, verification with a known good power source must be repeated (Figure 5).

- Use known good test leads.
- Verify the multi-meter leads are rated "CAT III 1,000V". This should be printed on the multi-meter leads.
- Install the multi-meter leads in the BLACK and RED sockets on the right side of the Fluke 1587 (VΩ (RED) and COM (BLACK)).
- Test the multi-meter operation by measuring the voltage across the 12-volt battery.
- Switch the FLUKE 1587 to the DC Volts selection and press the RANGE button until the 1000V range is selected - just one digit (a zero) is displayed.

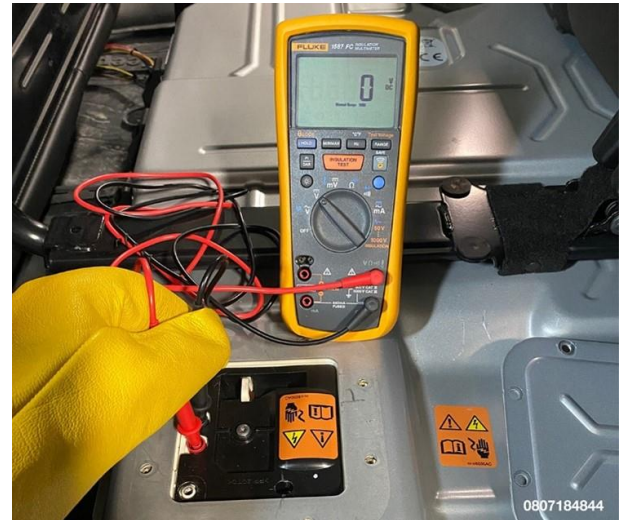
Figure 9 – HV Battery Test Points

15. Using the Fluke multi-meter, measure the voltage at the high voltage positive and high voltage negative test points as follows (Figure 9):
- Measure for voltage between the positive and negative high voltage test points.
 - Measure for voltage between positive test point and chassis ground.
 - Measure for voltage between negative test point and chassis ground.

16. The voltage reading should be near 0 volts for each measurement. (Some residual voltage may be present, up to 2.0 volts may be normal).
- If the voltage measured is below 2 volts, it is safe to work on the high voltage components with the exception of the high voltage battery internal components.

- If the voltage is greater than 50 volts, **an internal condition exists within the high voltage battery such as stuck contactors, that are preventing it from being powered down. This should be accompanied by contactor stuck DTCs. Do not attempt to carry out testing on any of the vehicle's high voltage components or wiring. The HV Battery Pack requires replacement. Reference the HV BATTERY SERVICING WITH WELDED CONTACTOR(S) procedure at the top of the HV PHEV BATTERY REMOVAL AND INSTALLATION procedure for safely removing a high voltage battery that will not power down (Refer to 12 - Electrified Powertrain System/Electric Powertrain Control/MODULES, High Voltage System/Removal and Installation).**

- If the voltage is between 2.0 volts and 50 volts, the HV system is safe to work on, however there is a problem that should be diagnosed. Disconnect each of the following HV modules one at a time and check the voltage at the test points. If the voltage drops to 2.0 volts or less, the faulted module has been found. Reconnect each module before continuing to the next.

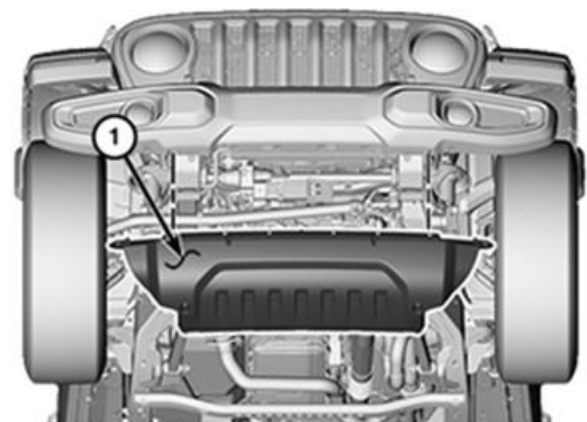
Figure 11 – Air Dam

21. Remove the air dam (1) (Figure 11).

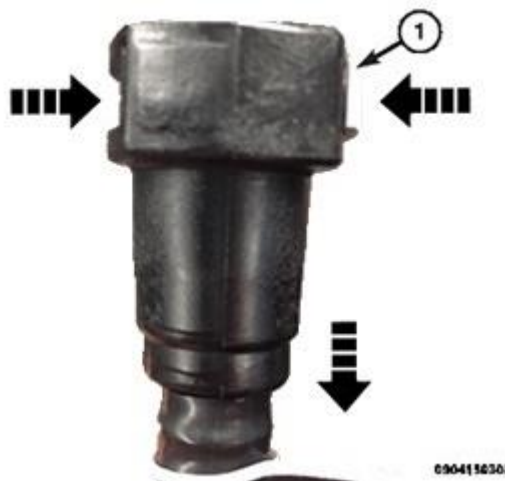
Figure 13 – Hose Connections

- Push in and hold both sides of the grey release (1) on the quick coupling (Figure 13).
- Pull the quick coupling away from air cleaner body cover.

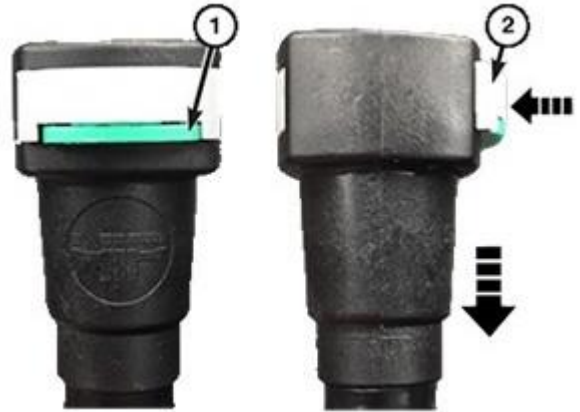
Figure 14 – Hose Connections

24. Disconnect the fuel vapor purge hose quick coupling (2) from the air cleaner body cover (Figure 12).
- Do not press on the green anti-tampering feature (1) (Figure 14).
 - Push in and hold only the side of the release (2) with the green anti-tampering feature and pull the quick coupling away from air cleaner body cover.

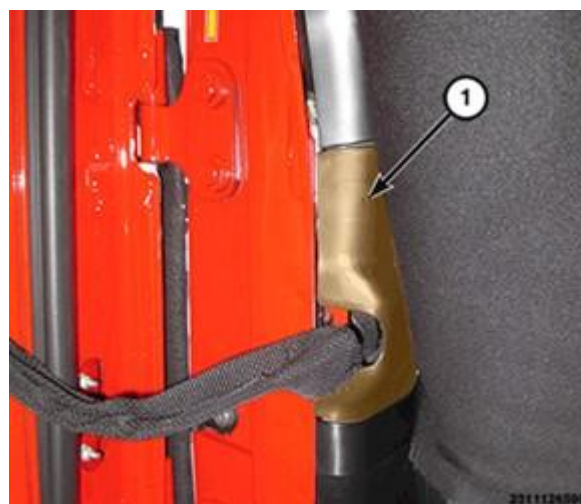
Figure 19 – B-pillar Trim Cover

- 36. Using a trim stick, release and remove the B-pillar trim cover (1) (Figure 19).

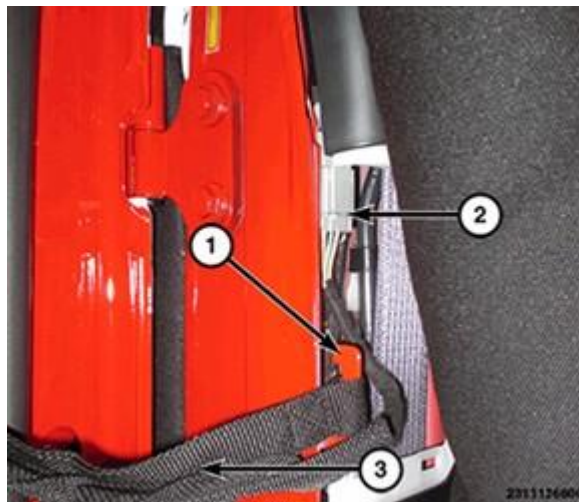
Figure 20 – Harness to Support Bracket

37. Disconnect the wire harness connector (2) and release the door tether from the support bracket (1) (Figure 20).

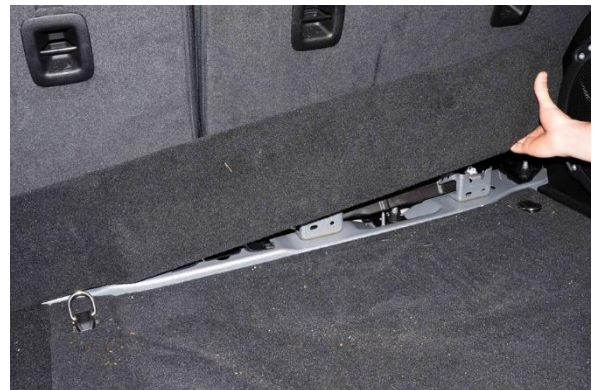
Figure 25 – Gap Hider

- 45. Remove the rear seat to load floor gap hider (Figure 25).

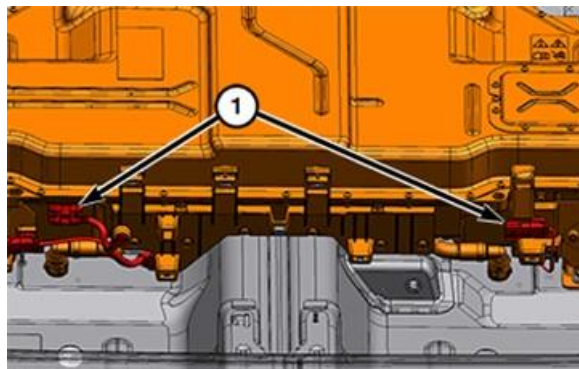
Figure 30 – HV Wire Harness Connectors

54. Disconnect the HV wire harness connectors (1) (Figure 30).

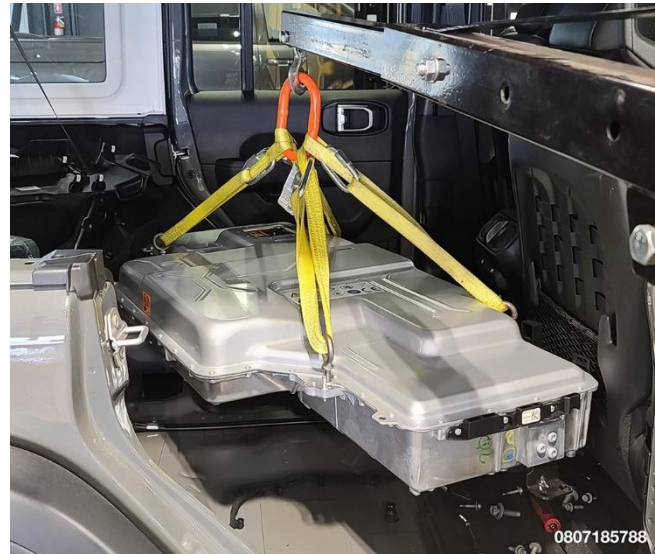
Figure 35 – Lift Straps

59. Connect the Lift Straps, HV Battery 2035200080 to the eyebolts and the lifting device. Adjust the straps so that the battery will be level during lifting as shown in the picture (Figure 35).

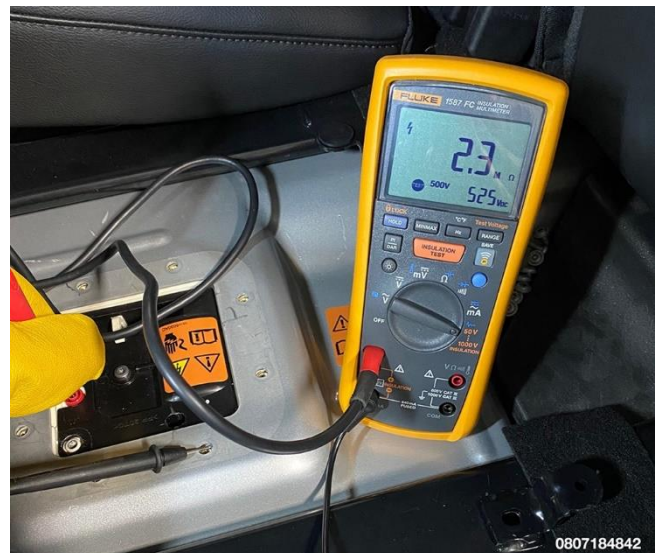
Figure 37 – Measure and Record Isolation Resistance Between HV Positive Test Point and Chassis Ground

95. Using the Meter, Multi 126-1587 measure and record the isolation resistance between the high voltage positive test point and chassis ground (Figure 37).

97. Isolation resistance should be 2.3 Mohms (+/- .2). If the measured isolation resistance is outside of this range, a loss of isolation condition exists within the high voltage circuitry. **Do not continue the High Voltage Power Up procedure until the condition causing the loss of isolation is corrected.**

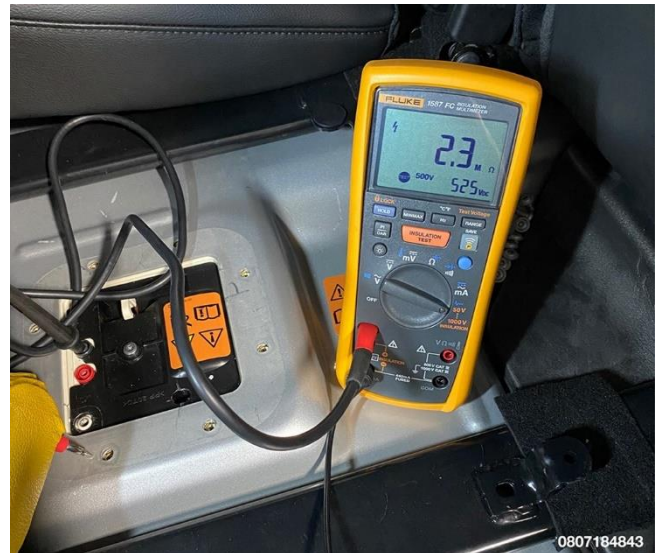
Figure 38 – Measure and Record Isolation Resistance Between HV Negative Test Point and Chassis Ground

96. Using the Meter, Multi 126-1587 measure and record the isolation resistance between the high voltage negative test point and chassis ground (Figure 38).

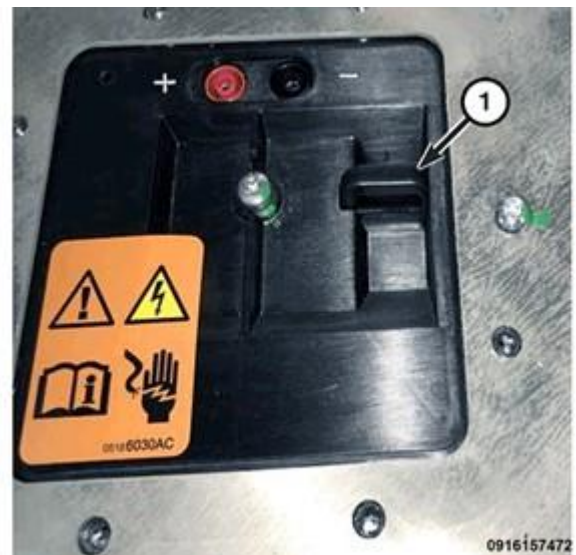
Figure 39 – Service Lockout Loop

98. If required, remove the lockout-tagout padlock from the service lockout loop (1) (Figure 39).
