March 27, 2024

Version 2

Safety Recall: 2014–20 MDX and 2018–20 MDX Sport Hybrid Fuel Pump Motor

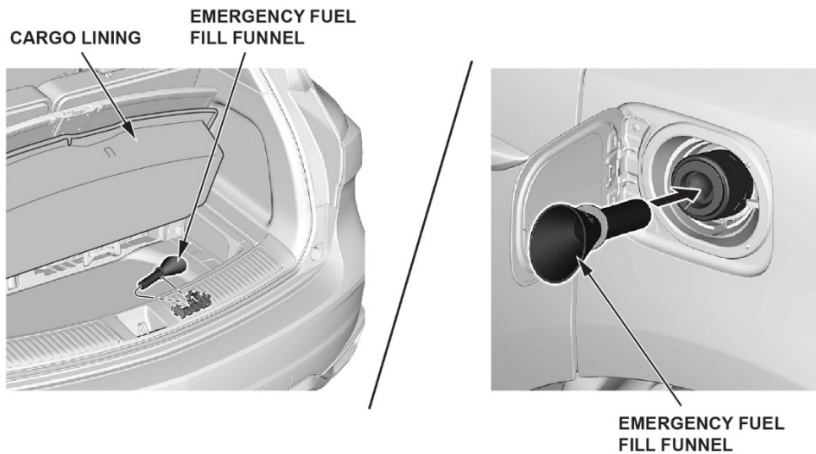
1. *MDX*: Remove the fuel fill cap to relieve the pressure in the fuel tank.
2. *MDX Sport Hybrid*: Insert the emergency fuel fill funnel into the fuel filler neck to relieve the pressure in the fuel tank.

NOTE: The emergency fuel fill funnel is in the cargo area behind the cargo lining.

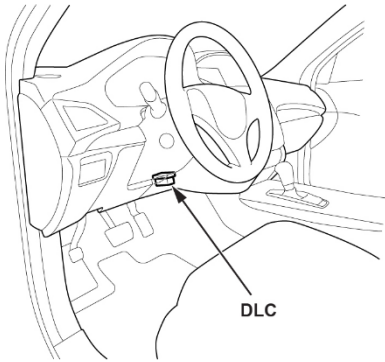
- Connect an i-HDS to the DLC located under the driver's side of the dashboard.

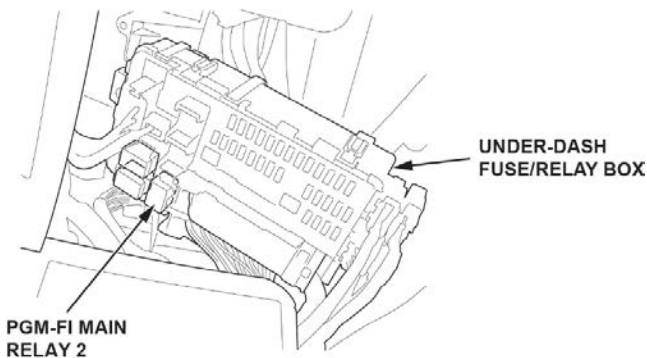
Without an i-HDS: Remove the PGM-FI main relay 2 from the under-dash fuse/relay box.

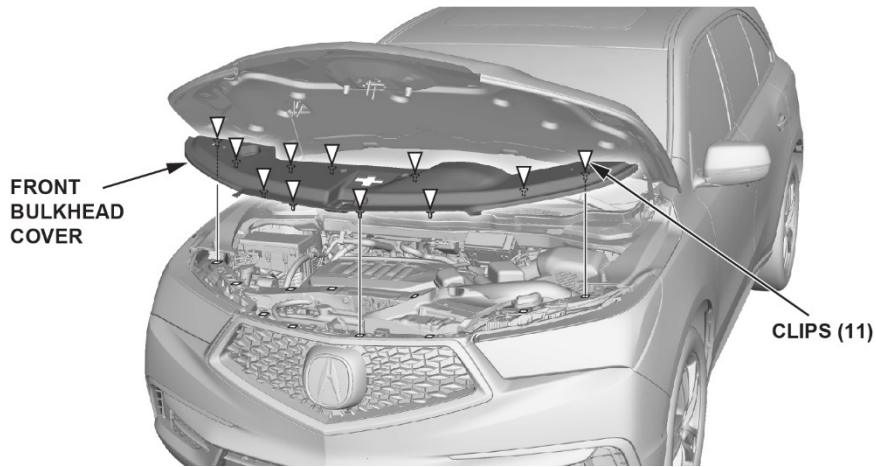
8. Remove the front bulkhead cover.

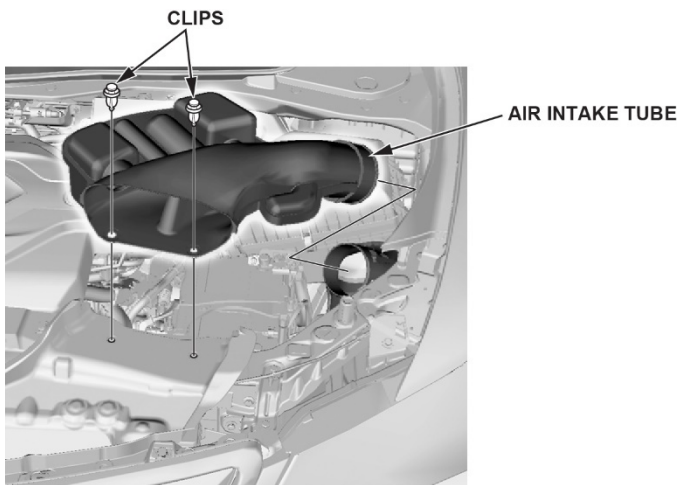
9. Remove the air intake tube.

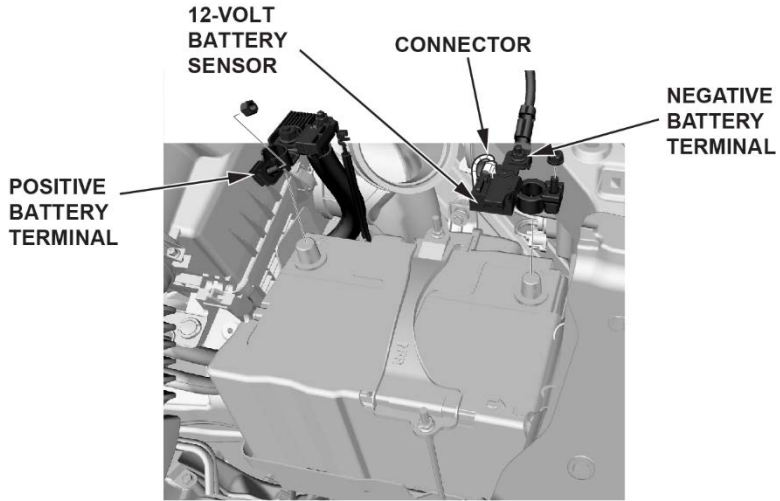
10. Disconnect both 12-volt battery terminals.

To protect the terminal connector from damage, do not hold it when removing the negative terminal.

- Always disconnect the negative terminal first.
- Do not disconnect the 12-volt battery sensor from the cable.

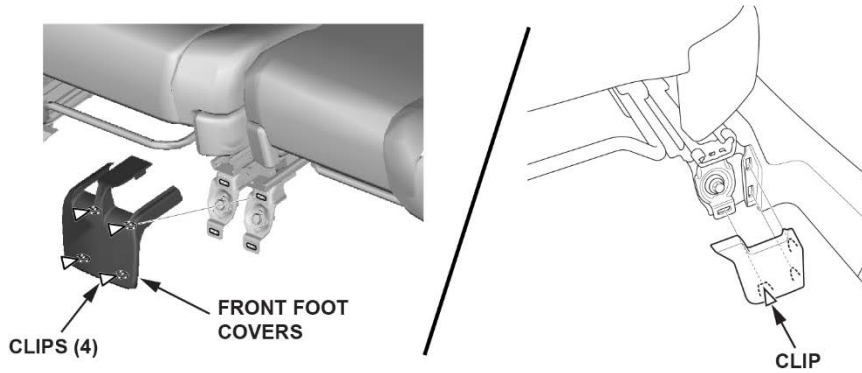
11. Remove the left side second row seat front foot covers.

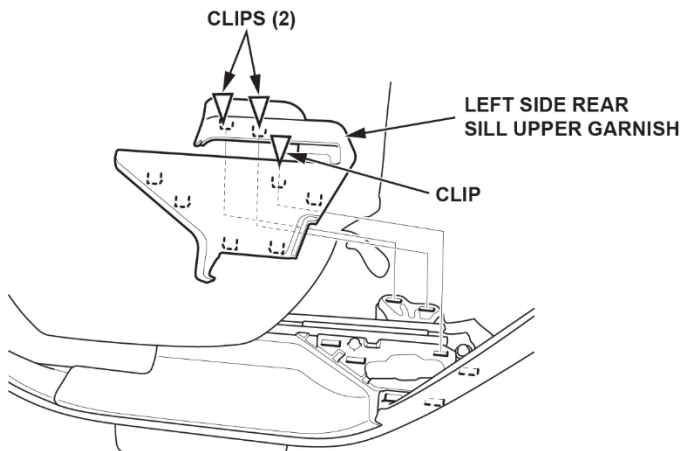
12. Remove the left side rear sill upper garnish.

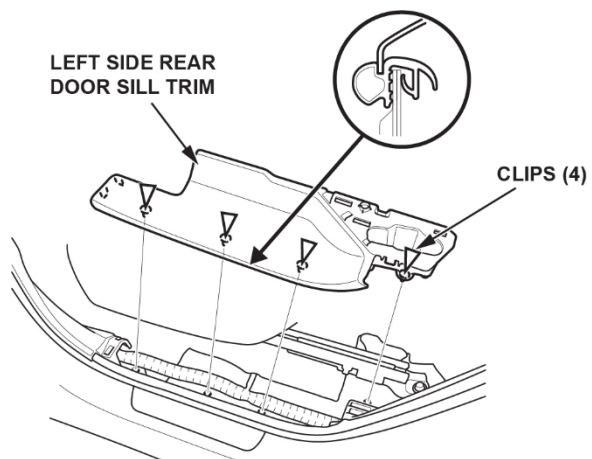
13. Remove the left side rear door sill trim.

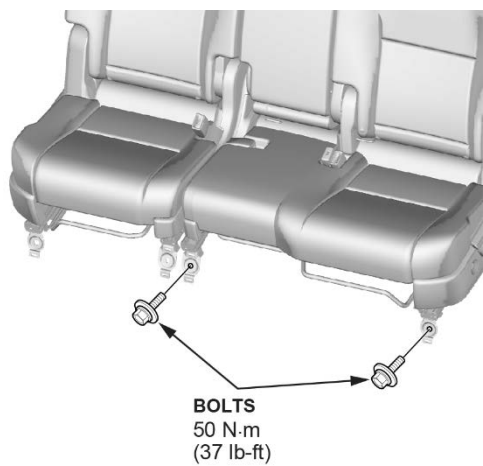
14. Remove the left side second row front seat bolts.

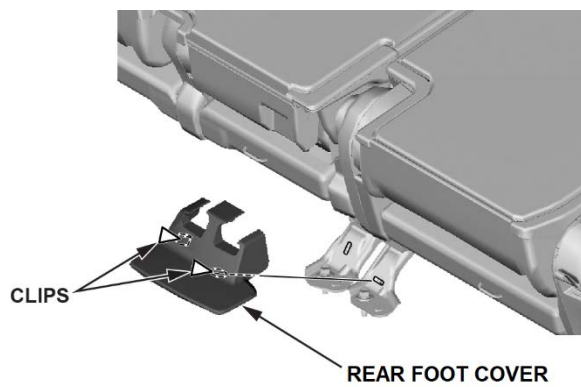
15. Remove the second row seat rear foot cover.

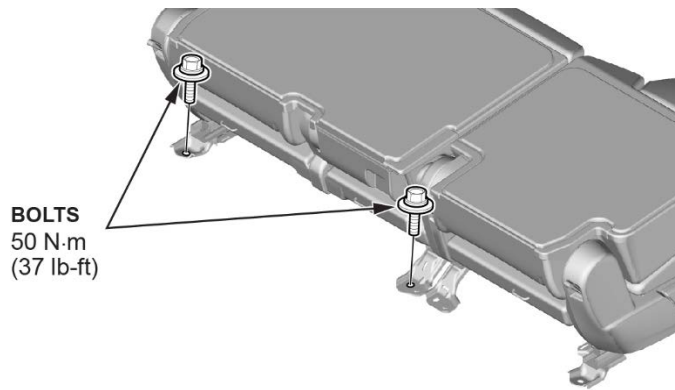
16. Remove the left side second row rear seat bolts.

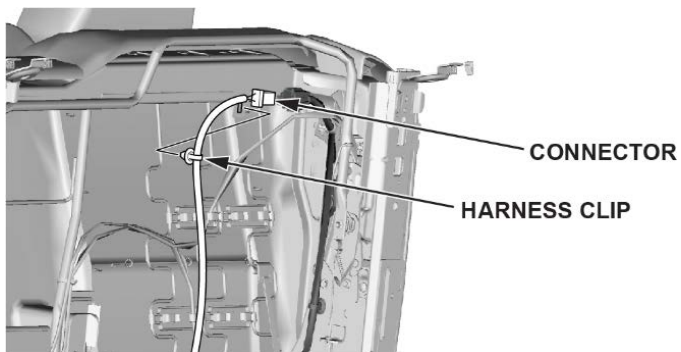
17. Lift up the left side second row seat, and then remove the harness clip and disconnect the connector.

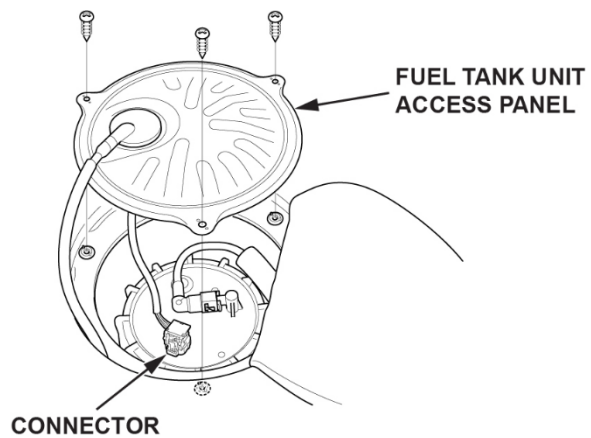
19. Remove the fuel tank unit access panel and disconnect the fuel tank unit connector.

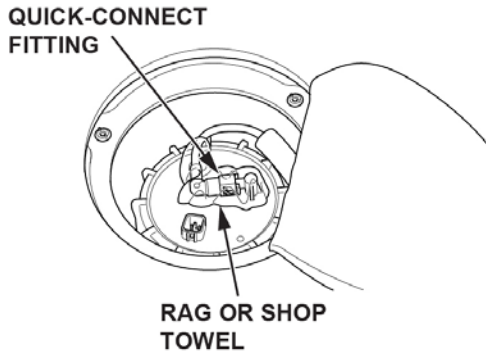
20. Place a rag or shop towel over the quick-connect fitting.

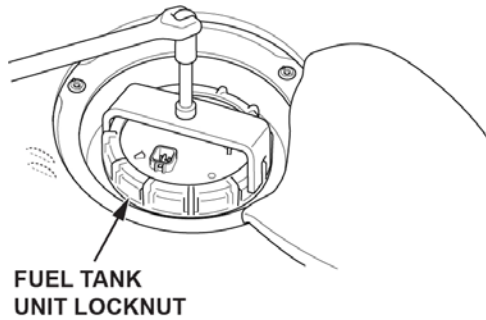
22. Remove the fuel tank unit locknut using the fuel sender wrench (T/N 070AA-T0AA100) as shown.

NOTE: Keep the fuel sender wrench from floating.

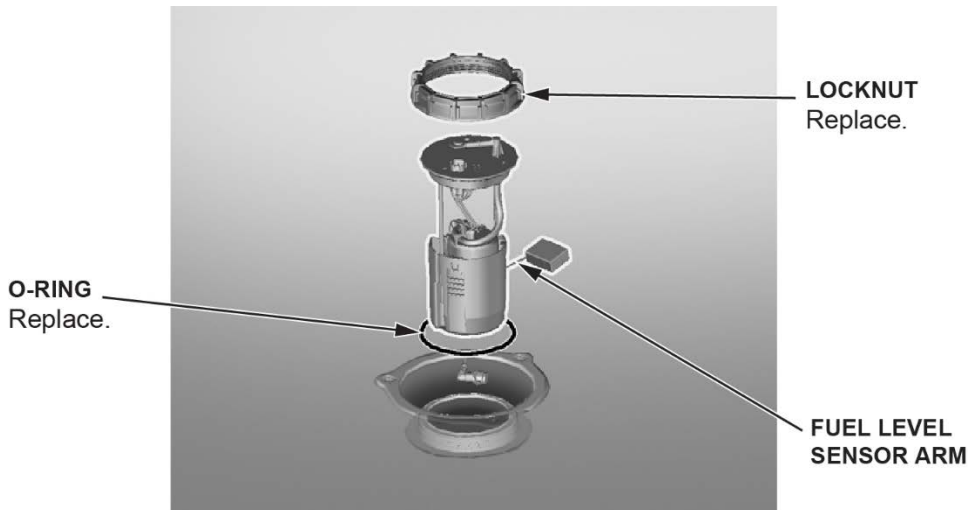
23. Remove the fuel tank unit locknut, then remove the fuel tank unit.

Do not to bend or twist the fuel level sensor arm excessively. This may damage the fuel level sensor or cause it to send inaccurate readings.

NOTE: After unlocking the fuel tank unit cam lock ring, clean the top of the fuel pump flange and adjacent areas to make sure it's free of dirt, dust, and debris.

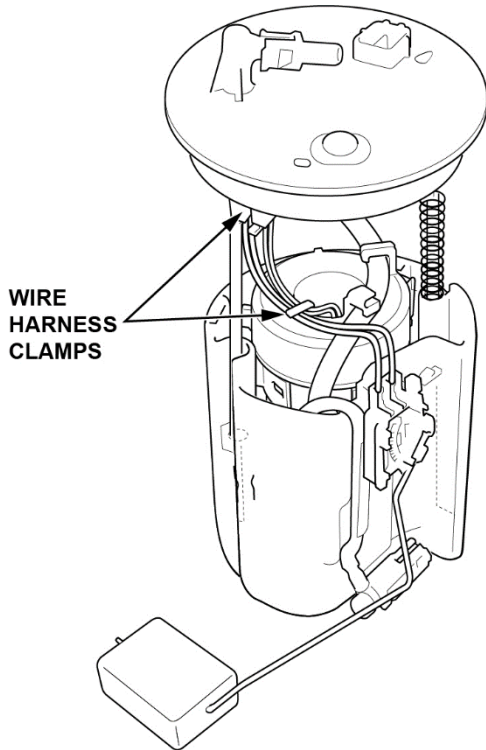
25. Spread the wire harness clamps, and remove the wire harness. Make sure not to damage the wire harness.

Do not spread the clamps too wide. Spreading them too wide may damage them.

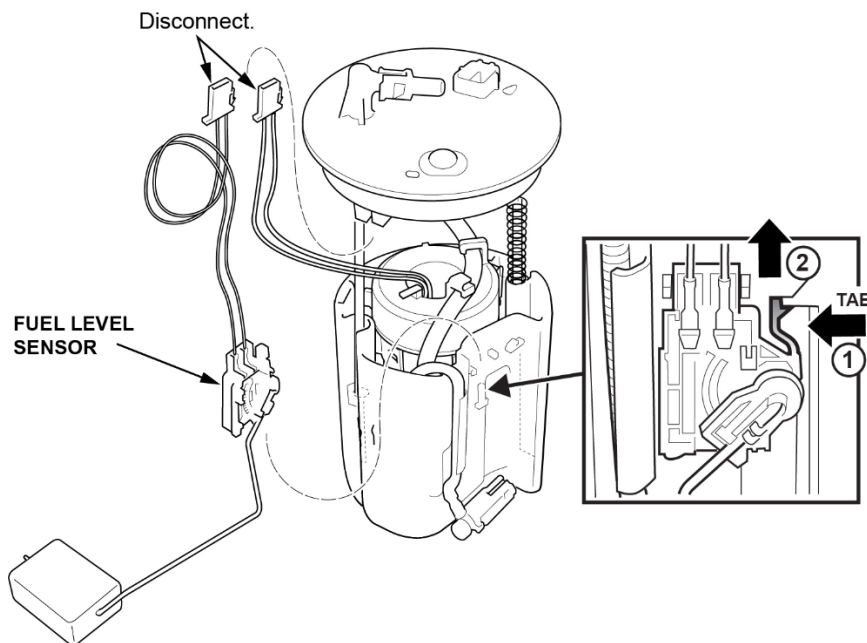
26. Press the tab on the fuel level sensor to release the lock. Then, push up on the fuel level sensor.

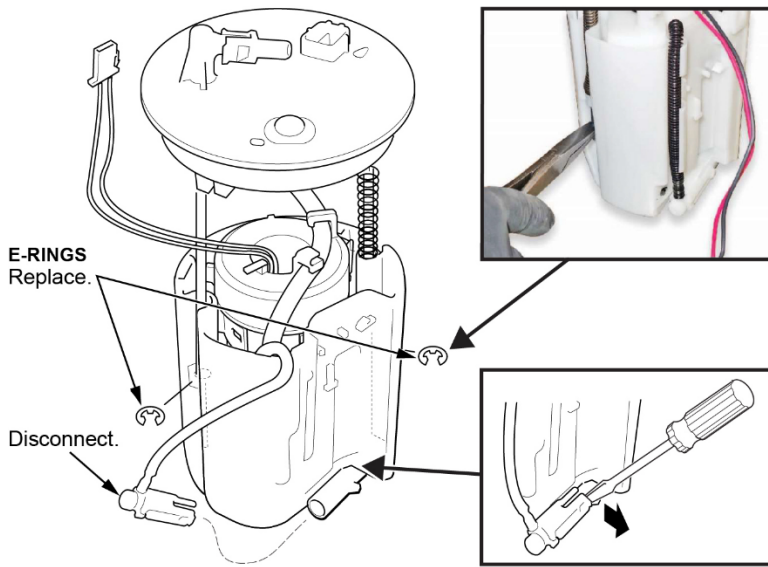
27. Remove the E-rings and discard them.

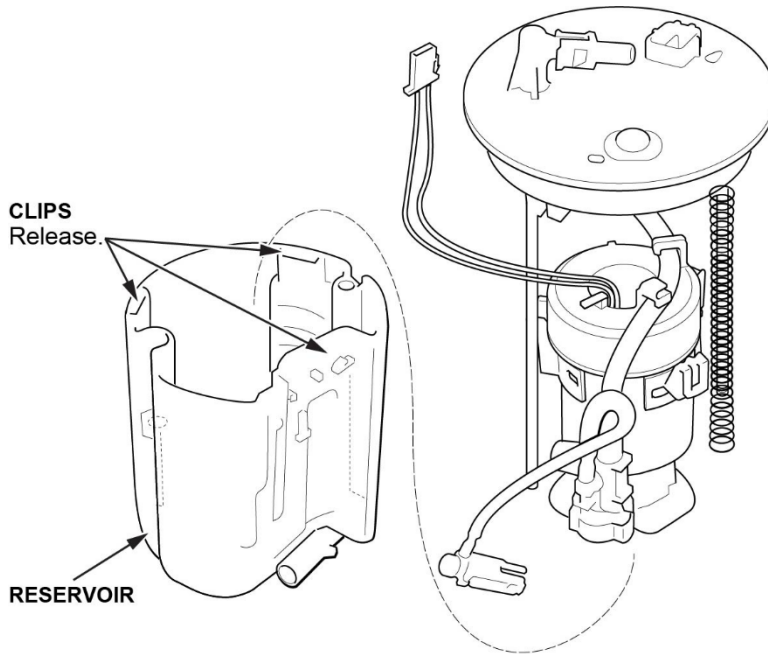
29. Remove the fuel filter assembly from the reservoir by releasing the three clips.

Do not spread the clips too wide. Spreading them too wide may damage them.

NOTE: The spring may slide off the sliding shaft. Retain this spring. It will be used during assembly.

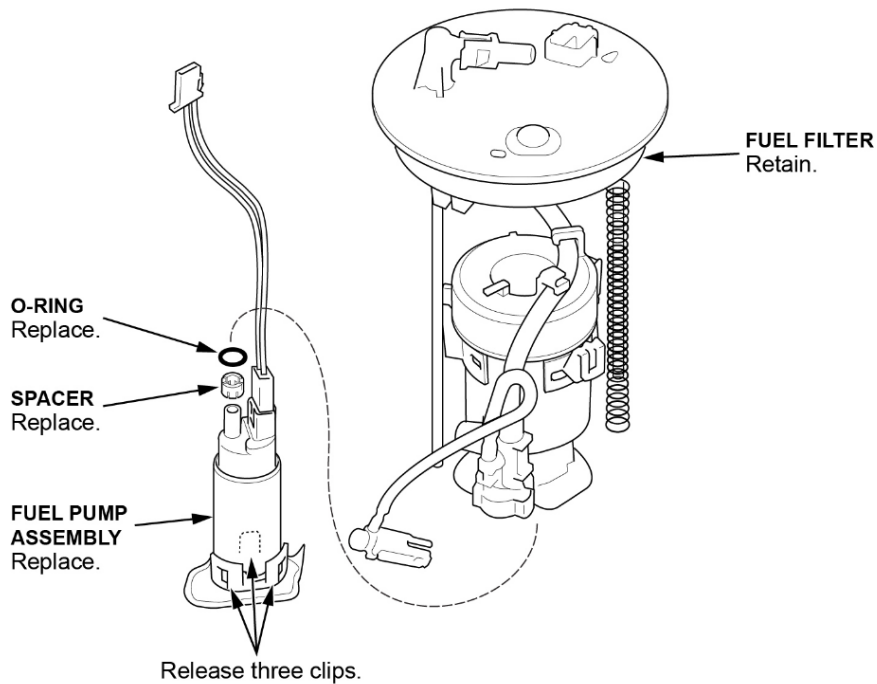
30. Release the three clips at the base of the fuel pump assembly and remove it from the fuel filter.

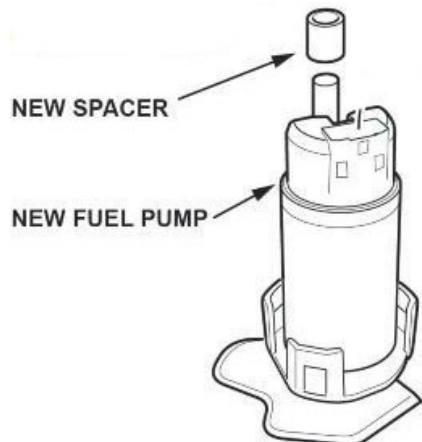
32. Install the new spacer onto the new fuel pump motor.

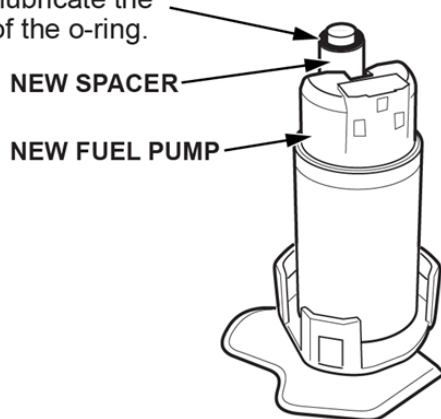
NEW O-RING

33. Install the new O-ring, then lubricate ONLY the outside edge of it, using clean engine oil.

NOTE: Do not pinch the O-ring during installation.

Lubricate after installing.
Do not lubricate the
inside of the o-ring.

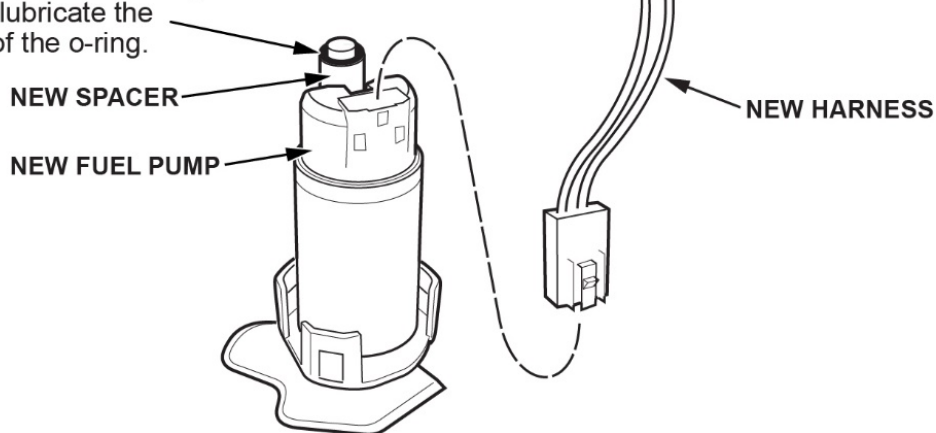
34. Install the new harness making sure the connection is secure and the connectors are firmly locked into place.

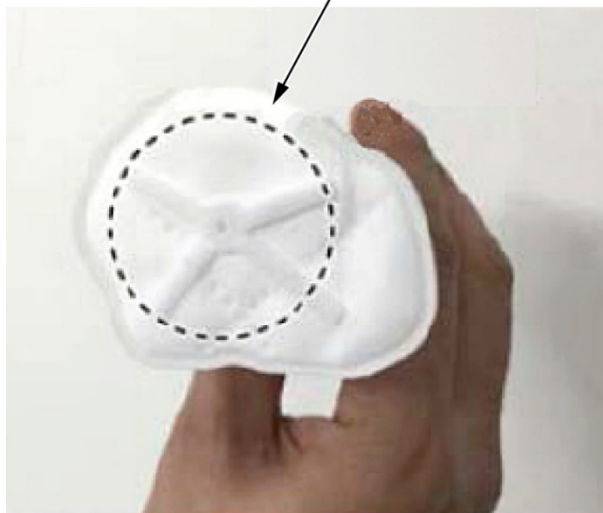
SUCTION FILTER

35. With the palm of your hands press the fuel pump into the suction fuel filter.

When pressing the fuel pump into the suction filter make sure you do so with a single firm push. Failure to do so may damage the O-ring. If it is seated properly, you will hear a click.

If you do not hear the click, remove all parts and inspect the O-ring for damage. If the O-ring is damaged, it must be replaced. Reassemble using the above process.

- When inserting the pump, be careful not to break the suction filter.
- If the O-ring is damaged; replace it with a new one.
- After installing the fuel pump to the suction filter, make sure the clips are firmly attached to the new fuel pump.

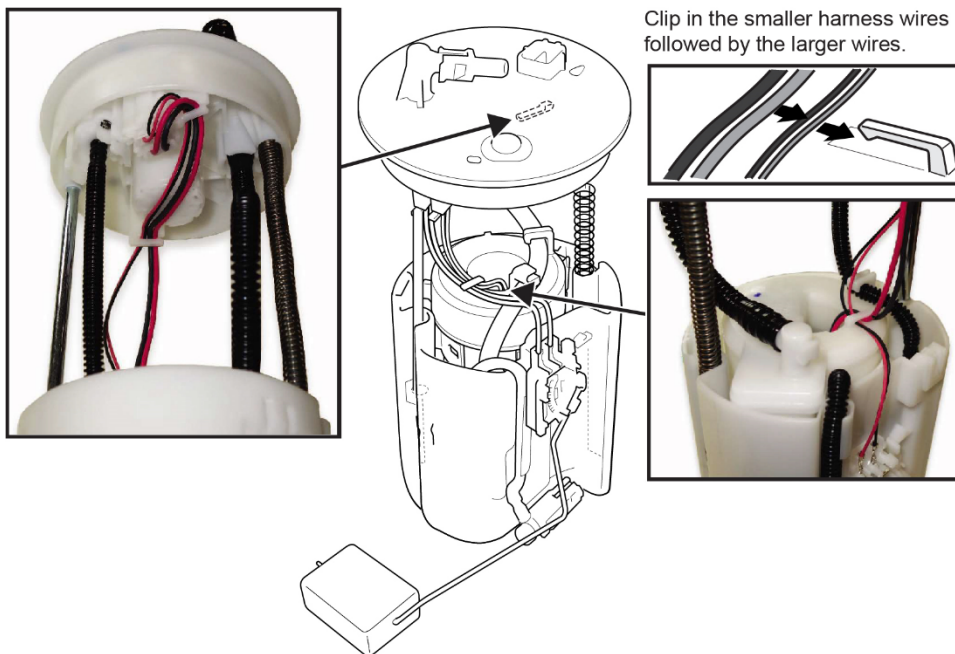
HARNES ROUTING:

39. Install the wiring harness to the clamps.

Do not spread the clamps too wide. Spreading them too wide may damage them.

- Clip in the smaller harness wires followed by the larger wires.
- Make sure not to damage the wire harness.
- Make sure to route the wire harness **exactly** as shown in the photo taken before disassembly.

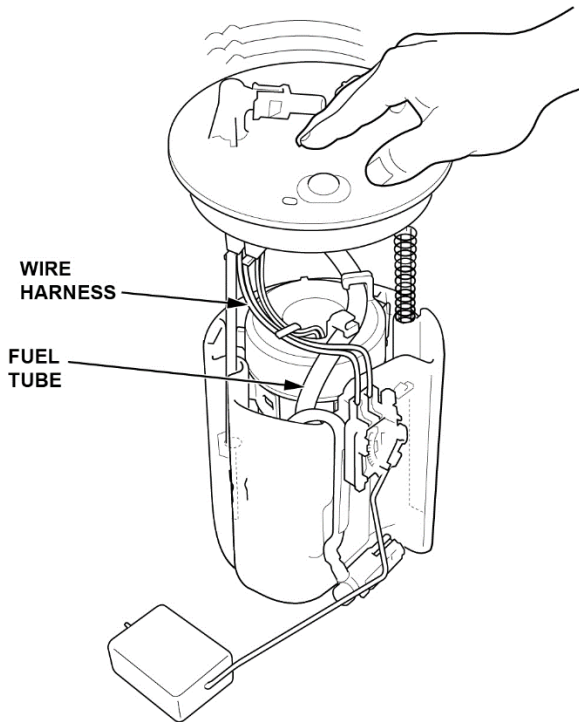
40. While compressing the fuel tank unit, make sure the movement is smooth and the fuel tube and wiring harness do not stretch, pinch, or bind.

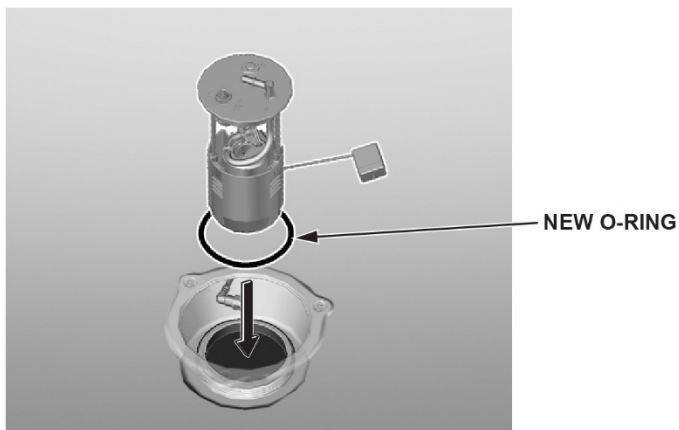
41. Insert the fuel tank unit partially into the fuel tank with a new O-ring.

- Before installing the new O-ring, clean the fuel tank around the fuel pump opening where the O-ring will seat. The tank opening must be free of dirt, dust, and debris.
- Be careful not to damage the O-ring.
- Do not coat the O-ring with any oil.

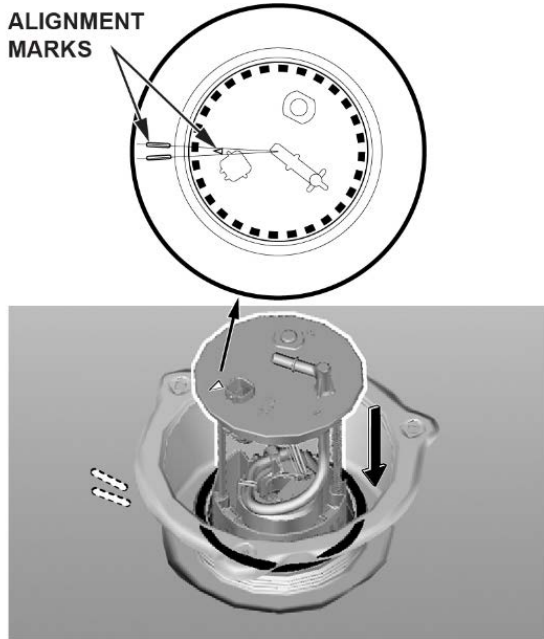
42. Line up the mark on the fuel tank unit to the marks on the fuel tank, then insert the fuel tank unit into the fuel tank.
NOTE: To avoid any leaks, check the O-ring, either visually or by hand, to make sure it is not pinched.

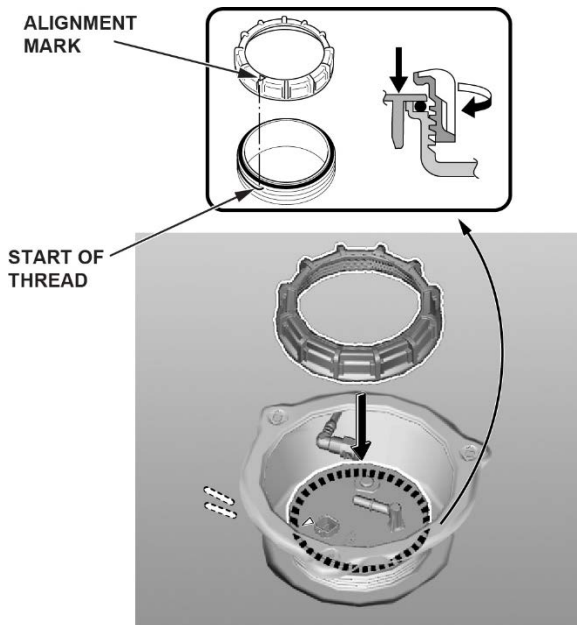
43. Line up the mark on the new locknut to the start of the thread on the fuel tank.

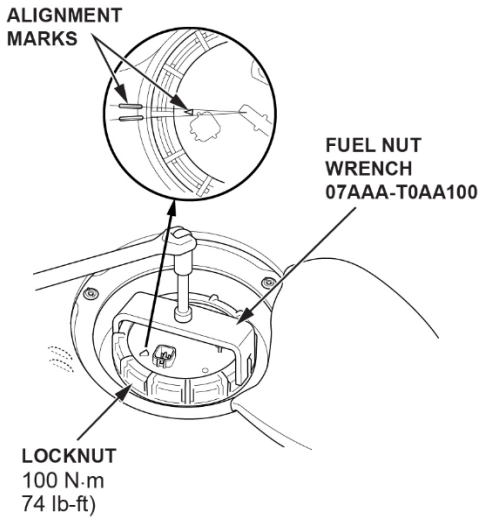
44. Press down on the fuel tank unit while turning the locknut clockwise by hand.

45. Using the fuel nut wrench, tighten the locknut to **100 N·m (74 lb-ft)**.

- During installation, check the O-ring, either visually or by hand, to make sure it is not pinched.
- After tightening, make sure the mark on the fuel tank unit is still lined up with the marks on the fuel tank.

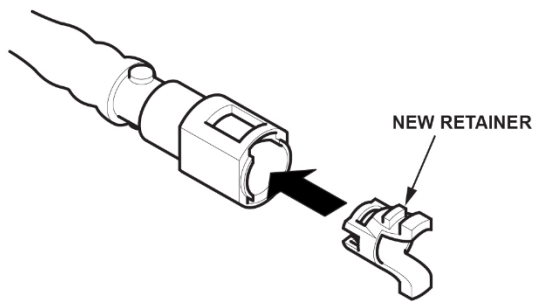
46. Remove the quick-connect fitting retainer from the fuel tank unit, then install a new retainer onto the quick-connect fitting.

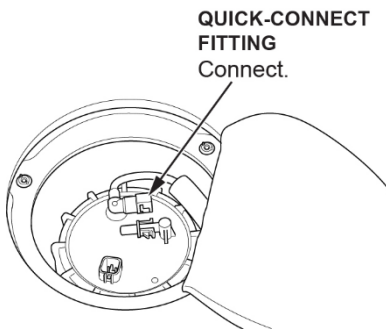
47. Connect the fuel line quick-connect fitting.

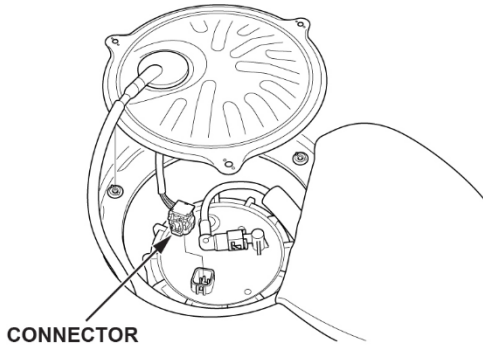
48. Connect the fuel tank unit connector.

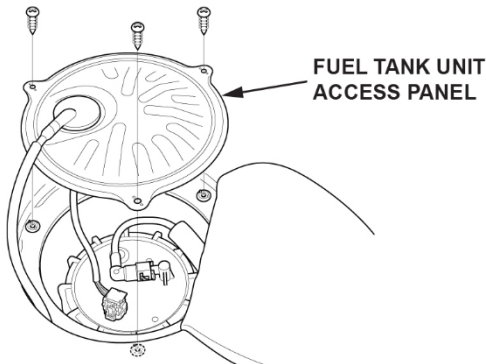
51. Install the fuel tank unit access panel.
