TECHNICAL INSTRUCTIONS

SAFETY RECALL 23TA15

PASSENGER AIRBAG MAY NOT DEPLOY

CERTAIN 2020-2021 COROLLA VEHICLES

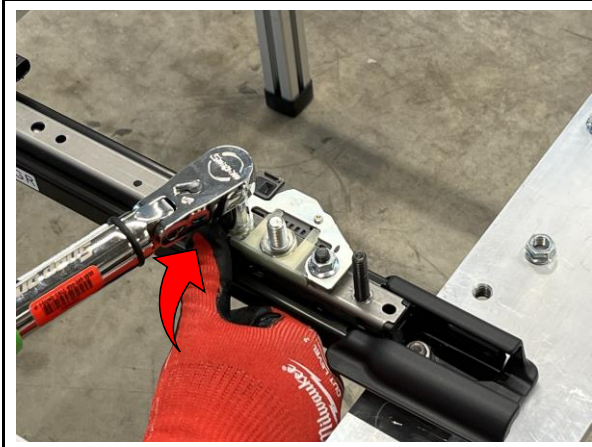
- a) If necessary, install the **NEW** rear OCS assembly to the seat track assembly.

When installing, be sure to use your thumb to gently push on the left corner of each sensor to seat the NEW OCS properly.

Torque: 25 N*m (18.5 ft.*lbf)

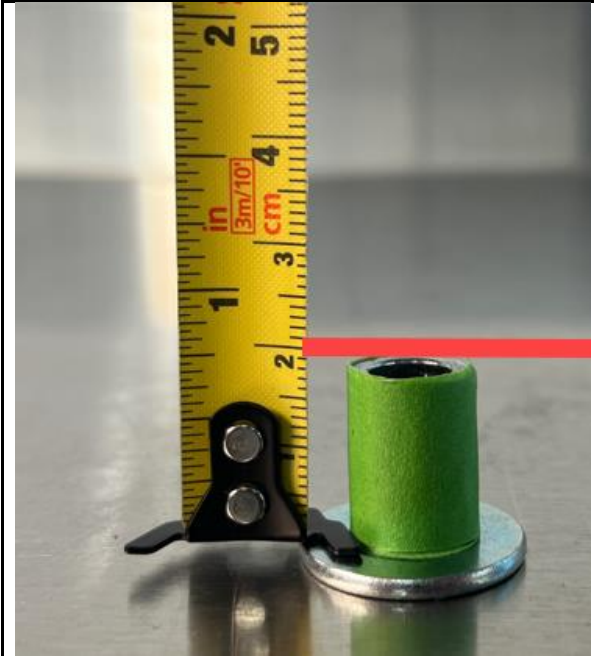
- a) Prepare the interference sleeve for installation by using masking tape. Cut approximately 20mm (3/4") of tape and wrap the interference sleeve **2 times**, ensuring no wrinkles or creases exist.

This will ensure that no contact between the sleeve and seat track assembly exists during the installation of the left side seat track nuts.
