**TECHNICAL INSTRUCTIONS**  
**FOR**  
**SAFETY RECALL – 23LA03**

**PASSENGER AIRBAG MAY NOT DEPLOY**

**CERTAIN 2020-2022 ES250, ES350, ES300H VEHICLES**

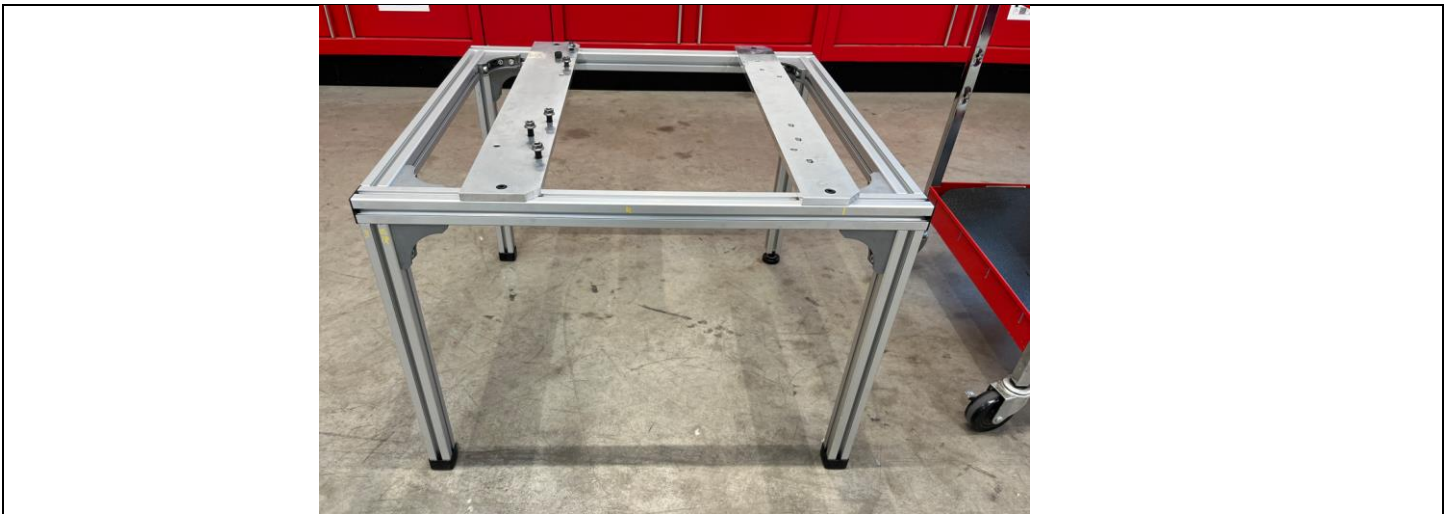
- Recall SST: Seat Jig Assembly (This was shipped to your dealer at Phase 1 Remedy Launch).**
- It is critical that the seat jig assembly is used during sensor replacement, so the seat tracks remain square and do not become misaligned. Seat track out of alignment will impact the occupant detection weight readings by the ECU.**

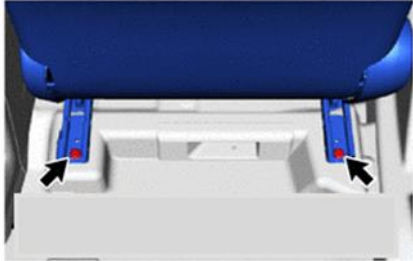
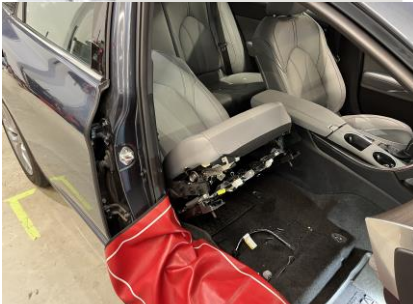
Powered Seat

## VI. INSPECT FRONT AND REAR OCS SERIAL NUMBERS

**NOTE: Manual seat track assembly will follow the same inspection instructions.**

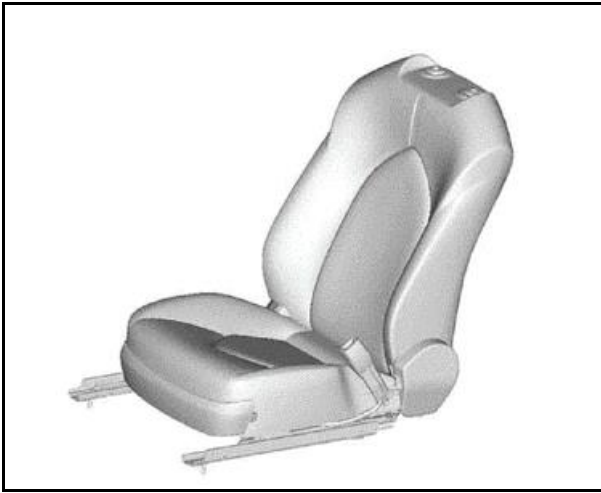
**If the first 5 digits of the OCS serial number are illegible, the sensor must be replaced.**

In the event that the application cannot successfully scan the vinyl VIN certification label due to its compromised condition or if it is missing, please reach out to the Quality Compliance team at [quality\\_compliance@toyota.com](mailto:quality_compliance@toyota.com). Include a photograph of the damaged VIN label, if applicable, as well as the VIN label located beneath the windshield in your correspondence.

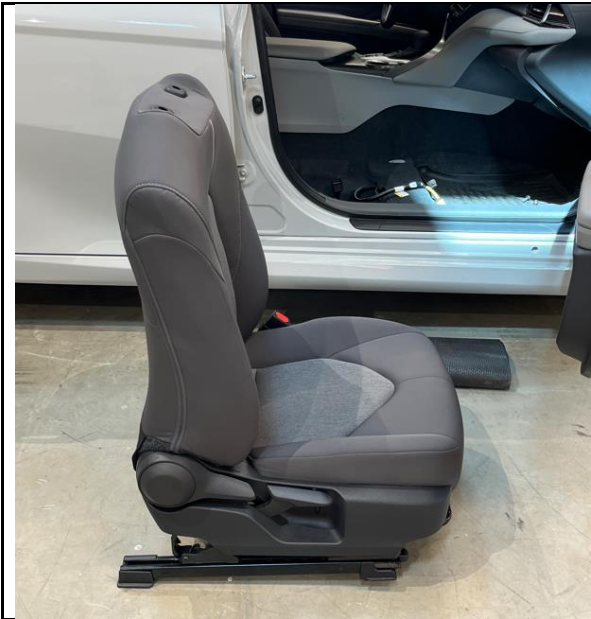
## VII. REPLACE FRONT AND/OR REAR OCS ASSEMBLIES

**NOTE:** Manual seat track assembly will follow the same repair instructions.

Perform this procedure only when OCS replacement has been determined in the previous section.

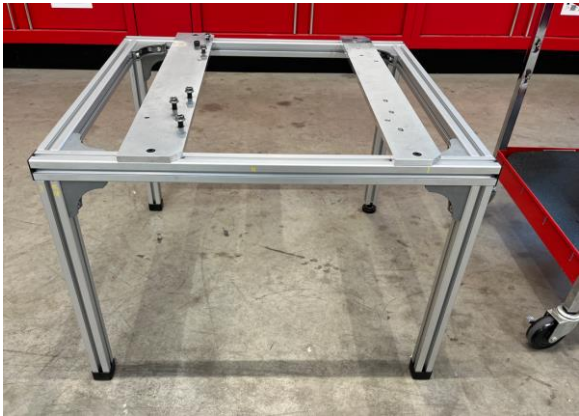
- a) Identify the correct rear bolt and front alignment pinhole combination to match the seat frame type being mounted to the jig.

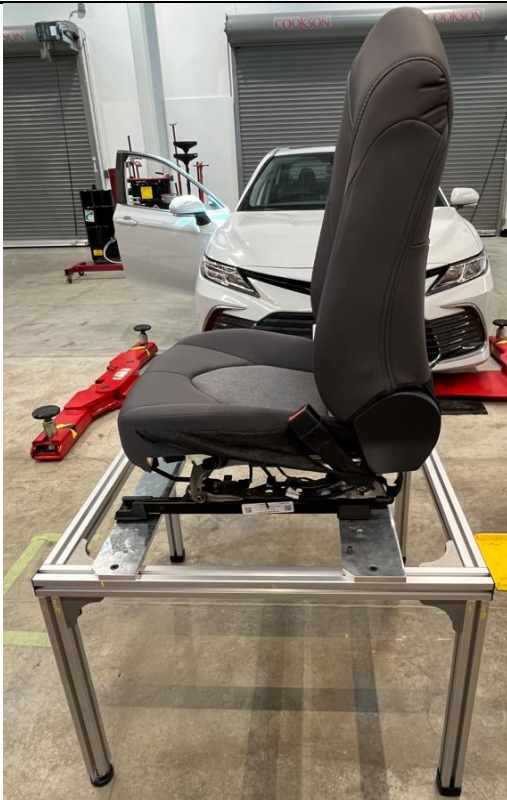
- a) Place the passenger front seat assembly onto the jig and secure it using the 2 provided bolts, nuts, and washers through the rear seat track mounting holes.

**Torque: 27 N\*m (20 ft.\*lbf)**

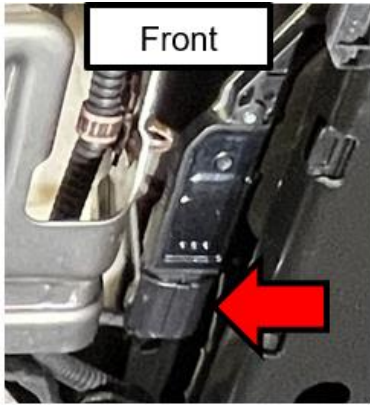
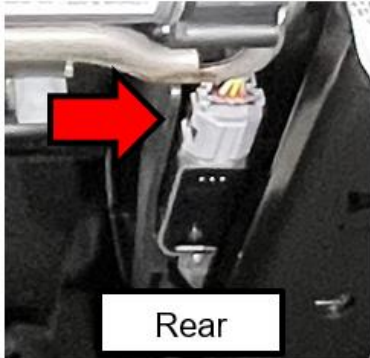
4. **DISCONNECT THE OCS CONNECTORS**  
a) Disconnect the front and rear OCS connectors.

**NOTICE:**  
Be sure to disconnect both front and rear OCS connectors before lifting up the seat track in the following step.

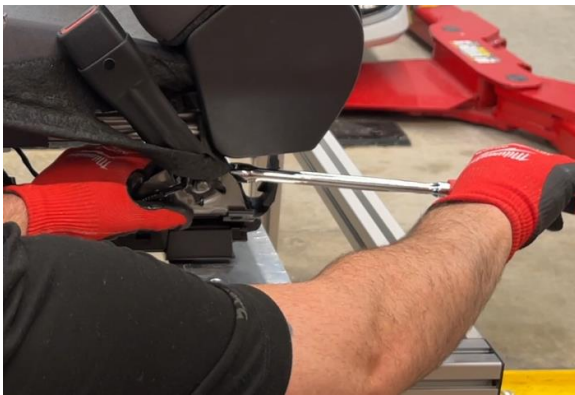
- a) Loosen and remove the front and rear seat track nuts using a 14mm socket and ratcheting wrench.

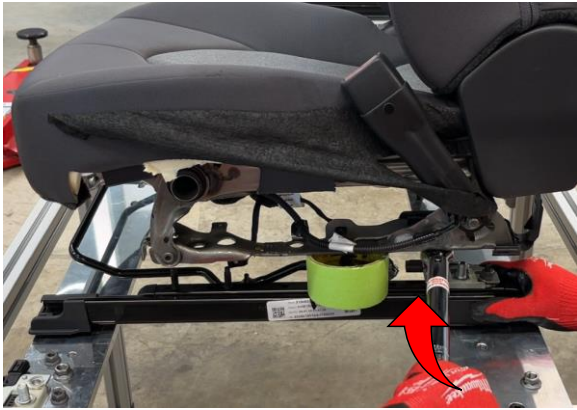
- a) If necessary, install the **NEW** rear OCS to the seat track assembly.

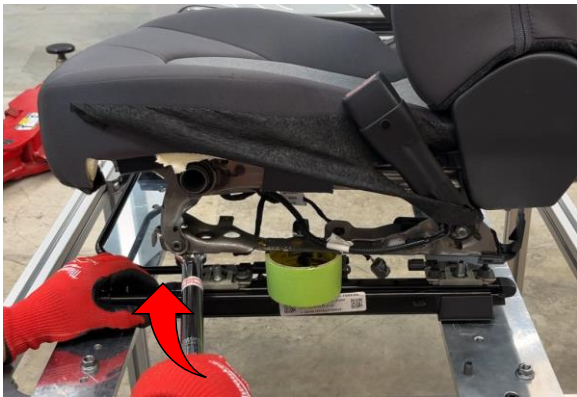
When installing, be sure to use your thumb to gently push on the left corner of each sensor to seat the **NEW** OCS properly.

**Torque: 30 N\*m (22.5 ft.\*lbf)**

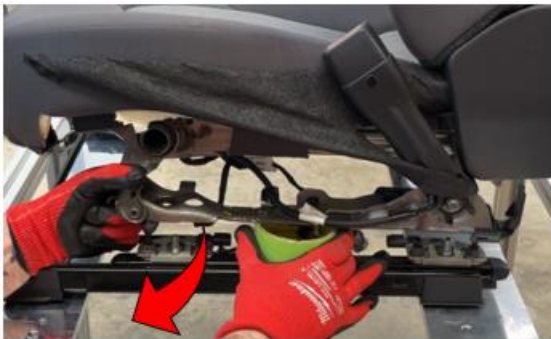
- b) If necessary, install the **NEW** front OCS assembly to the seat track assembly.

When installing, be sure to use your thumb to gently push on the left corner of each sensor to seat the **NEW** OCS properly.

**Torque: 30 N\*m (22.5 ft.\*lbf)**

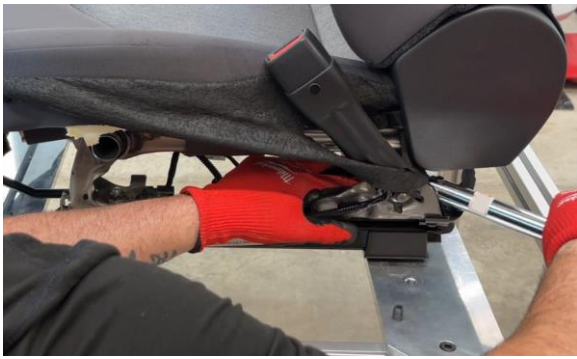
- c) Remove the spacer and place the upper seat assembly back onto the seat track assembly.

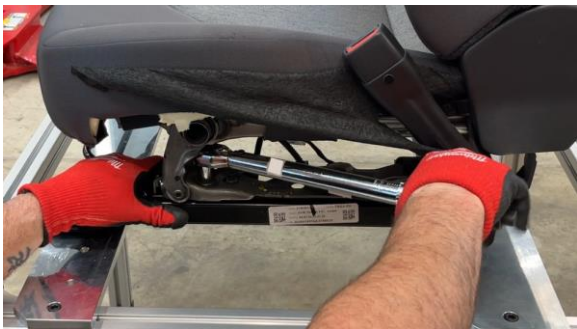
d) Re-install the rear seat track nut.

**Torque: 47 N\*m (35 ft.\*lbf)**
