**TECHNICAL INSTRUCTIONS**  
**FOR**  
**SAFETY RECALL – 23LA03**  
**PASSENGER AIRBAG MAY NOT DEPLOY**  
**CERTAIN 2020-2021 RX350, RX450 VEHICLES**

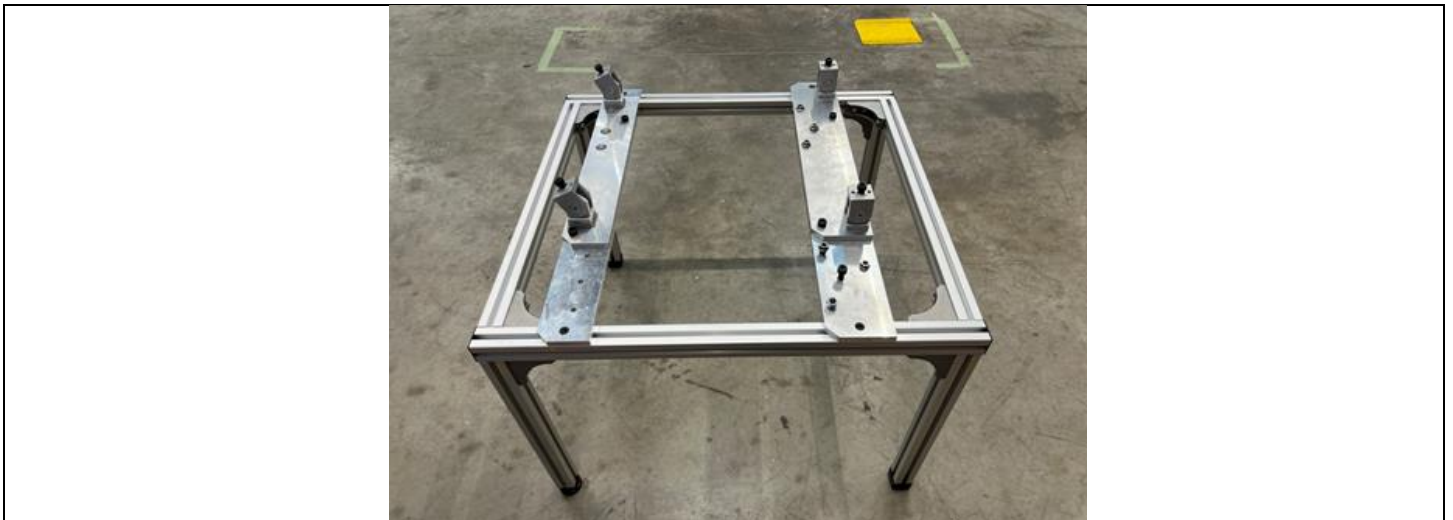
- Recall SST: Seat Jig Assembly (This was shipped to your dealer at Phase 1 Remedy Launch).**
- It is critical that the seat jig assembly is used during sensor replacement, so the seat tracks remain square and do not become misaligned. Seat track out of alignment will impact the occupant detection weight readings by the ECU.**

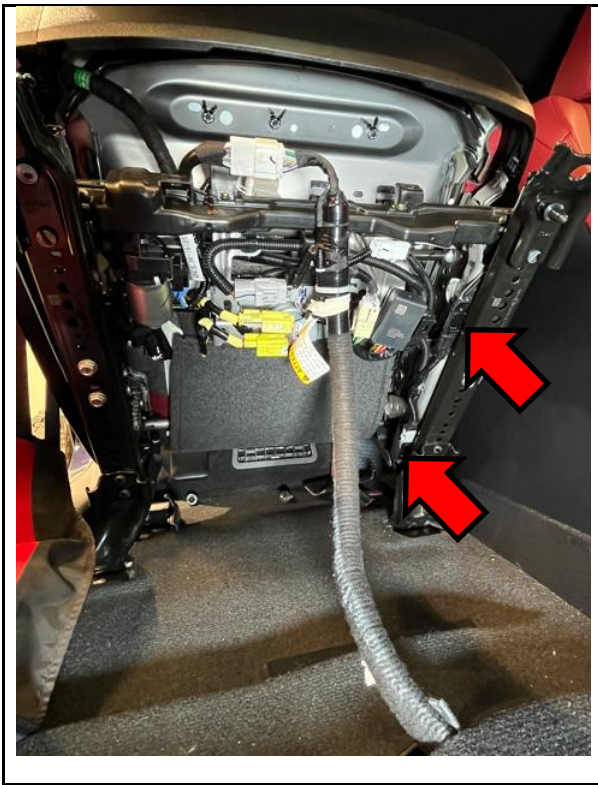
- b) Take note of the passenger seat position, so seat can be returned to this position later.
- c) Place the passenger front seat in the following positions before unbolting:
- Recline Angle - Upright Position
  - Front Tilt Height – Highest Position
  - Seat Lifter Height – Highest Position
- d) Using a T50 “TORX” socket, unbolt the 4 passenger seat bolts.
- e) Lean the passenger front seat back to view the underside of the seat.

**DO NOT disconnect any seat harness connectors at this time.**

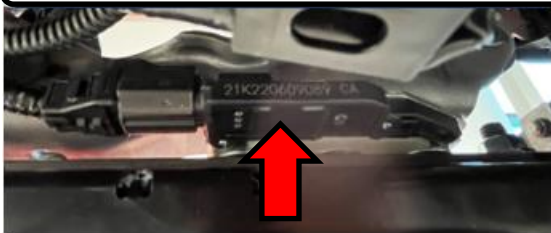
Front

- a) Viewing from underneath the seat, locate and identify the front and rear OCSs.

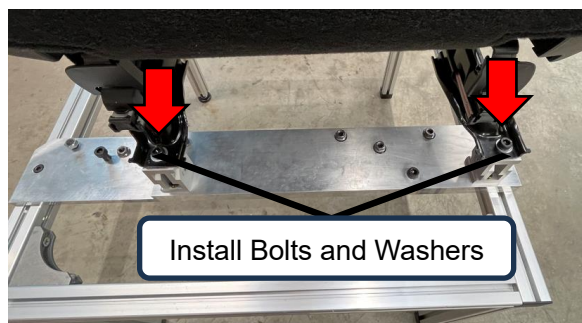
- a) Place the passenger front seat assembly onto the jig and secure it using the 4 provided bolts and washers.

**Torque: 27 N\*m (20 ft.\*lbf)**

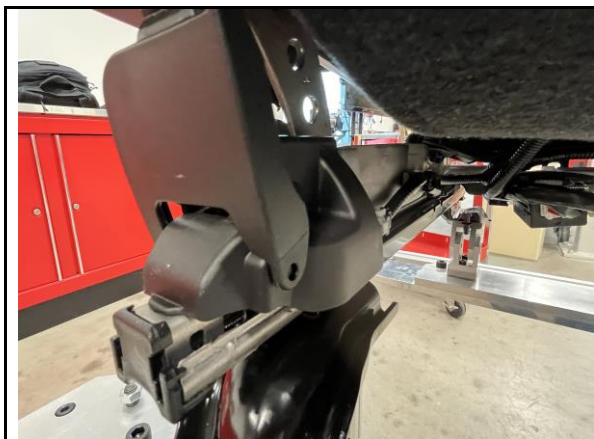
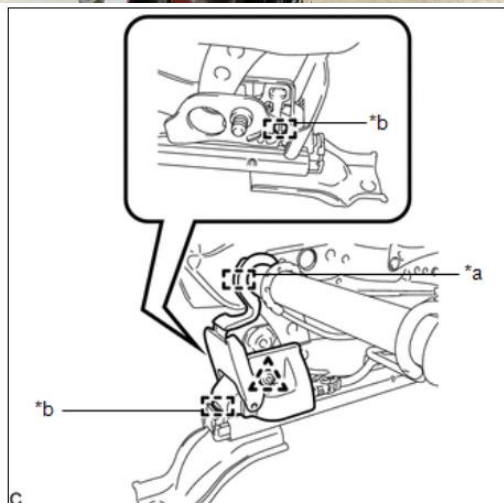
| *a | Hook |
| *b | Guide |

- Disengage the clip.
- Disengage the hook.
- Disengage the two guides to remove the front seat lower cushion shield.

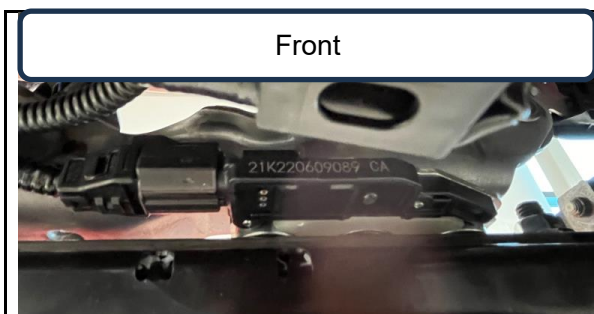
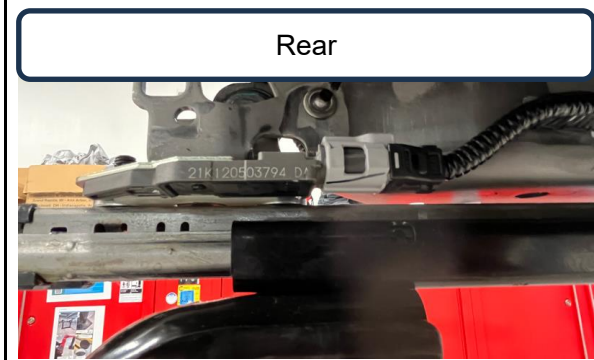
- Disconnect the front and rear OCS connectors.

Be sure to disconnect both front and rear OCS connectors before lifting up the seat track in the following steps.

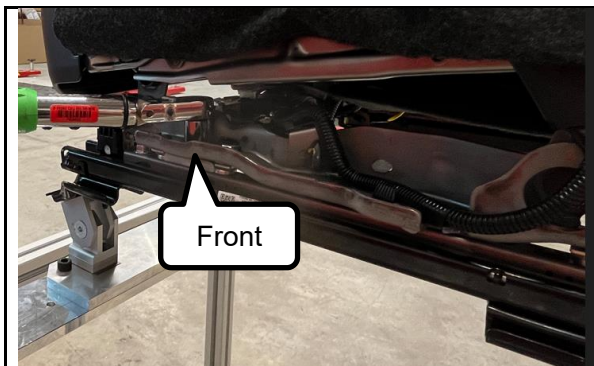
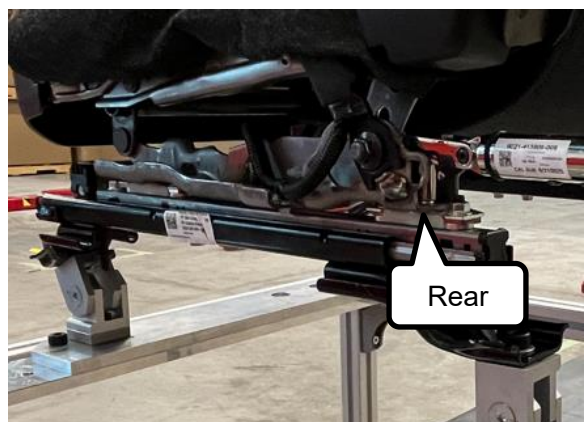
**DO NOT** loosen any nuts other than the ones instructed.

- a) Loosen and remove the front and rear seat track nuts using a 14mm socket and ratcheting wrench.

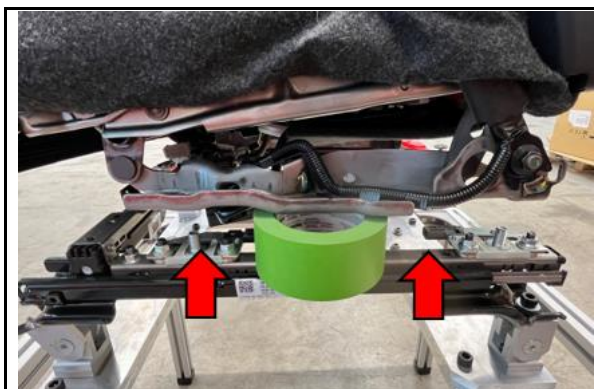
## 7. INSTALL A 3.5-4.5" SPACER BETWEEN THE LOWER SEAT TRACK RAIL AND THE UPPER TRACK ASSEMBLY

Be sure to use a foam block, tape roll, wood block, or similar to provide enough space to access the front and rear OCS assembly nuts.

**DO NOT** exceed 4.5" of space when inserting tape roll. Damage may occur if this is not followed

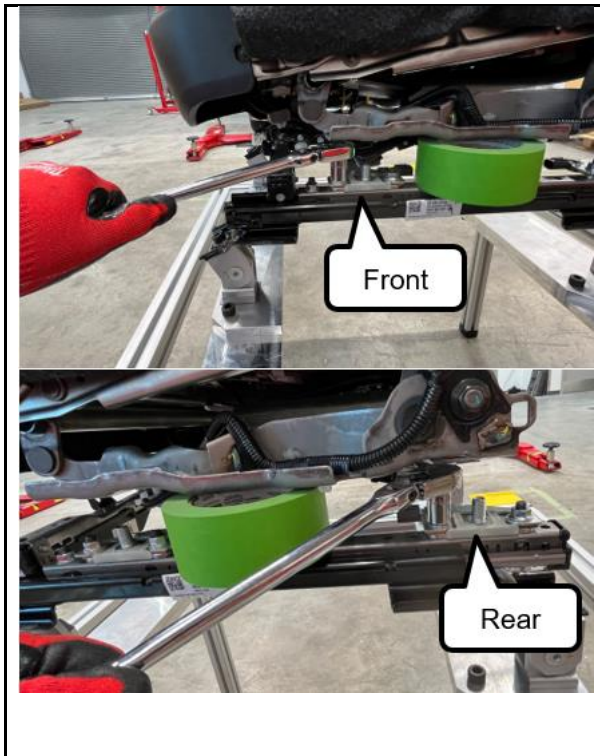
**DO NOT** loosen any nuts other than the ones instructed.

- a) Using a ratcheting or box wrench, remove the front and/or rear OCS, as instructed by the mobile inspection app.

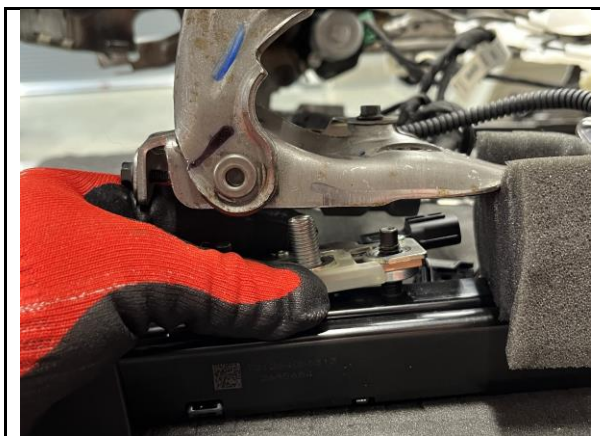
- b) If necessary, remove the front OCS from the seat track.

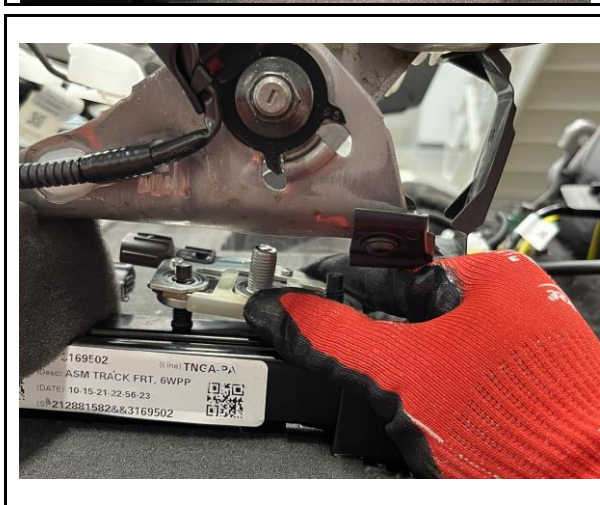
- c) If Necessary, remove the rear OCS from the seat track.

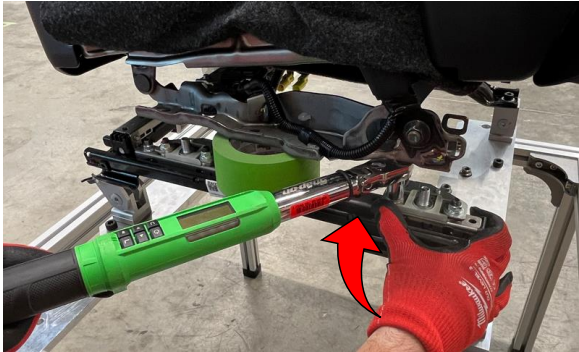
- a) If necessary, install the **NEW** rear OCS to the seat track assembly.

When installing, be sure to use your thumb to gently push on the left corner of each sensor to seat the **NEW** OCS properly.

**Torque: 25 N\*m (18 ft.\*lbf)**

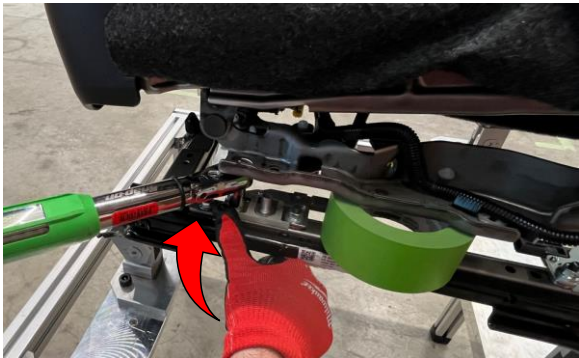
- b) If necessary, install the **NEW** front OCS to the seat track assembly.

When installing, be sure to use your thumb to gently push on the left corner of each sensor to seat the **NEW** OCS properly.

**Torque: 25 N\*m (18 ft.\*lbf)**

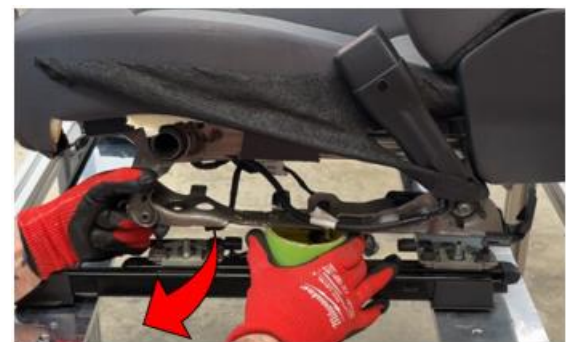
- c) Remove the spacer and place the upper seat assembly back onto the seat track assembly.

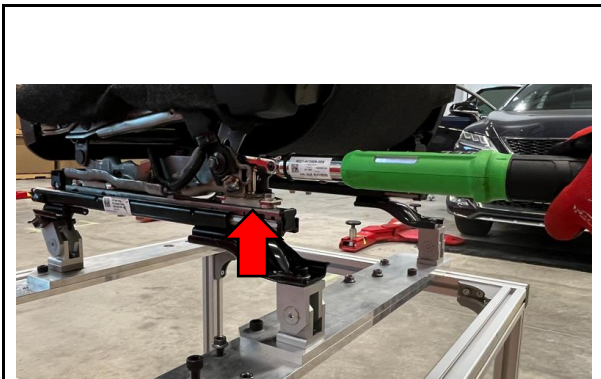
d) Re-install the rear seat track nut.

**Torque: 37 N\*m (27 ft.\*lbf)**

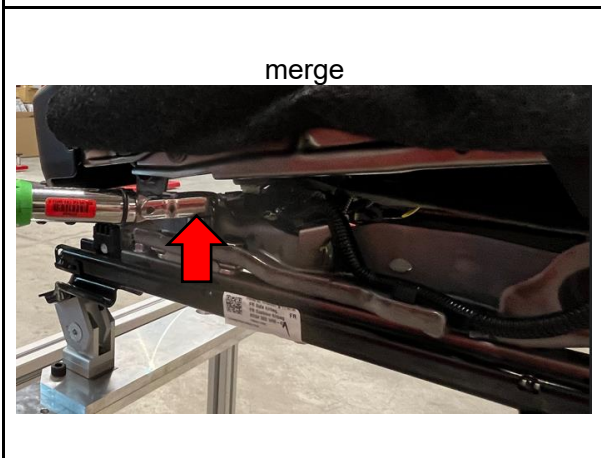
e) Re-install the front seat track nut.

**Torque: 37 N\*m (27 ft.\*lbf)**

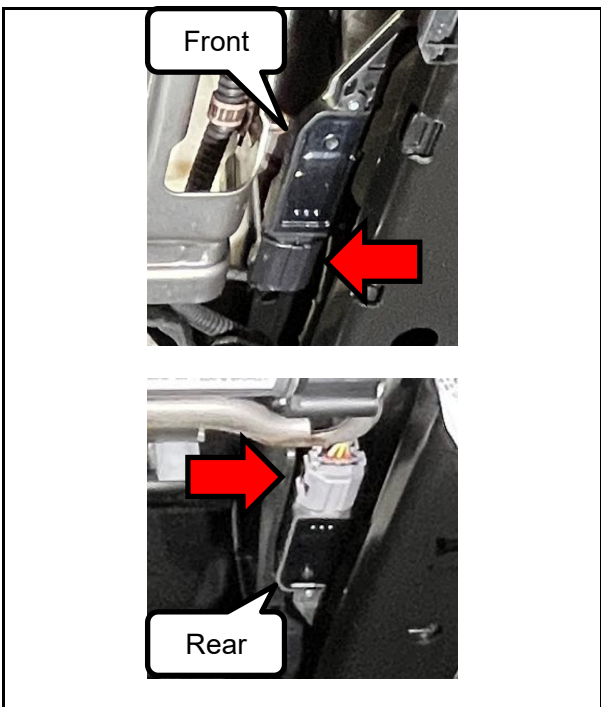
g) Reconnect both front and rear OCS connectors.

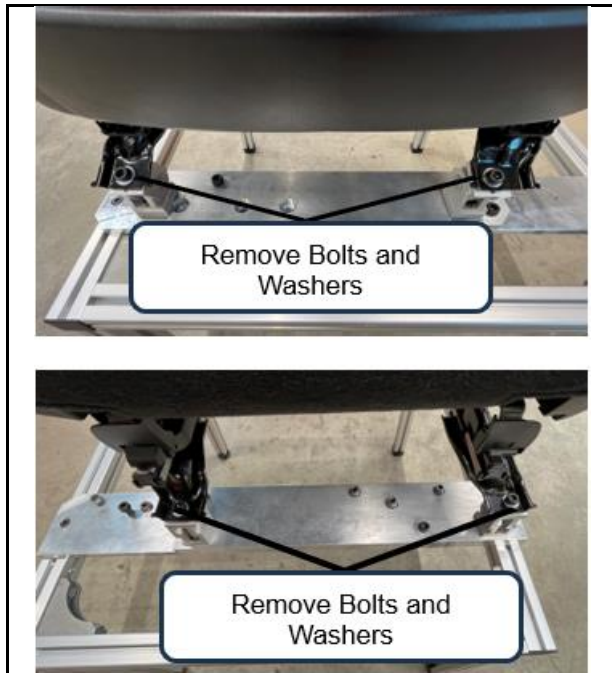
- h) Remove the 4 bolts and washers, then remove the seat assembly from the jig.
