# Safety Recall

## Code: 93U9

**Subject** High-Voltage Battery Modules

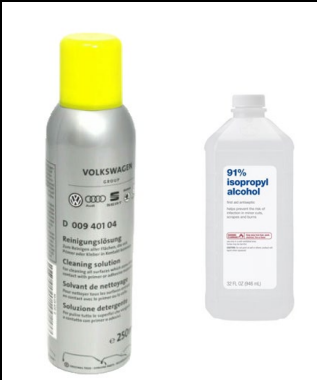
<p>Cleaner D -009-401-04 (shop supply) -OR- 91% Isopropyl Alcohol (locally sourced)</p>

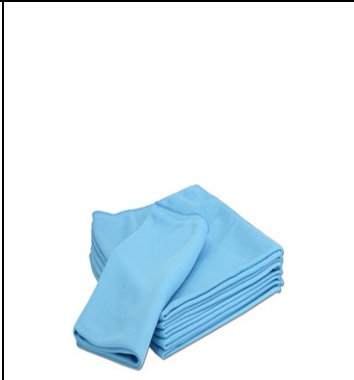
<p>Lint Free Towels (locally sourced)</p>
<p><b><i>NOTE: Use only 91% Isopropyl alcohol as a cleaner (9% water). Do not use Isopropyl with any additional surfactants (cleaners) or additives (scents).</i></b></p>

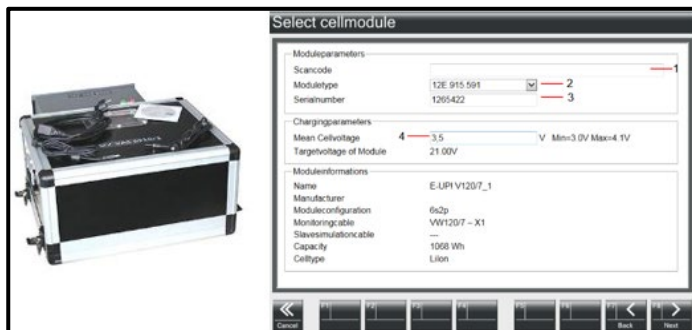
- Perform the Guided Function test plan, “008C – Determine mean cell voltage” and record the mean voltage value.

- When charging or discharging a new cell module, follow the instructions in the ELSA repair manual in conjunction with the operating instructions for the cell balancer being used.

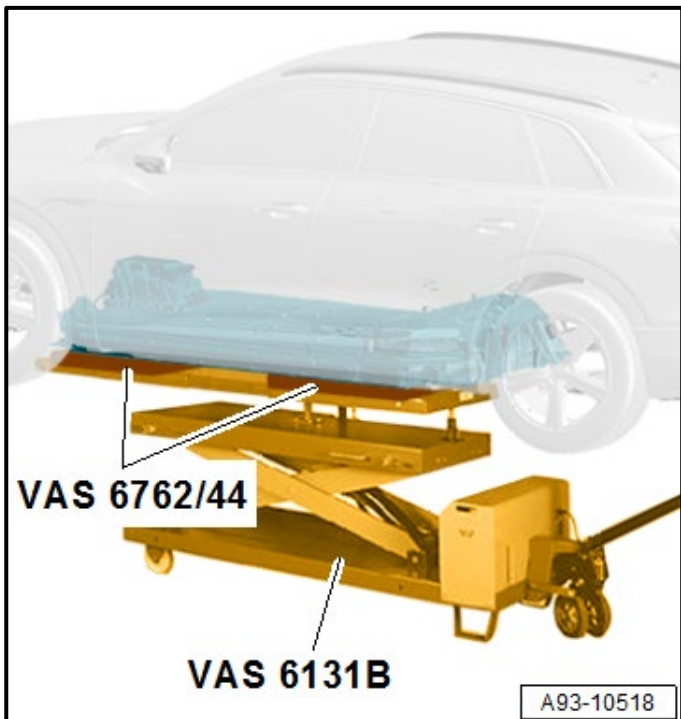
### Remove the high-voltage battery:

- Remove the high-voltage battery per the ELSA Repair Manual:
  - *Repair manual > Motor > Electric Drive Motor 0EF > 93 Electric drive > High-Voltage Battery Unit > High-Voltage Battery 1 AX2, Removing and Installing.*
- Note the following when removing the high-voltage battery:
  - Mark the position of the scissor lift table on the floor to aid in repositioning the table during reinstallation.
  - Pay close attention to all wiring harnesses when lowering the battery.
  - Pay close attention to all coolant hoses when lowering the battery.

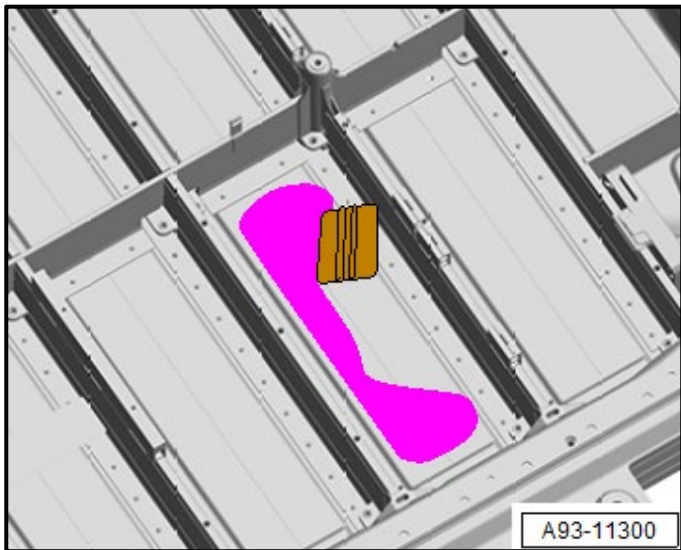
**Clean the mounting area for the new cell module:**

- Ensure that the old thermal compound is removed from the battery housing per the instructions outlined in the cell module removal section.
- Vacuum any shavings/debris from the module threaded connections.
- Do not allow the cleaner to come into contact with any of the lower housing frame sealant.

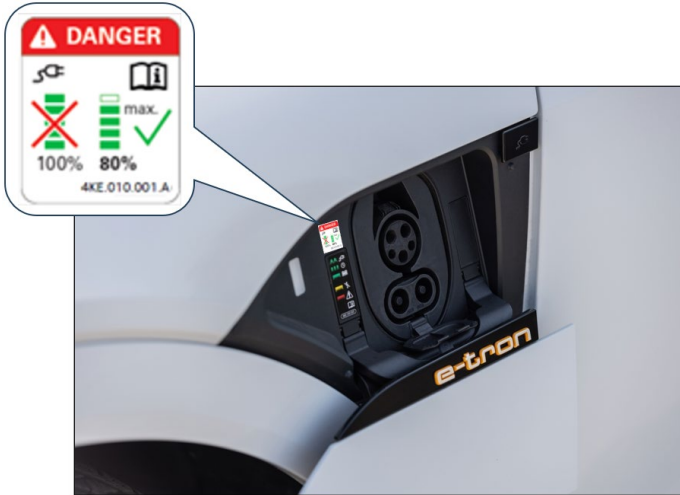
**REMOVE** sticker(s) (if present) from charging ports and near MMI display:

- Remove the sticker from the charging ports and from near the MMI and clean any adhesive residue.
