Safety Recall

Code: 93U9

Subject Interim Monitoring Program for High-Voltage Battery Modules (Offline Vehicles)

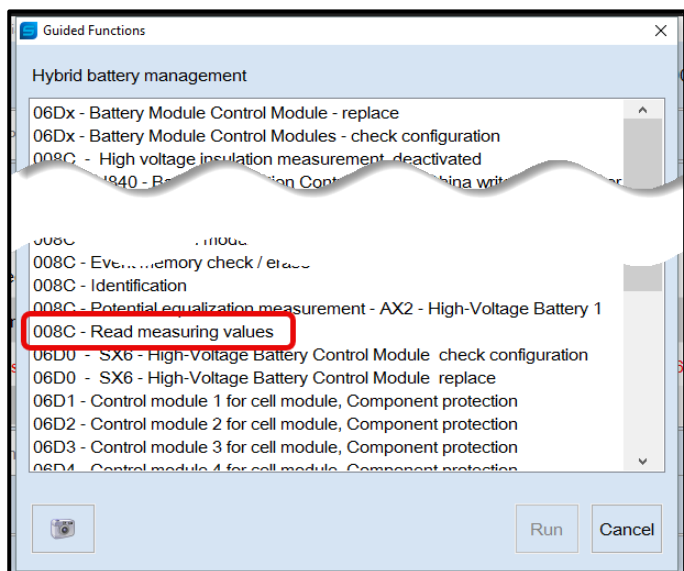
- Connect battery maintainer.
- Perform a full diagnostic scan of the vehicle.
- Select and perform the Guided Function test plan "008C – Read measuring values" for diagnostic address 008C.

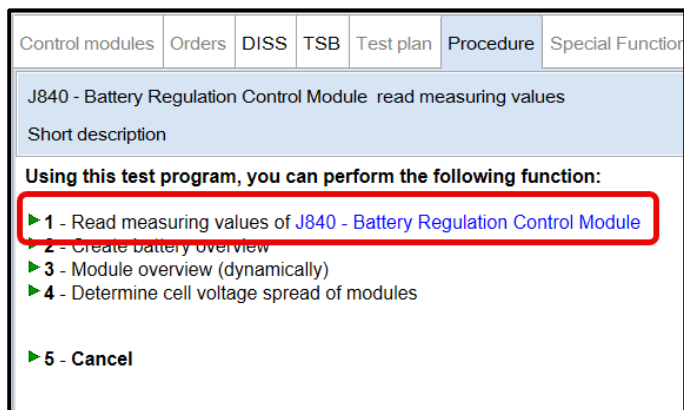
- Select the option "Read measuring values of J840 – Battery Regulation Control Module."

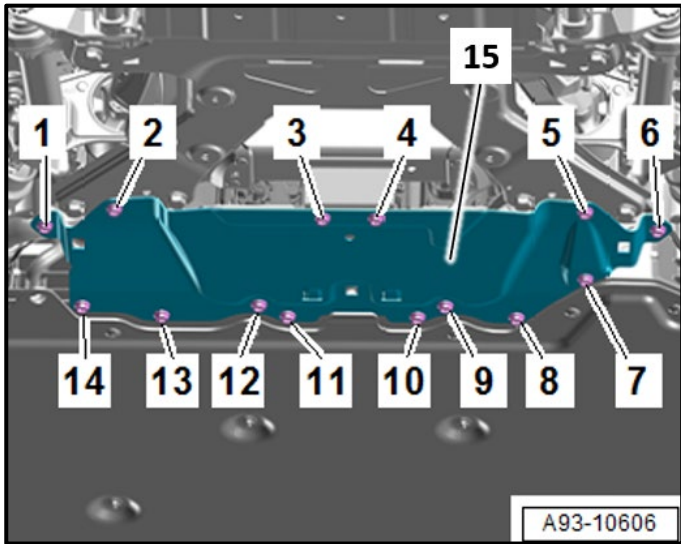
Remove the impact guard:

- Remove the impact guard <15> per the ELSA Repair Manual:
 - *Repair manual > Chassis > Suspension, Wheels, Steering > 40 Front Suspension > Subframe > Impact Guard, Removing and Installing.*

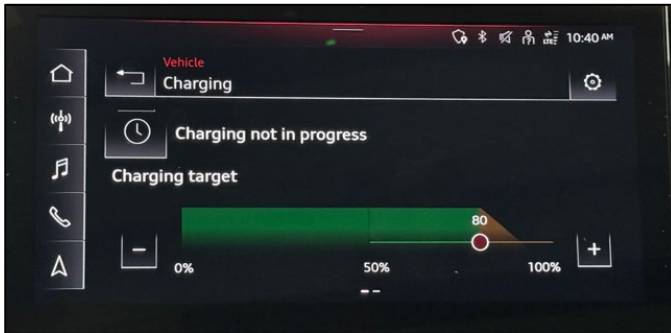
Set max charging level to 80% in the MMI:

- Home
- Vehicle
- Charging and Efficiency
- Charging
- Press and hold green bar to move Target charge rate to 80%
