Safety Recall

Code: 93V2

Subject High-Voltage Battery Modules

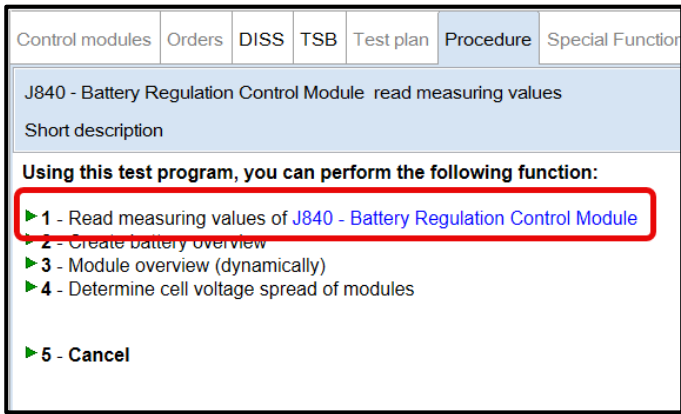
- Select the option “Read measuring values of J840 – Battery Regulation Control Module.”

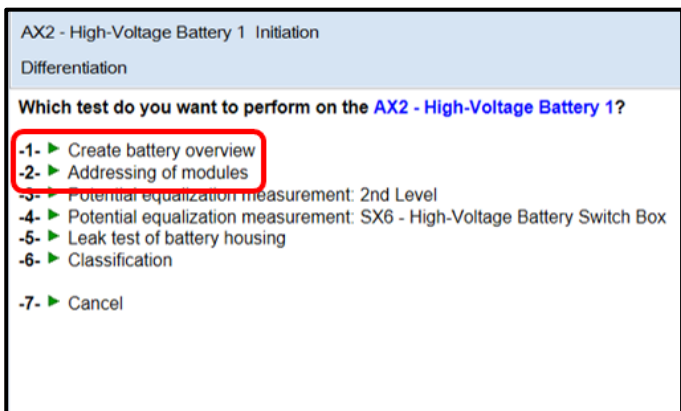
High-voltage battery preliminary operation:

- Perform the steps below in conjunction with following Guided Function test plans:
 - “008C – Initiation > -1- Create battery overview”.
 - “008C – Initiation > -2- Addressing of modules”.
- Refer to the ELSA Repair Manual for high-voltage battery preliminary operation:
 - *Repair manual > Motor > Electric Drive Motor 0EF > 93 Electric drive > High-Voltage Battery Components > High-Voltage Battery Preliminary Operation > High-Voltage Battery Preliminary Operation, Preparing for Calibration - 95 kWh / 115 kWh*
 - *Repair manual > Motor > Electric Drive Motor 0EF > 93 Electric drive > High-Voltage Battery Components > High-Voltage Battery Preliminary Operation > High-Voltage Battery Preliminary Operation - 95 kWh / 115 kWh.*

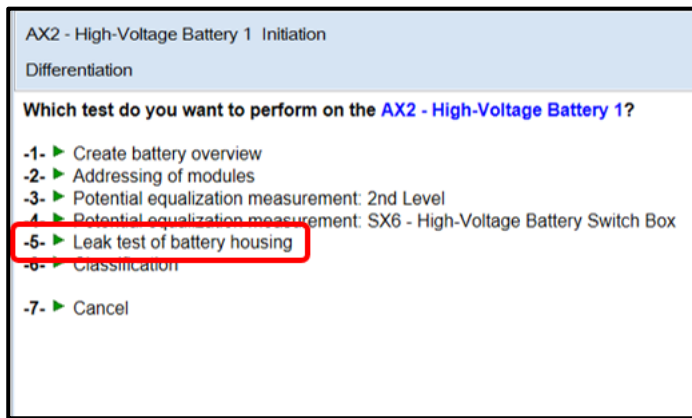
Perform high-voltage battery leak test:

- Perform the steps below in conjunction with the test plan, “008C – Initiation > select option: Leak test of battery housing.”
- Perform a leak test of the high-voltage battery per the ELSA Repair Manual:
