Safety Recall

Code: 93U9

Subject Document History	Interim Monitoring Program for High-Voltage Battery Modules (Offline Vehicles)																															
Affected Vehicles	<table border="1"> <thead> <tr> <th data-bbox="529 394 646 426">Date</th> <th data-bbox="987 394 1104 426">Summary</th> </tr> </thead> <tbody> <tr> <td data-bbox="496 436 630 468">02/27/2024</td> <td data-bbox="667 436 1341 468">Updated parts table. Added link to dealer webinar recording.</td> </tr> <tr> <td data-bbox="496 478 630 510">02/16/2024</td> <td data-bbox="667 478 881 510">Original publication</td> </tr> </tbody> </table> <table border="1"> <thead> <tr> <th data-bbox="483 594 581 625">Country</th> <th data-bbox="613 562 727 657">Beginning Model Year</th> <th data-bbox="768 562 849 657">Ending Model Year</th> <th data-bbox="1052 594 1141 625">Vehicle</th> <th data-bbox="1336 573 1425 646">Vehicle Count</th> </tr> </thead> <tbody> <tr> <td data-bbox="508 667 557 699">USA</td> <td data-bbox="638 667 686 699">2019</td> <td data-bbox="776 667 824 699">2022</td> <td data-bbox="987 667 1198 699">E-TRON QUATTRO</td> <td data-bbox="1344 667 1409 699">3,896</td> </tr> <tr> <td data-bbox="508 709 557 741">

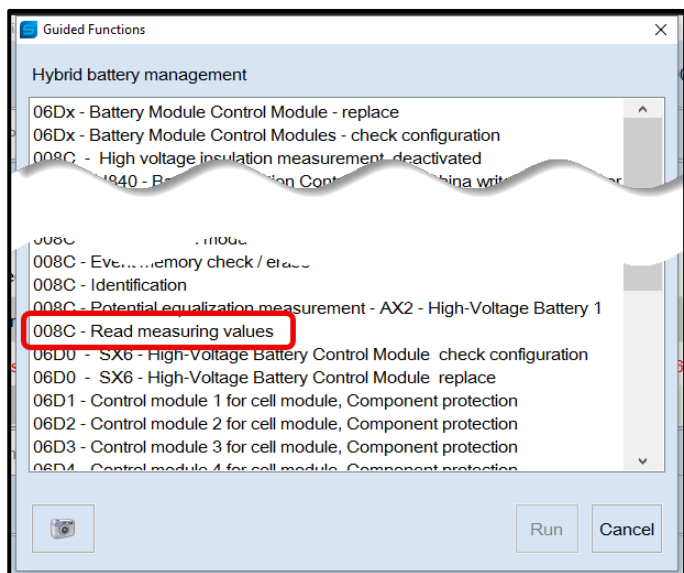
- Connect battery maintainer.
- Perform a full diagnostic scan of the vehicle.
- Select and perform the Guided Function test plan "008C – Read measuring values" for diagnostic address 008C.

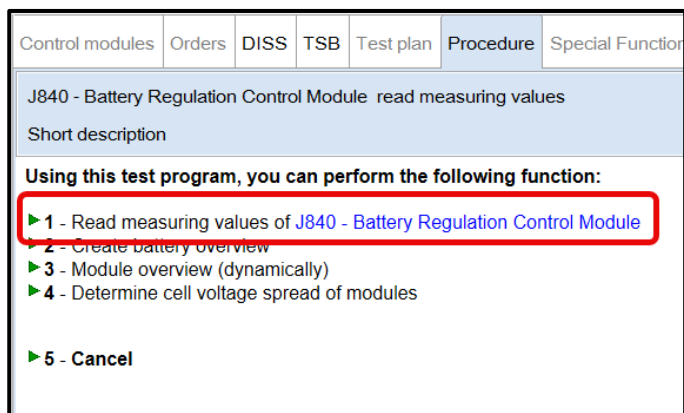
- Select the option "Read measuring values of J840 – Battery Regulation Control Module."

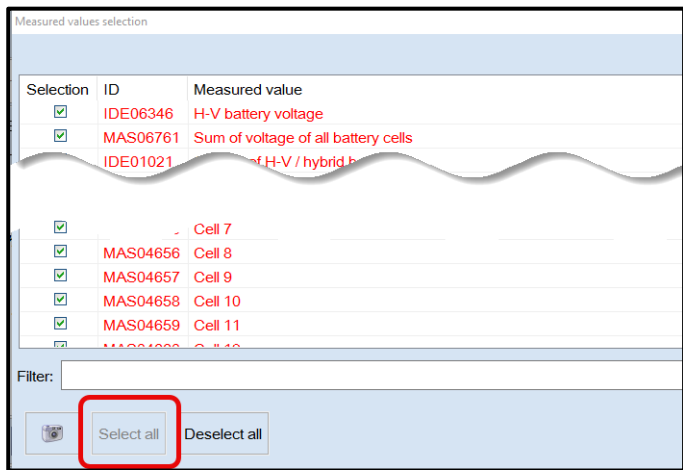
- Select all MVB's, then select OK.

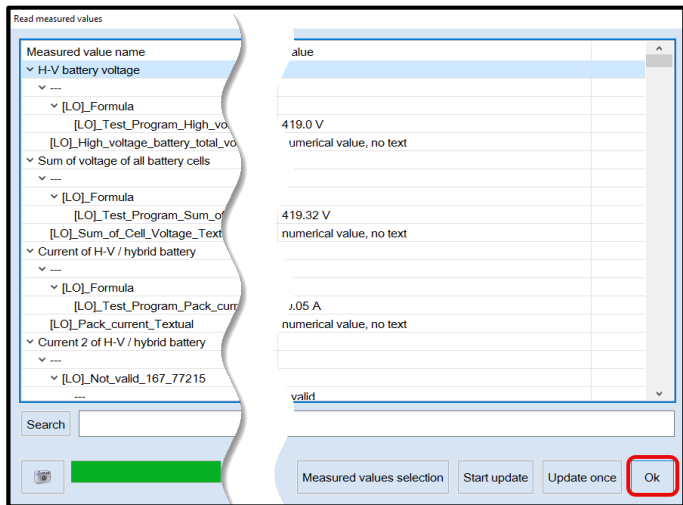
- When all MVB's are displayed, select OK.
- Follow the on screen prompts until the test plan is completed.
- Exit GFF.
- Ensure the diagnostic log is sent to GFF Paperless.

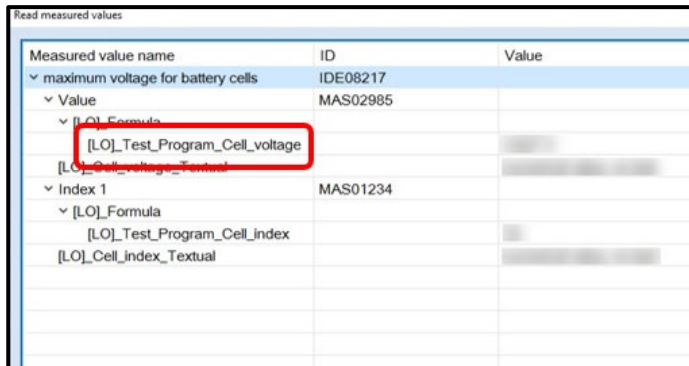
After reading out the maximum cell module voltage from the MVBs, avoid moving the vehicle if possible. The vehicle must not be charged or have any electrical consumers used. If this step is not followed, there is a risk that the new cell module will not be balanced correctly resulting in possible faults and having to remove and re-balance the cell module again.

Measured value name	ID	Value
maximum voltage for battery cells	IDE08217	
Value	MAS02985	
[LO]_Formula		
[LO]_Test_Program_Cell_voltage		
[LO]_Cell_voltage_Textual		
Index 1	MAS01234	
[LO]_Formula		
[LO]_Test_Program_Cell_index		
[LO]_Cell_index_Textual

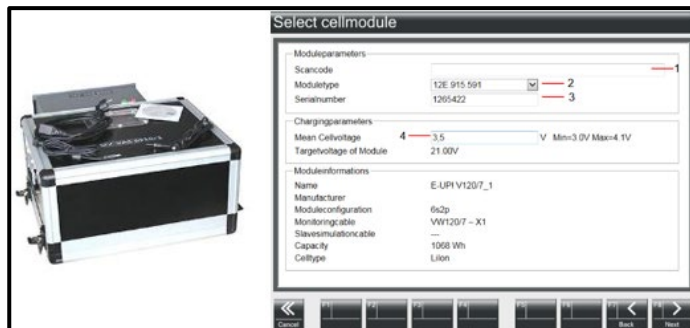
Perform cell balancing on new cell module(s):

- Check Measured Value Block (MVB) "maximum voltage for battery cells, IDE08217.
- The voltage reading listed will be entered in the DSS Manager program when balancing the new cell module.
- Follow the VAS6910 operating instructions in conjunction with the DSS Manager program to perform the cell balancing on the new cell module.

Operating instructions for the VAS6910 and DSS Manager program can be found on the Audi Special Tools and Equipment website.

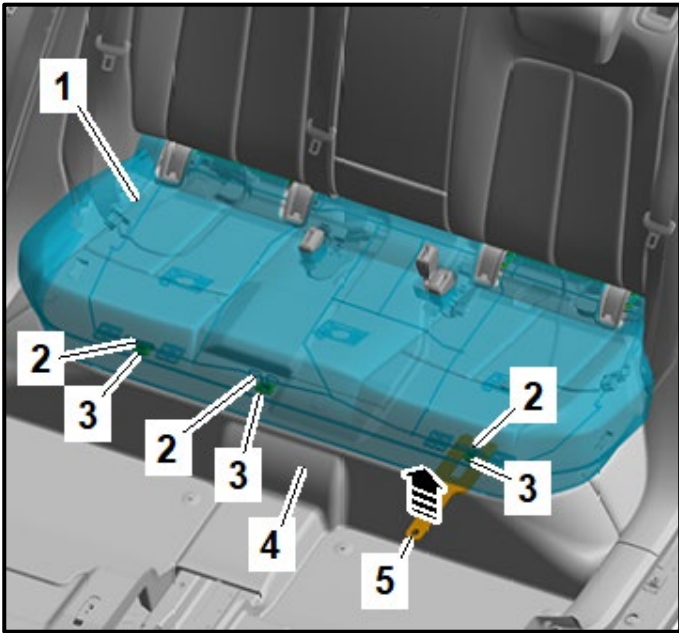
Remove the rear bench seat:

- Remove the rear bench seat <1> per the ELSA Repair Manual:
 - *Repair manual > Body > Body Interior > 72 Seat Frames > Rear Seats > Bench Seat/Single Seat, Removing and Installing.*

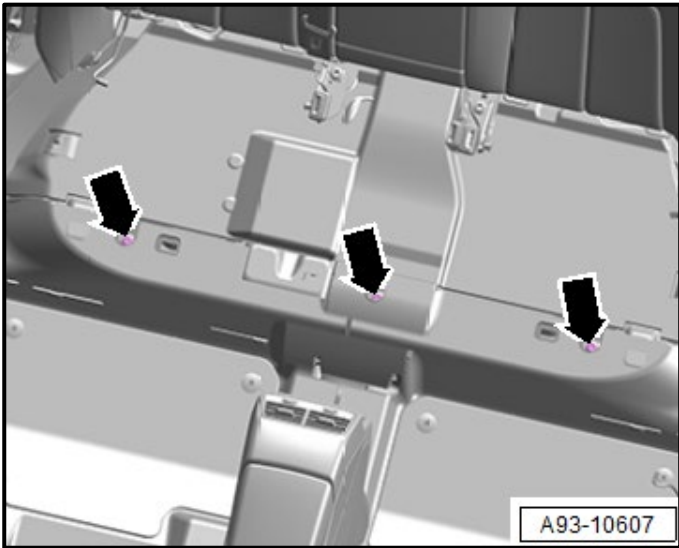
- Remove the bolts <arrows>.

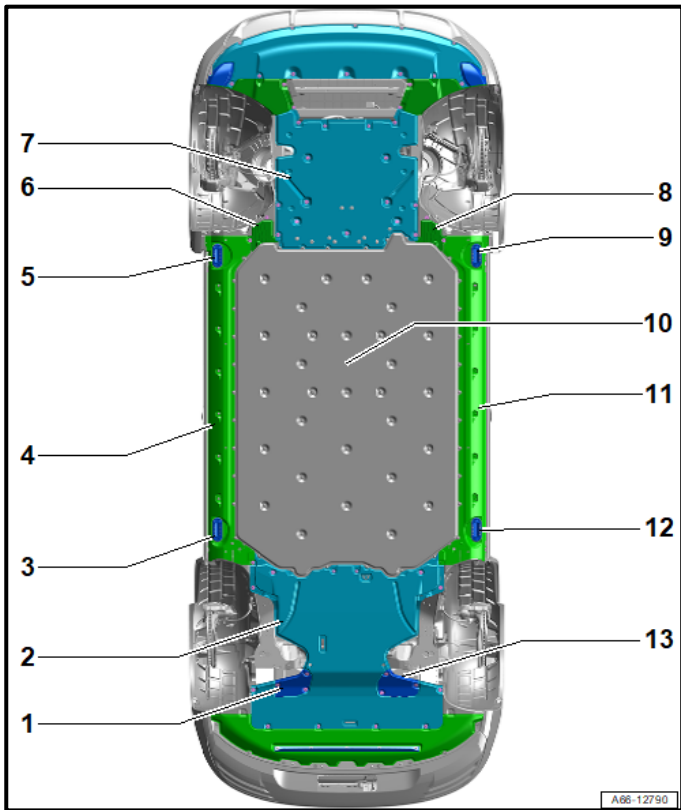
Remove front and rear underbody trim panels:

- Remove the following underbody trim panels:
 - Front trim panels <6>, <7>, and <8>.
 - Rear trim panels <1>, <2>, and <13>.

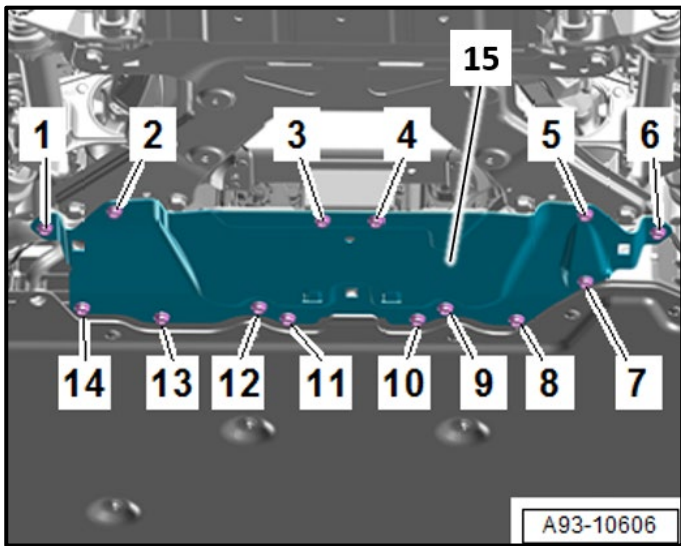
Remove the impact guard:

- Remove the impact guard <15> per the ELSA Repair Manual:
 - *Repair manual > Chassis > Suspension, Wheels, Steering > 40 Front Suspension > Subframe > Impact Guard, Removing and Installing.*

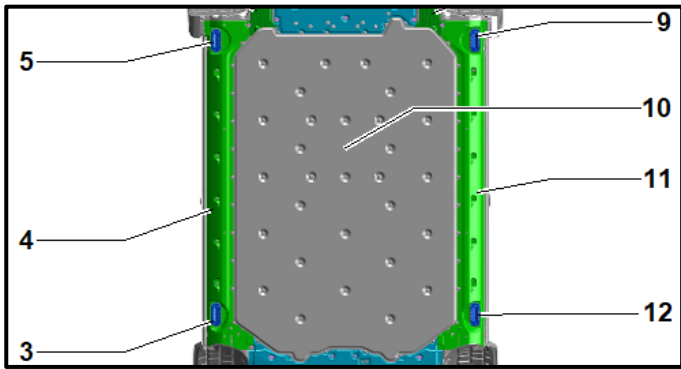
Remove left and right underbody trim panels:

- Lower the vehicle so that the hoist arms are no longer contacting the vehicle.
- Remove the left and right side trim panels <4> and <11>.
- Lift the vehicle again.

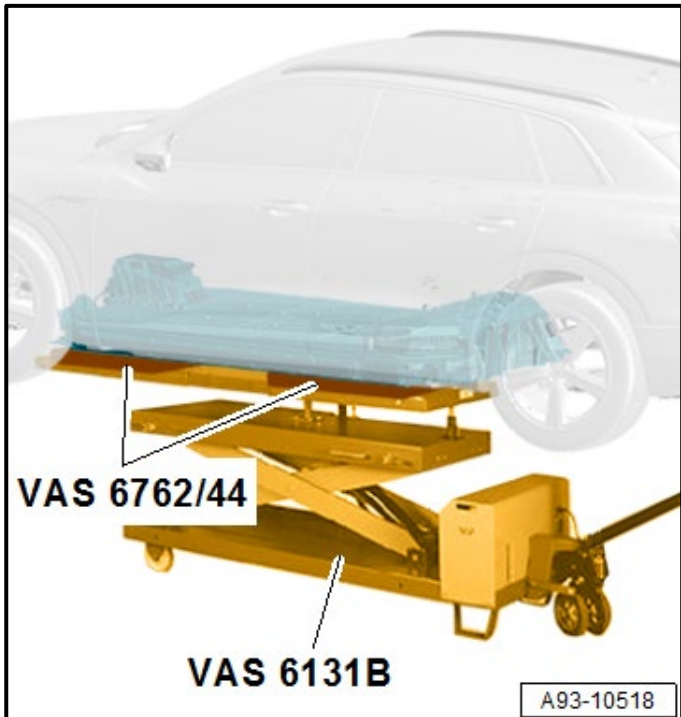
Remove the high-voltage battery:

- Remove the high-voltage battery per the ELSA Repair Manual:
 - *Repair manual > Motor > Electric Drive Motor 0EF > 93 Electric drive > High-Voltage Battery Unit > High-Voltage Battery 1 AX2, Removing and Installing.*
- Note the following when removing the high-voltage battery:
 - Mark the position of the scissor lift table on the floor to aid in repositioning the table during reinstallation.
 - Pay close attention to all wiring harnesses when lowering the battery.
 - Pay close attention to all coolant hoses when lowering the battery.

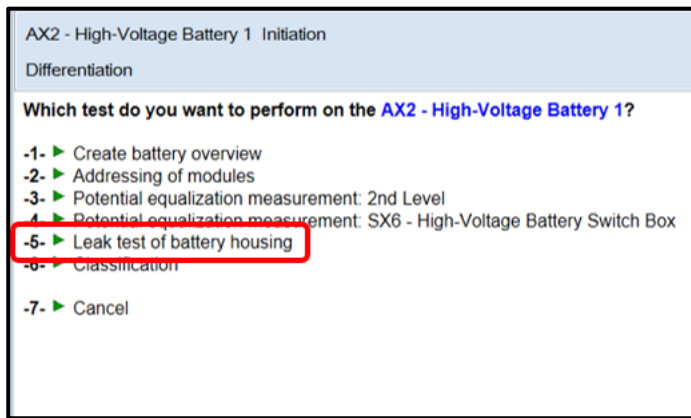
Perform high-voltage battery leak test:

- Perform the steps below in conjunction with test plan, “008C - Initiation > select option: Leak test of battery housing.”
- Perform a leak test of the high-voltage battery per the ELSA Repair Manual:

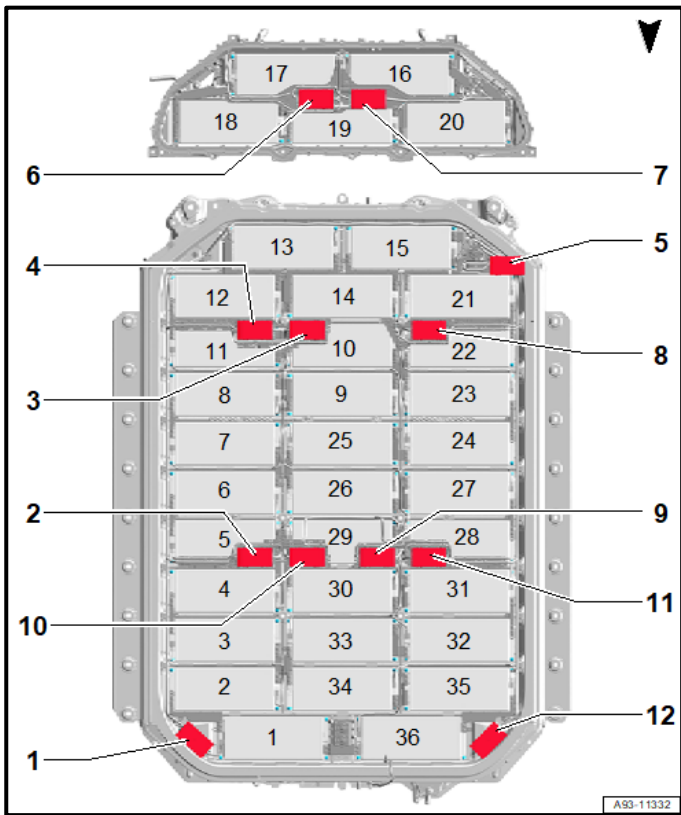
Identify the cell module that requires replacement:

- Locate and clearly mark the cell modules that are going to be replaced per the ELSA Repair Manual:
 - *Repair manual > Motor > Electric Drive Motor 0EF > 93 Electric drive > High-Voltage Battery Components > Battery Modules, Battery Connector and Control Modules, Marking.*

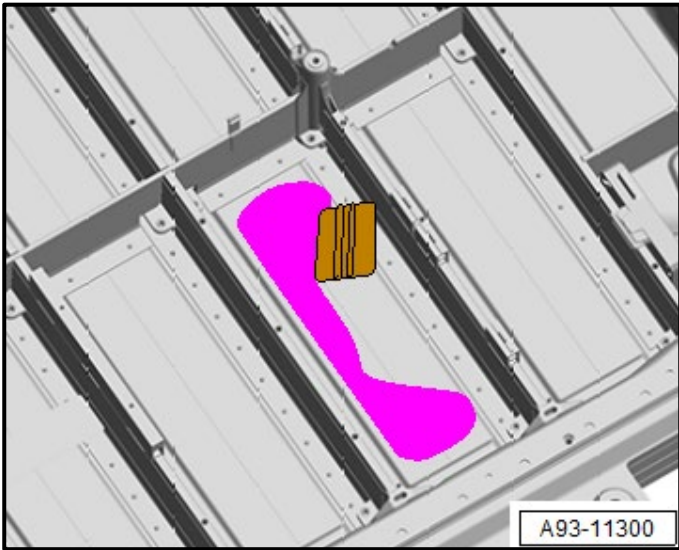
Clean the mounting area for the new cell module:

- Ensure that the old thermal compound is removed from the battery housing per the instructions outlined in the cell module removal section.
- Vacuum any shavings/debris from the module threaded connections.
- Do not allow the cleaner to come into contact with any of the lower housing frame sealant.

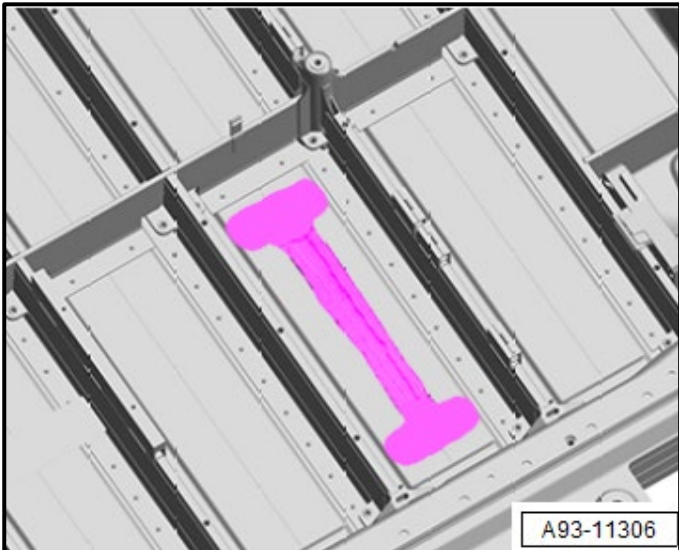
Installing new cell module(s):

- Refer to the ELSA Repair Manual for cell module installation:
 - *Repair manual > Motor > Electric Drive Motor 0EF > 93 Electric drive > High-Voltage Battery Components > Battery Module, Installing.*
- Note the following when installing a new cell module:
 - Double check the expiration date of the heat paste before applying.
 - Before applying the heat paste to the battery housing, release a small amount through the applicator on a piece of paper to ensure the paste is mixing properly.
 - Apply the specified amount of two-part thermal compound into the battery housing per the repair manual instructions.

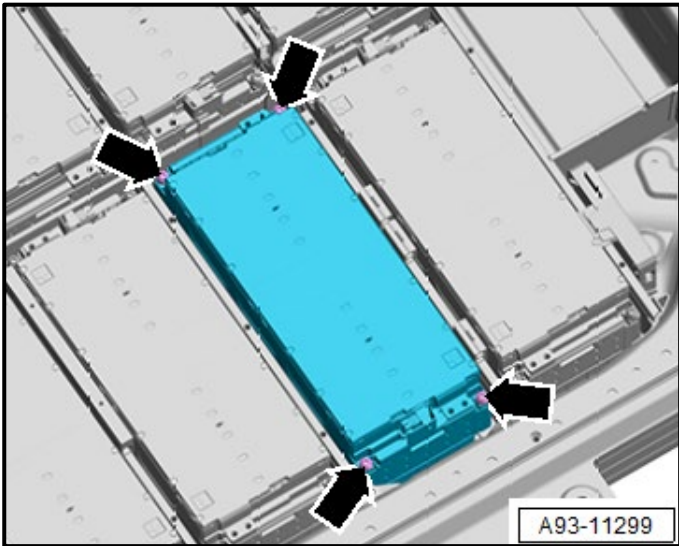
- Tighten new bolts <arrows> per the ELSA Repair Manual:
 - *Repair manual > Motor > Electric Drive Motor 0EF > 93 Electric drive > High-Voltage Battery Components > Component Location Overview - Battery Modules > Component Location Overview - Battery Modules, 95 kWh / 115 kWh.*

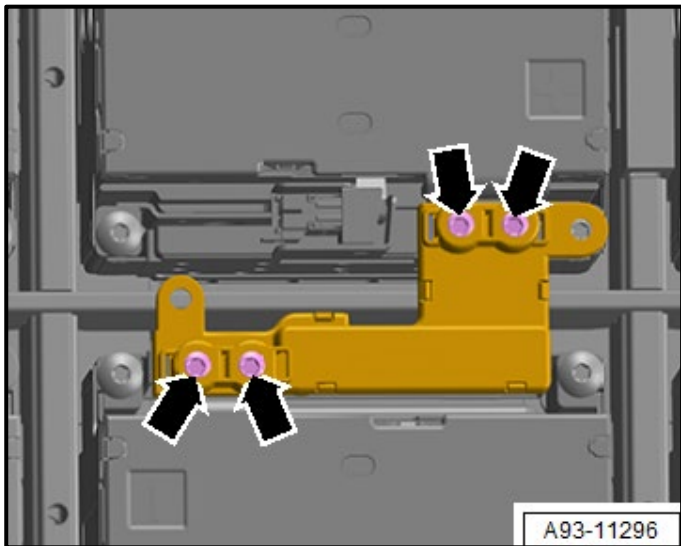
- If the voltage measurement is ok, install the battery connector immediately.
- Tighten the bolts <arrows> per the ELSA Repair Manual:
 - *Repair manual > Motor > Electric Drive Motor 0EF > 93 Electric drive > High-Voltage Battery Components > Component Location Overview - Battery Connector > Component Location Overview - Battery Connectors, 95 kWh / 115 kWh.*
- Continue with reassembly.

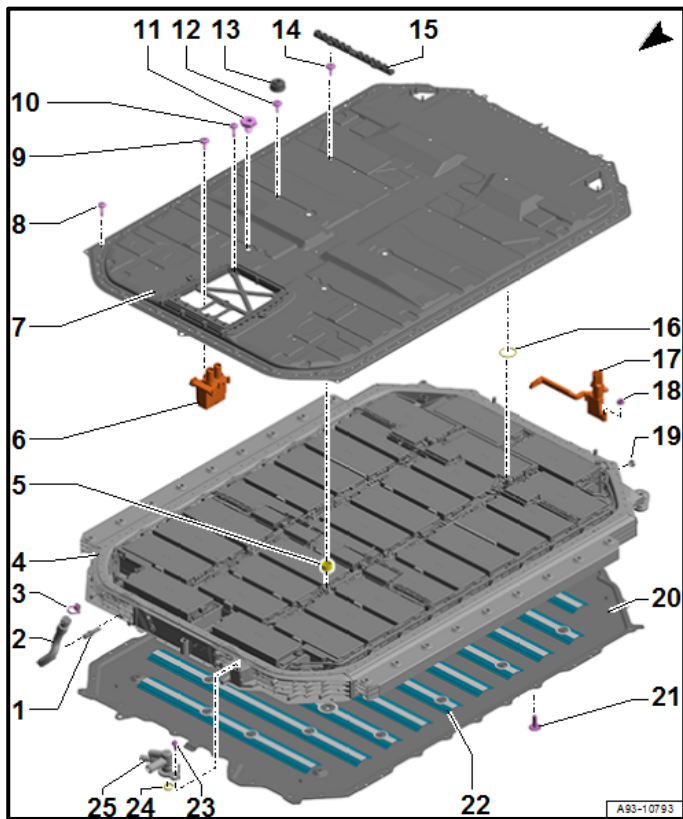
Install the high-voltage battery cover(s):

- Refer to the ELSA Repair Manual for battery cover installation:
- **Layer 1 battery cover installation:**
 - *Repair manual > Motor > Electric Drive Motor 0EF > 93 Electric drive > High-Voltage Battery Components > Battery Housing Cover, Removing and Installing > Cover for Battery Housing Layer 1, Removing and Installing, 95 kWh / 115 kWh.*
- Torque all the high-voltage battery cover bolts per the ELSA Repair Manual:
 - *Repair manual > Motor > Electric Drive Motor 0EF > 93 Electric drive > High-Voltage Battery Components > Overview - Removed High-Voltage Battery > Overview - Removed High-Voltage Battery, 95 kWh / 115 kWh.*
- Use new hardware when specified by the repair manual.

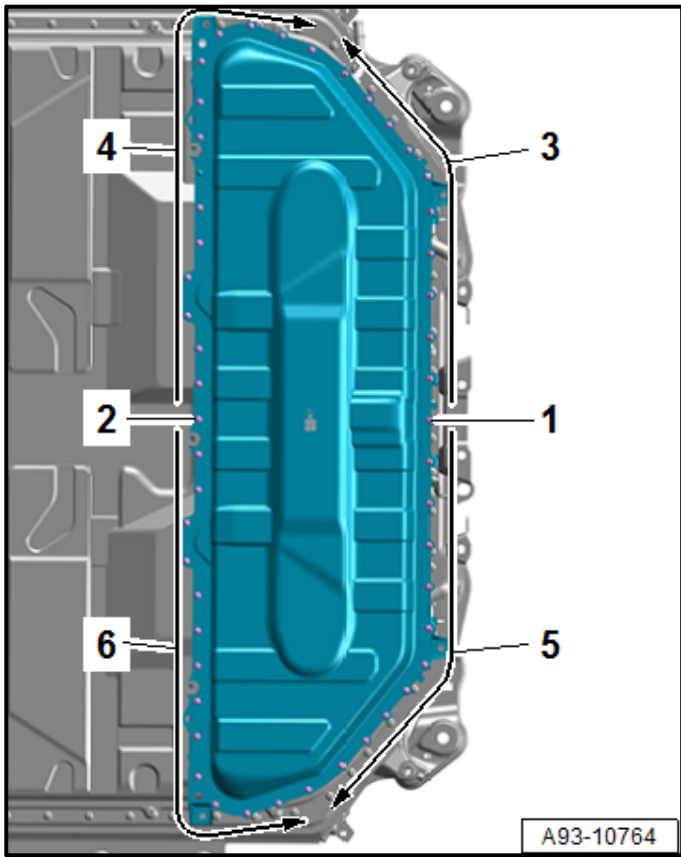
- **Layer 2 battery cover installation:**

- *Repair manual > Motor > Electric Drive Motor 0EF > 93 Electric drive > High-Voltage Battery Components > Battery Housing Cover, Removing and Installing > Cover for Battery Housing Layer 2, Removing and Installing, 95 kWh / 115 kWh.*
- Torque all the high-voltage battery cover bolts per the ELSA Repair Manual:
 - *Repair manual > Motor > Electric Drive Motor 0EF > 93 Electric drive > High-Voltage Battery Components > Overview - Removed High-Voltage Battery > Overview - Removed High-Voltage Battery, 95 kWh / 115 kWh.*
- Use new hardware when specified by the repair manual.

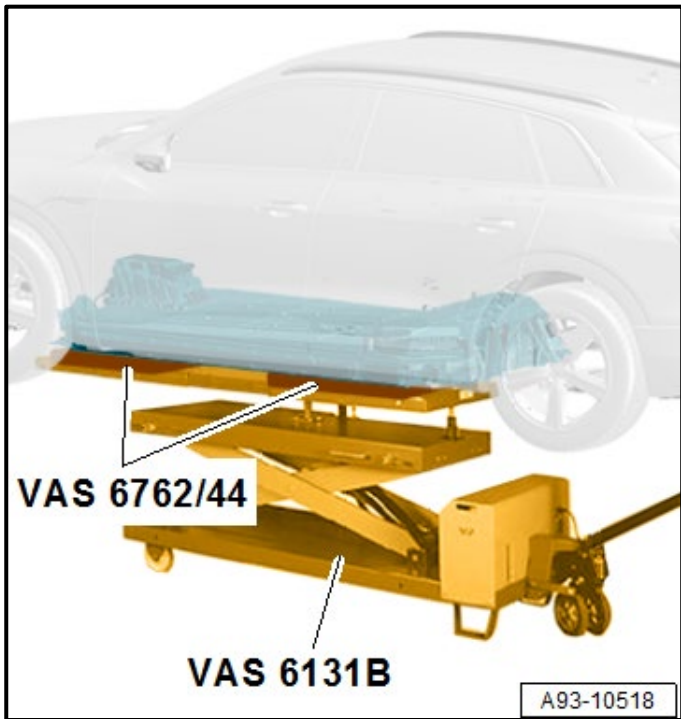
Re-install high-voltage battery:

- Installation is the reverse order of removal.
- See the ELSA Repair Manual: *Repair manual > Motor > Electric Drive Motor 0EF > 93 Electric drive > High-Voltage Battery Unit > High-Voltage Battery 1 AX2, Removing and Installing.*
- Torque the bolts for the high-voltage battery per the ELSA Repair Manual, using new bolts where specified:
 - *Repair manual > Motor > Electric Drive Motor 0EF > 93 Electric drive > High-Voltage Battery Unit > Overview - Installed High-Voltage Battery > Overview - Installed High-Voltage Battery, 95 kWh / 115 kWh*

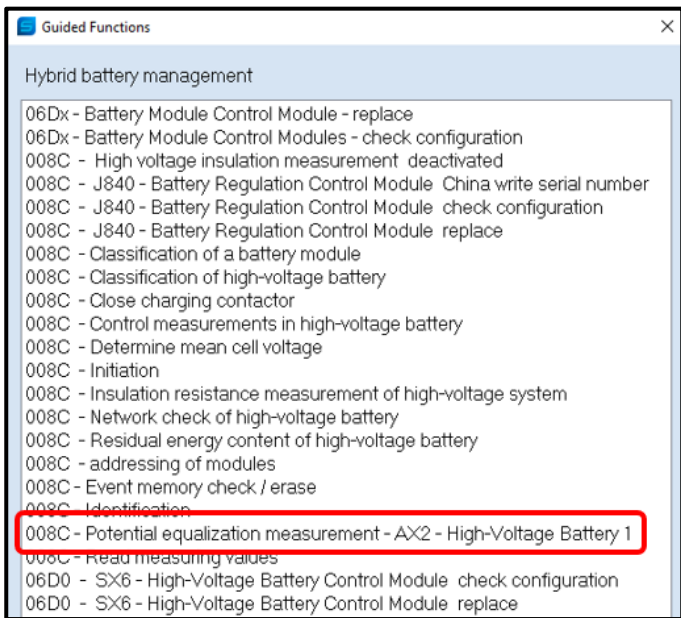
Perform potential equalization measurement:

- See the ELSA Repair Manual: *Repair manual > Motor > Electric Drive Motor 0EF > 93 Electric drive > Potential Equalization Cables > Potential Equalization Measurement.*
- Perform these steps in conjunction with Guided Function test plan, "008C - Potential equalization measurement - AX2 - High-Voltage Battery 1".

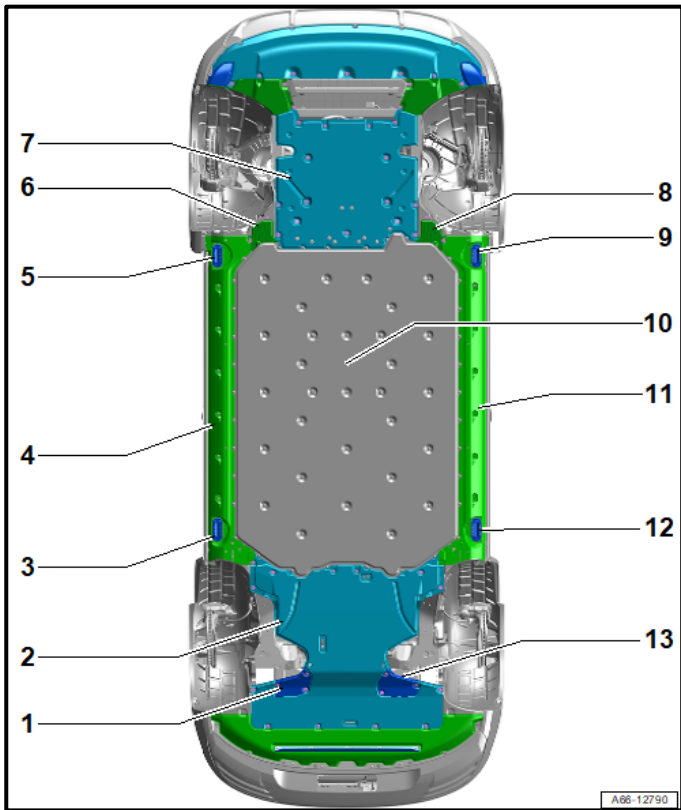
Reinstall underbody covers and impact guard:

- Installation is the reverse order of removal while noting the following:
 - Torque the impact guard per the ELSA Repair Manual: *Repair manual > Chassis > Suspension, Wheels, Steering > 40 Front Suspension > Overview – Subframe.*
 - Torque the underbody trim panels per the ELSA Repair Manual: *Repair manual > Body > Body Exterior > 66 Exterior Equipment > Underbody Trim Panel > Overview – Underbody Trim Panels.*
- Use new hardware when specified by the repair manual.
- Replace any damaged fasteners as needed.

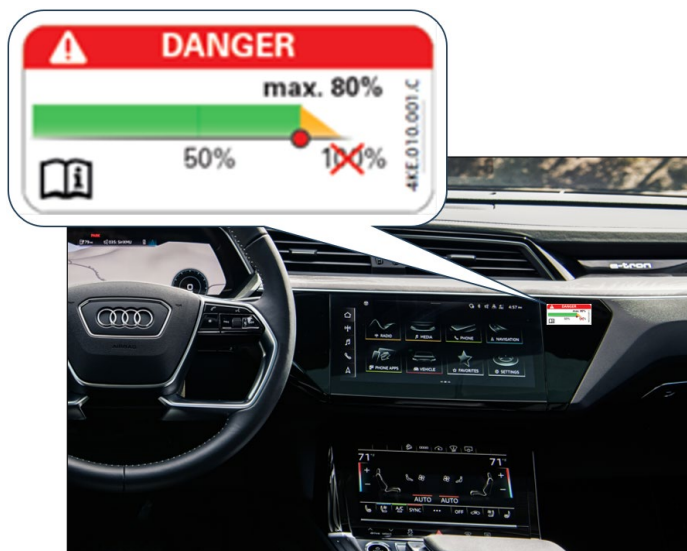
- Clean surface where sticker will be applied.
- Apply sticker near MMI display.

Part Number	Part Description
4KE-010-001-C	Sticker

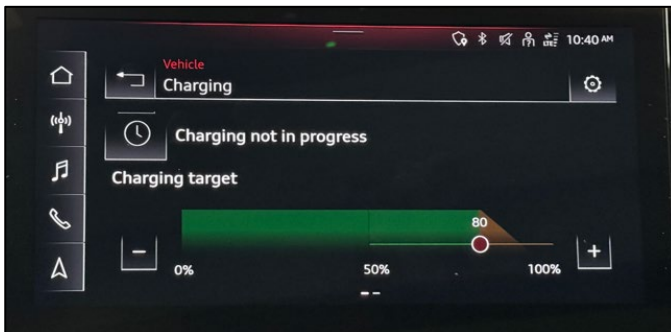
Set max charging level to 80% in the MMI:

- Home
- Vehicle
- Charging and Efficiency
- Charging
- Press and hold green bar to move Target charge rate to 80%

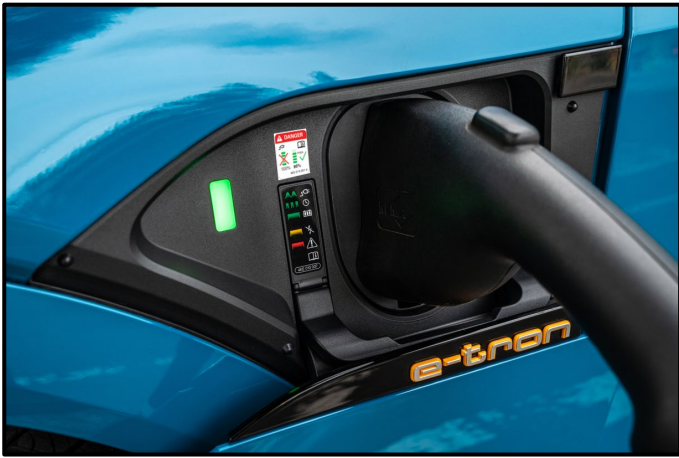
Charge high voltage battery to 80% charge level:

- To ensure the most accurate vehicle data collection results, the high voltage battery must be charged to 80% before returning to customer.
- If the battery charge is over 80%, it must be reduced to 80% before returning the vehicle to the customer.
