Safety Recall

Code: 93V2

Subject	Interim Monitoring Program for High-Voltage Battery Modules (Online Vehicles)				
Document History	Date		Summary		
	02/16/2024		Original publication		
Affected Vehicles	Country	Beginning Model Year	Ending Model Year	Vehicle	Vehicle Count
	USA	2019	2022	E-TRON QUATTRO	18,083
	USA	2020	2022	E-TRON SPORTBACK QUATTRO	4,407
Problem Description	<p>A potentially critical self-discharge condition exists in certain high-voltage battery modules that, in some instances, may lead to thermal overload, possibly resulting in smoke or a fire. A high-voltage battery overheating increases the risk of a fire.</p>				
Interim Monitoring Program for HV Battery Modules	<p>Customers with online data collection activated in their vehicles will be monitored under Audi's Online Field Monitoring program. Online data collection is active unless Privacy Mode is engaged in the vehicles. Audi of America's data collection practices for purposes of monitoring for vehicle safety and other purposes are described in our privacy statement, at audiusa.com/privacy. Please see the Owner's Manual to learn about the vehicle's available data collection choices through Privacy Mode.</p> <p>

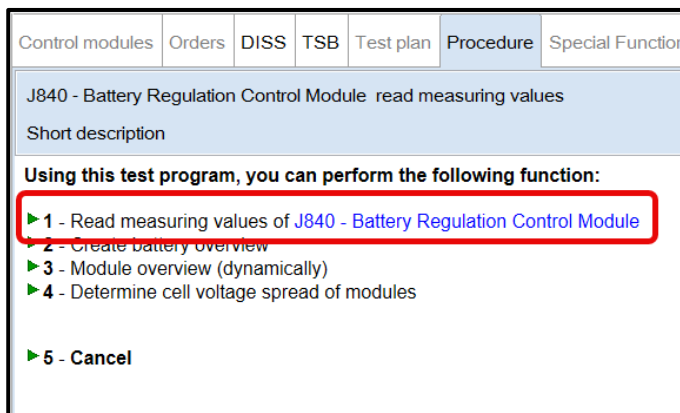
- Select the option “Read measuring values of J840 – Battery Regulation Control Module.”
