Safety Recall

Code: 93U9

Subject High-Voltage Battery Modules

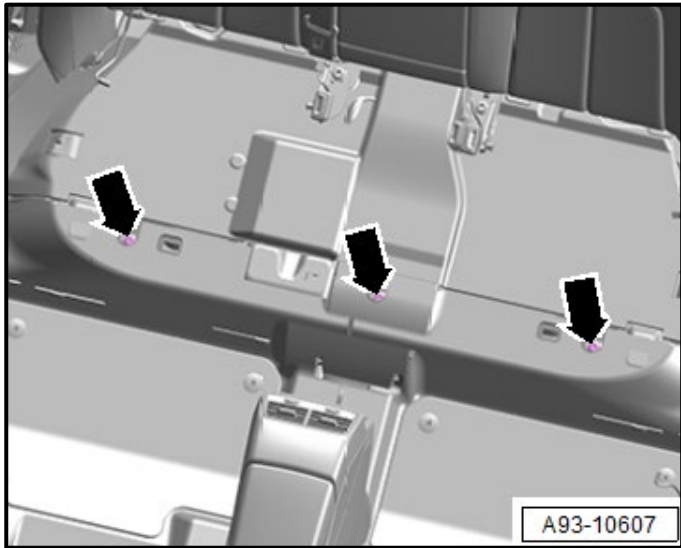
- Remove the bolts <arrows>.

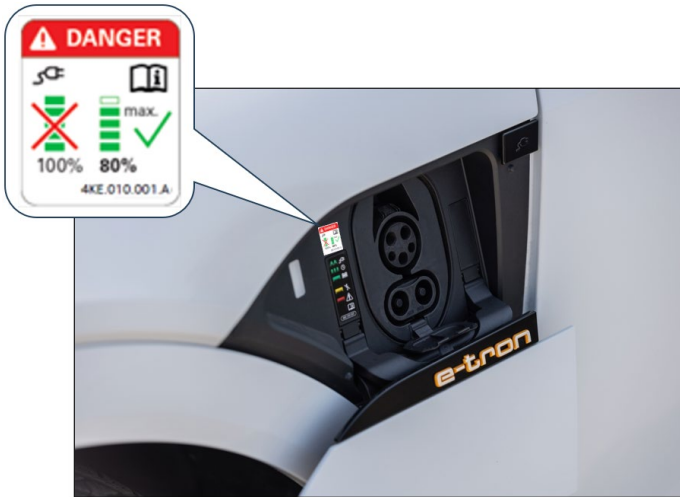
REMOVE sticker(s) (if present) from charging ports and near MMI display:

- Remove the sticker from the charging ports and from near the MMI and clean any adhesive residue.
