Safety Recall

Code: 93V2

Subject High-Voltage Battery Modules

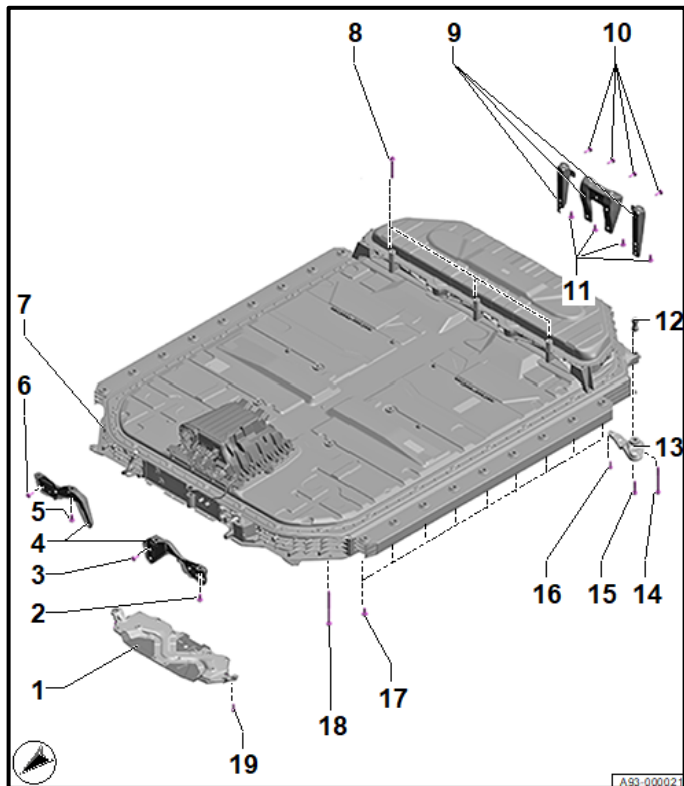
Repair Overview

Vehicles assigned criteria SW only:

- Perform final remedy software update

- Replace pre-determined cell modules.
- Perform final remedy software update.

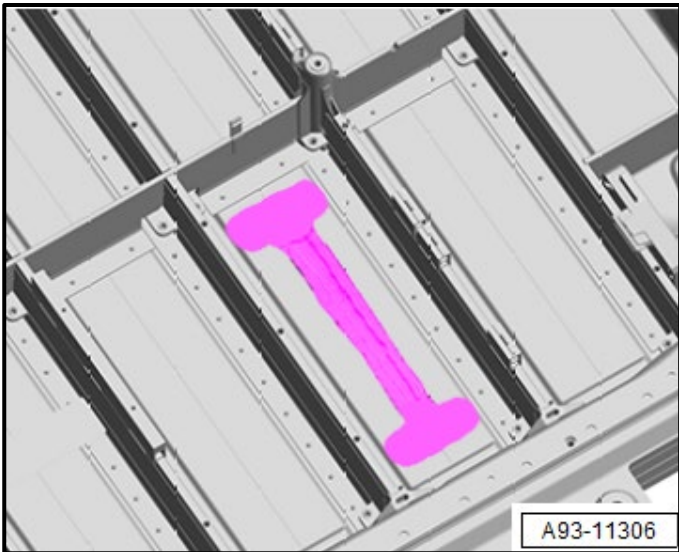
Installing new cell module(s):

- Refer to the ELSA Repair Manual for cell module installation:
 - *Repair manual > Motor > Electric Drive Motor 0EF > 93 Electric drive > High-Voltage Battery Components > Battery Module, Installing.*
- Note the following when installing a new cell module:
 - Double check the expiration date of the heat paste before applying.
 - Before applying the heat paste to the battery housing, release a small amount through the applicator on a piece of paper to ensure the paste is mixing properly.
 - Apply the specified amount of two-part thermal compound into the battery housing per the repair manual instructions.
