Safety Recall

Code: 93U9

Subject High-Voltage Battery Modules

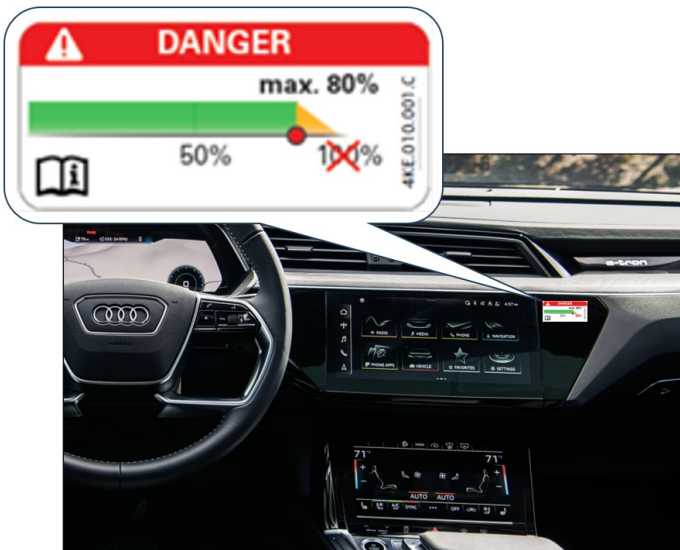
Section F – Campaign Completion Label

Install Campaign Completion Label
