Recall Campaign Bulletin

Campaign No. 2024010011, April 2024

SUBJECT: **Various Models**
Model Year 2021-2024

Replace Fuel Pump Delivery Module Wave 2

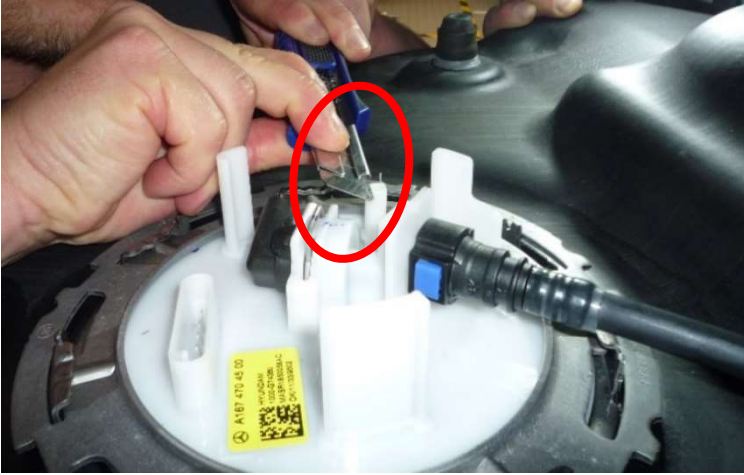
Figure 3

i For **all** vehicles with code 228 stationary heater, the connection for the fuel supply system must be cut off before installing the fuel pump (**Figure 3**).
