## FINAL NOTICE

**Subject:** R23CH: (FMVSS 121 Noncompliance)  
Vision (EV Only) & All American (All Fuel Types)  
Loss of Air Pressure Gauge & Low Air Warning

**IMPORTANT SAFETY RECALL**  
NHTSA Number: 23V-425 (School Bus)  
NHTSA Number: 23V-424 (Non-School Bus)

## R23CH: INOPERATIVE AIR PRESSURE GAUGES

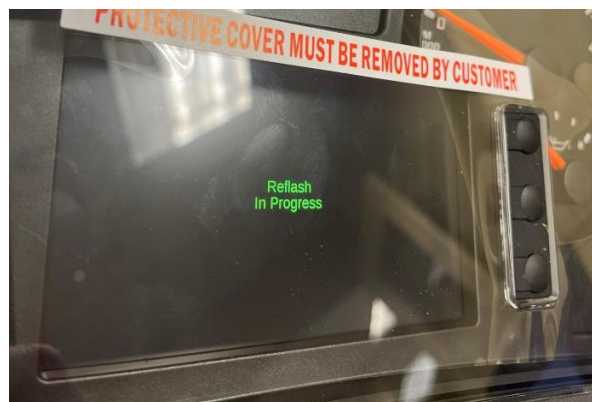
Figure 1

- This cluster flash is unique from any other update Blue Bird Field Service has published. The calibration process will transpire as follows:
  - Once flash is started, the status bar on the AmeFlash tool will progress from 0-100%, left to right. During this process, the cluster will display “REFLASH IN PROGRESS”. See Figure 1.
  - Once that completes, the cluster display will be black and will not auto-initialize.
  - The red low air visual indicators SHOULD begin to flash rapidly. See Figure 2.
  - If they do not, remove the cluster battery fuse within the PDU, count to 3, and re-install it. The low air warning LED’s should begin to flash rapidly for ~30 seconds. After which the cluster will re-start and the bus can be restored to service.
