**IMPORTANT SAFETY RECALL**  
NHTSA Number: 23V-778 (School Bus)  
NHTSA Number: 23V-777 (Non-School Bus)

**SUBJECT:** R23CU: FMVSS (Noncompliance) Right Front Barrier

# RECALL R23CU

## T3RE Right Front Barrier Securement

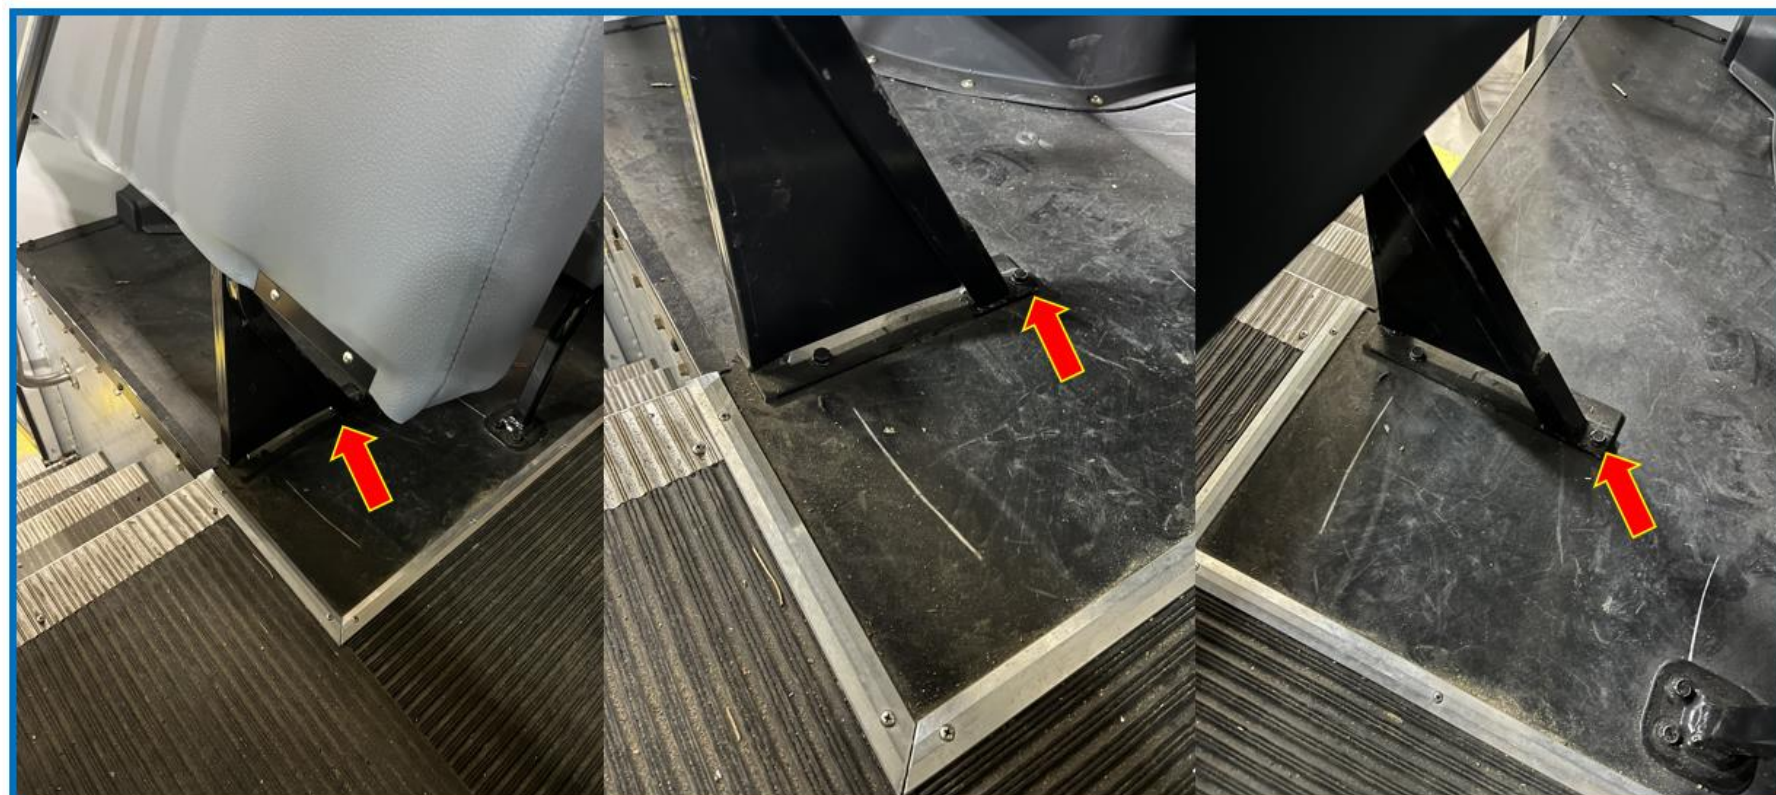
FIG 1

1. Remove fastener highlighted in Fig 1.

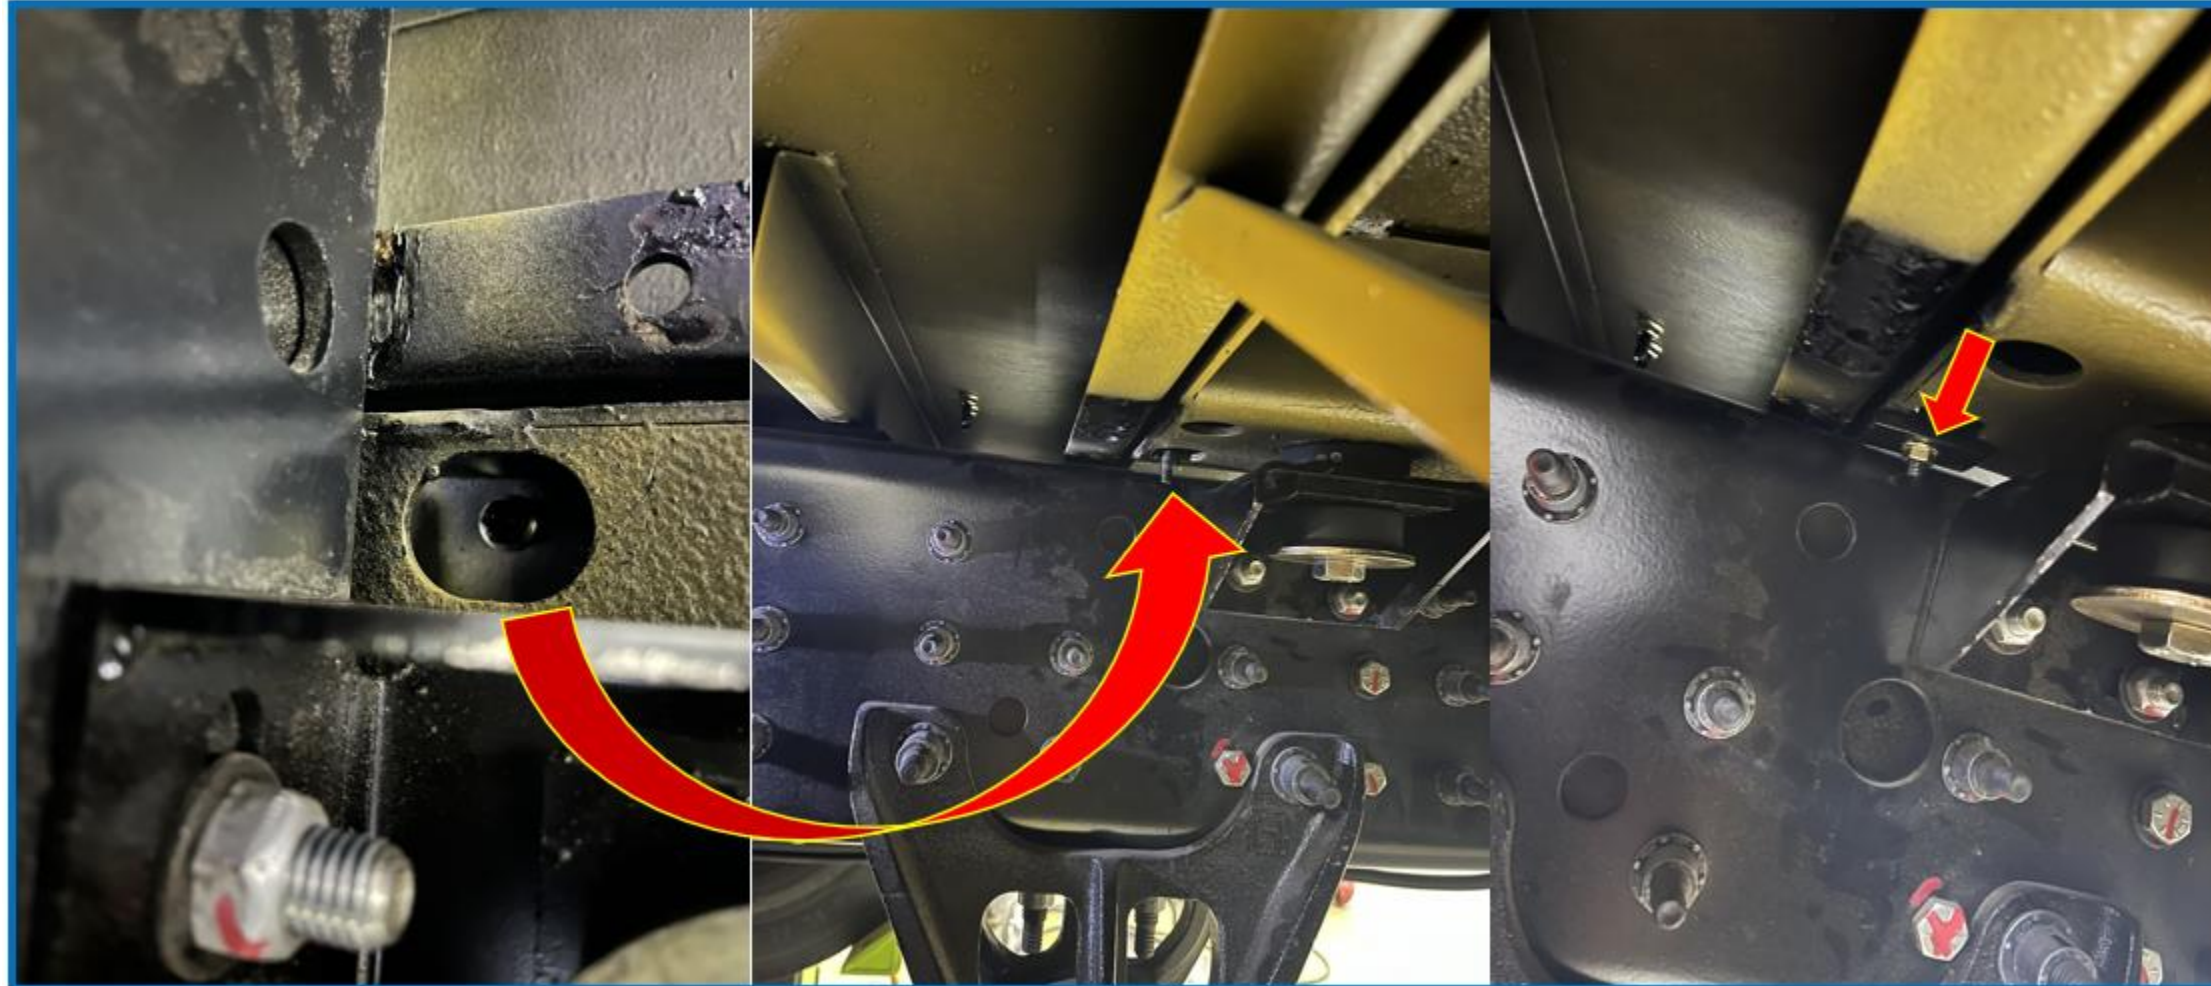
FIG 2

2. Install new bolt, washer, and locknut per Fig 2. Torque to 18-20 Ft-Lbs

Item	Description	Part number	Quantity
1	CAPSCREW,HEX,FLG,5/16-18X4.50,GRD5,BLACK ZN	01542463	1
2	NUT,HEX HD,5/16-18,FLG PRVG TORQ,GR F,YDICH	01480433	1
3	WASHER,1.25 X 2.00 X 0.25 W/0.437 HOLE	10000930	1
