IMPORTANT SAFETY RECALL
NHTSA Number: 23V-778 (School Bus)
NHTSA Number: 23V-777 (Non-School Bus)

SUBJECT: R23CU: FMVSS (Noncompliance) Right Front Barrier

RECALL R23CU

T3RE Right Front Barrier Securement

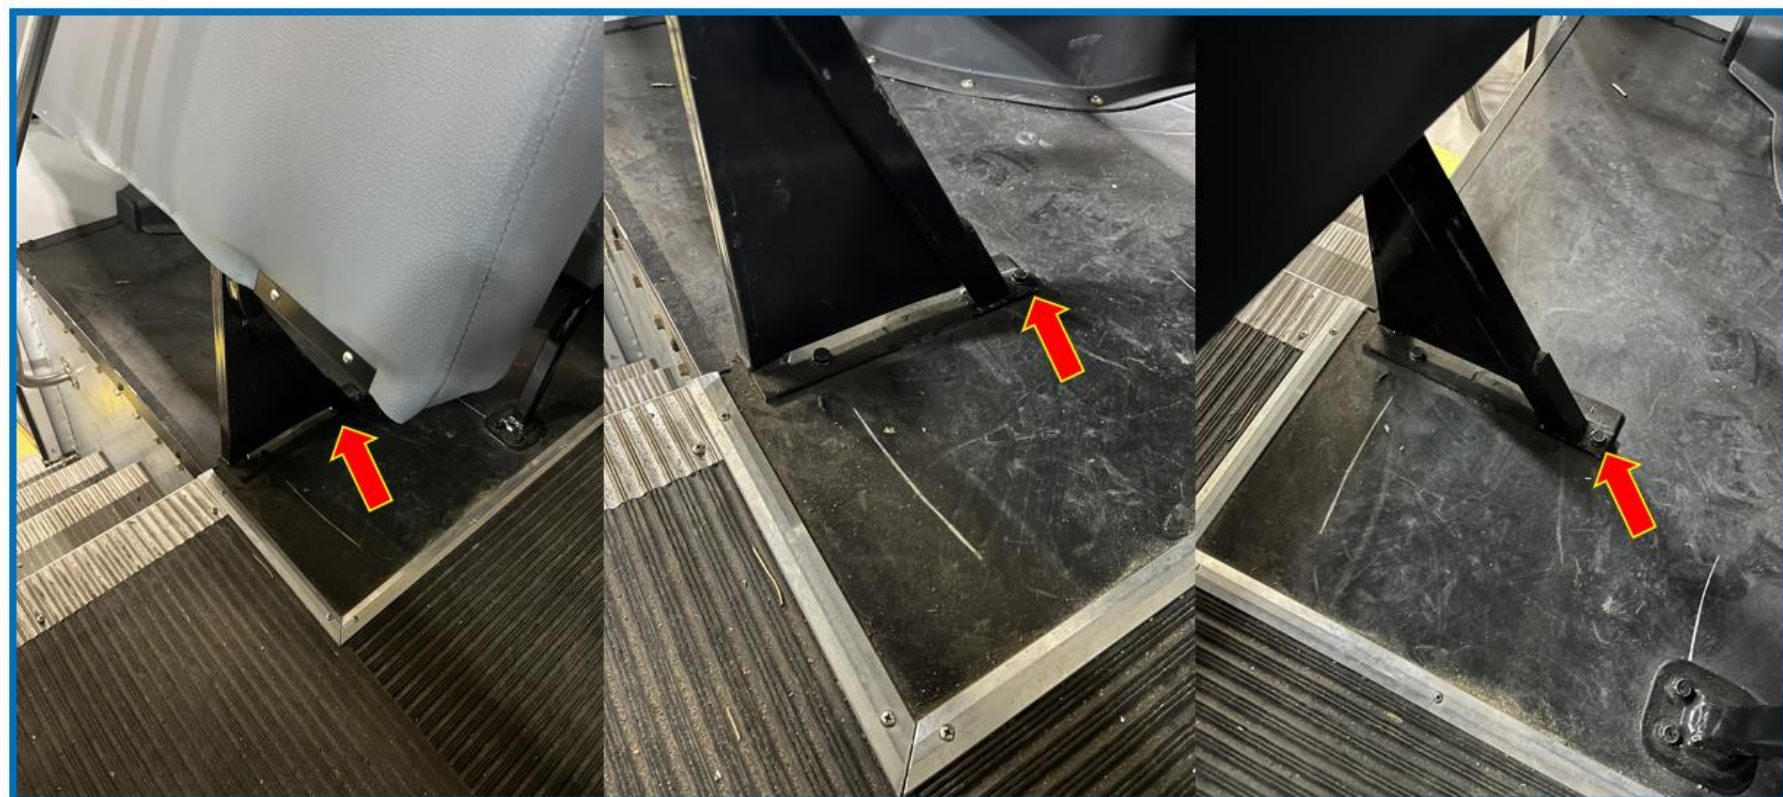
FIG 1

1. Remove fastener highlighted in Fig 1.
