**RECREATIONAL VEHICLE  
SAFETY RECALL NOTICE**

Safety Recall: 23V-822

**IMPORTANT SAFETY RECALL – 5th Notice**

Keystone RV Company has decided that a defect which relates to motor vehicle safety exists in certain model 2021-2022 Coleman Travel Trailers. As a result, Keystone RV is conducting a safety recall. We apologize for any inconvenience this action may cause you; however your safety and continued satisfaction are of the utmost importance to us.

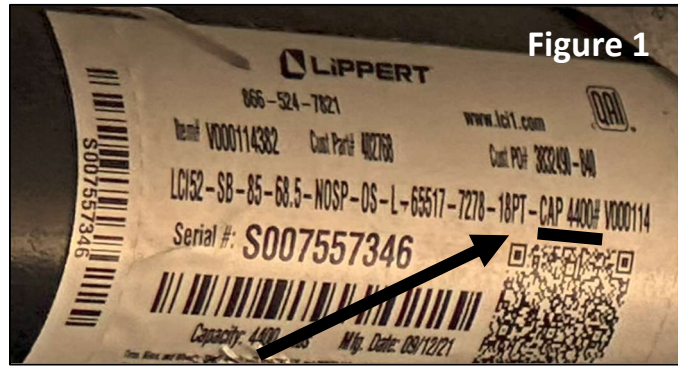
**Figure 1**

It has been decided that the vehicles in the recall population may have axle springs rated at 4400 pounds rather than the 5100 pound axle rating as specified on Federal Identification Tag. The axles installed had the wrong size springs. Under certain conditions during travel, undersized axle springs can be overloaded leading to an increased risk of axle spring failure and increasing the risk of a crash.

You may choose to self-inspect the axle's tags. If the tag reads as CAP 4400#, as shown in Figure 1, as soon as possible, please make an appointment to have your RV serviced by your dealership. Customers should unload all cargo and empty holding tanks (fresh water, grey water, black water, and water heater) and take their unit to an authorized dealer for remedy of the incorrectly installed axles springs. The labor

Keystone representatives have been in contact with the staff at your selling dealership regarding this situation. The remedy is to replace under rated 4400 LB springs with the correct size 5100 LB springs. This would require both 2200 LB springs be replaced. The service and parts required for this corrective action will be provided at no charge to you.

If the axle's tag reads as CAP 5100#, please take a picture of axle tag clearly showing the tag information, and email us at [recall@keystonerv.com](mailto:recall@keystonerv.com)
