**RECREATIONAL VEHICLE**  
**SAFETY RECALL NOTICE**

Safety Recall: 23V-822

**IMPORTANT SAFETY RECALL – 4th Notice**

Keystone RV Company has decided that a defect which relates to motor vehicle safety exists in certain model 2021-2022 Coleman Travel Trailers. As a result, Keystone RV is conducting a safety recall. We apologize for any inconvenience this action may cause you; however your safety and continued satisfaction are of the utmost importance to us.

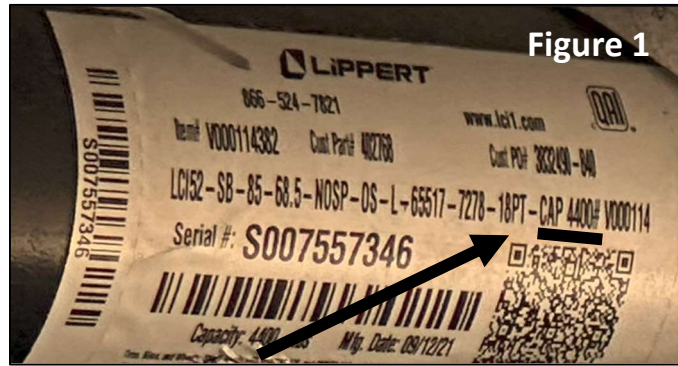
**Figure 1**

It has been decided that the vehicles in the recall population may have axle springs rated at 4400 pounds rather than the 5100 pound axle rating as specified on Federal Identification Tag. The axles installed had the wrong size springs. Under certain conditions during travel, undersized axle springs can be overloaded leading to an increased risk of axle spring failure and increasing the risk of a crash.

You may choose to self-inspect the axle's tags. If the tag reads as CAP 4400#, as shown in Figure 1, as soon as possible, please make an appointment to have your RV serviced by your dealership. Customers should unload all cargo and empty holding tanks (fresh water, grey water, black water, and water heater) and take their unit to an authorized dealer for remedy of the incorrectly installed axles springs. The labor

Keystone representatives have been in contact with the staff at your selling dealership regarding this situation. The remedy is to replace under rated 4400 LB springs with the correct size 5100 LB springs. This would require both 2200 LB springs be replaced. The service and parts required for this corrective action will be provided at no charge to you.
