**RECREATIONAL VEHICLE  
SAFETY RECALL NOTICE**

Safety Recall: 23V-822

Safety Advisory: 23-447

**IMPORTANT SAFETY RECALL – 7<sup>th</sup> Notice**

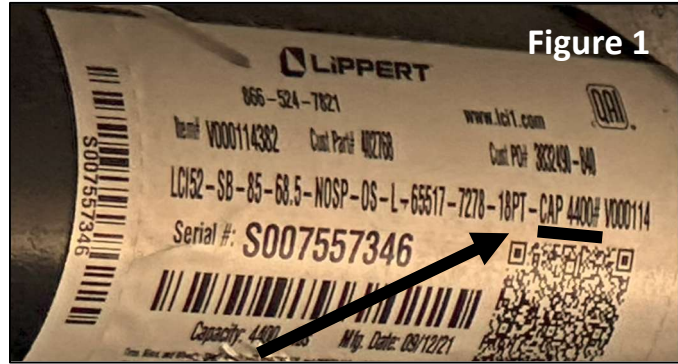
**Figure 1**

It has been decided that the vehicles in the recall population may have axle springs rated at 4400 pounds rather than the 5100 pound axle rating as specified on Federal Identification Tag. The axles installed had the wrong size springs. Under certain conditions during travel, undersized axle springs can be overloaded leading to an increased risk of axle spring failure and increasing the risk of a crash.

You may choose to self-inspect the axle's tags. If the tag reads as CAP 4400#, as shown in Figure 1, as soon as possible, please make an appointment to have your RV serviced by your dealership. Customers should unload all cargo and empty holding tanks (fresh water, grey water, black water, and water heater) and take their unit to an authorized dealer for remedy of the incorrectly installed axles springs. The labor

Keystone representatives have been in contact with the staff at your selling dealership regarding this situation. The remedy is to replace under rated 4400 LB springs with the correct size 5100 LB springs. This would require both 2200 LB springs be replaced. The service and parts required for this corrective action will be provided at no charge to you.

If the axle's tag reads as CAP 5100#, please take a picture of axle tag clearly showing the tag information, and email us at [recall@keystonerv.com](mailto:recall@keystonerv.com)
