Safety Recall: 2018–19 Accord Front Passenger’s Seat Belt Buckle Replacement

Supersedes 25-030, dated June 27, 2025, to revise the information highlighted in **yellow**.

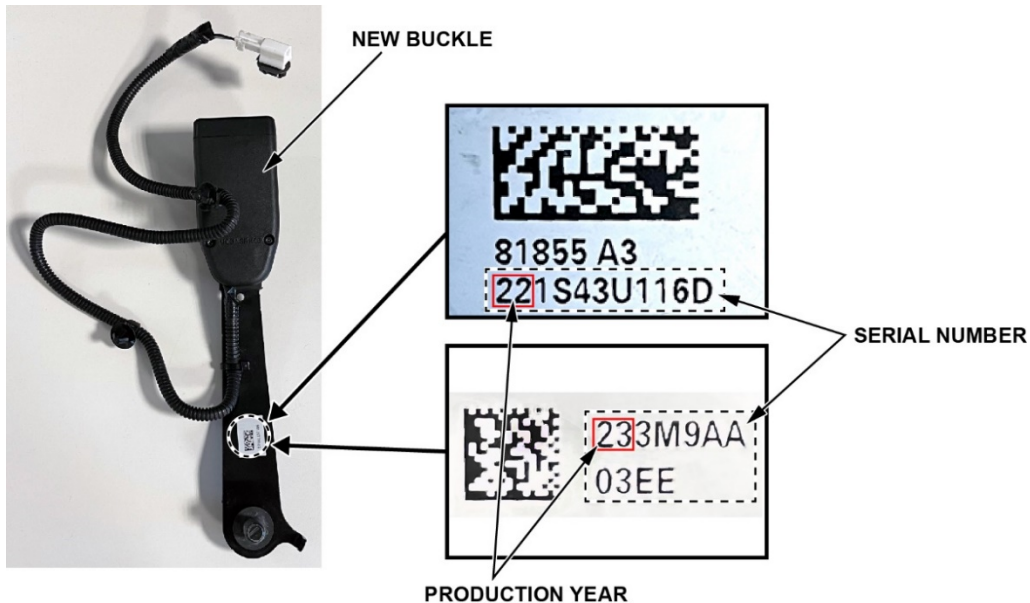
1. If the new replacement seat belt buckle serial number begins with “18”, **DO NOT INSTALL** the buckle. The buckle should be returned to American Honda. The first two digits of the serial number indicate the year of production and should begin with “19” or greater.

2. Before installing the new buckle, write the 11-digit serial number (including the digits reflecting the year of production) of the NEW buckle on the repair order. The serial number is a required field on the warranty claim and must be provided to your Warranty Administrator to ensure the claim is not rejected.
