## Safety Recall: 2019–20 RDX Front Passenger’s Seat Belt Buckle Replacement

### BACKGROUND

Due to improper manufacturing of the seat belt buckle channel, the front passenger’s seat belt buckle may not latch properly. An improperly latched seat belt buckle may not securely restrain occupants during a collision, increasing the risk of injury.

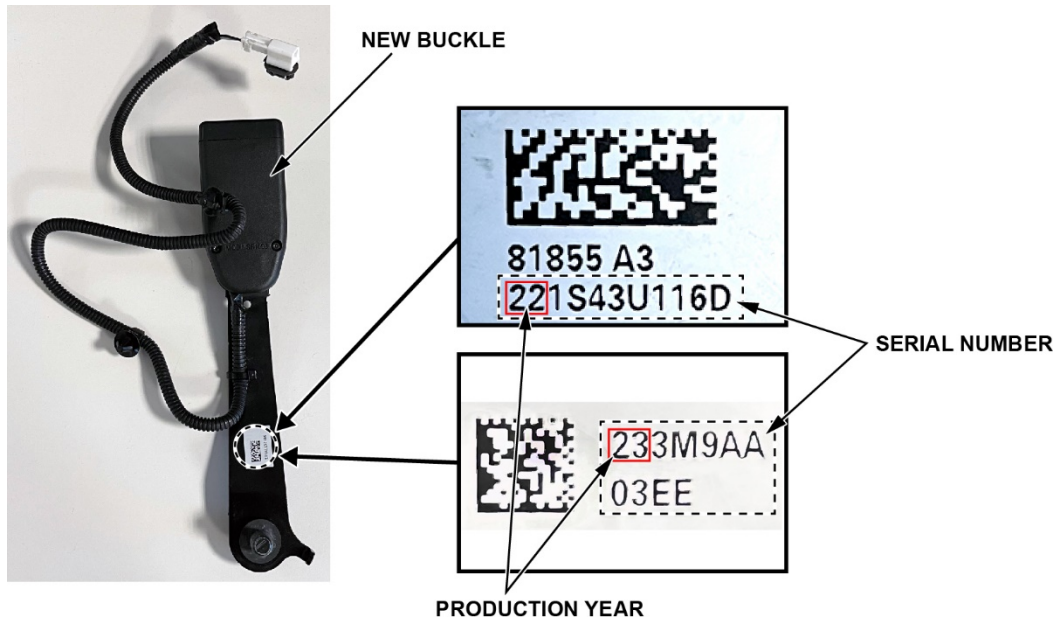
NOTE: The first two digits of the serial number indicate the year of production and should begin with "19" or greater. If the serial number begins with "18", **DO NOT INSTALL** the buckle. The buckle should be returned to American Honda.

1. Before installing the new buckle, write the 11-digit serial number of the new buckle on the repair order. The serial number is a required field on the warranty claim and must be provided to your Warranty Administrator to ensure the claim is not rejected.

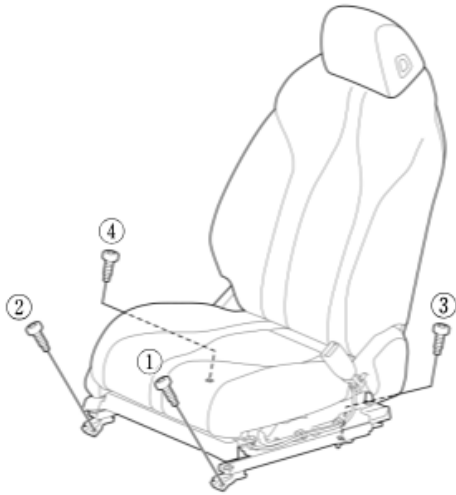
9. Adjust the seat as needed to tighten the bolts, then torque the bolts in sequence to **43 N·m (32 lb-ft)**.
