First Release

04-14-2023

On the vehicles affected by this recall, the emergency window exits were incorrectly adjusted and the force required to unlatch the emergency window exits could exceed the legally required 90 N (20 lb).

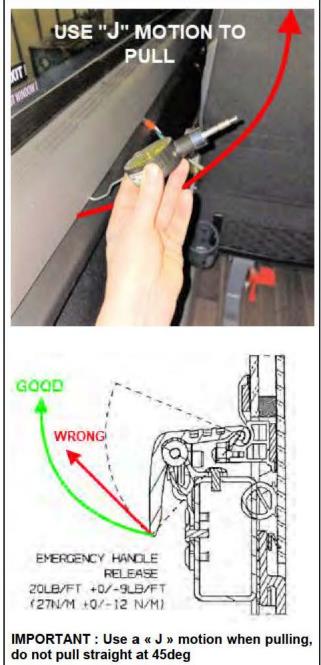
Use Prevost Tool G35694 or equivalent pull weight gauge with resettable highest weight indicator.

- Install the tool hook in the middle of the window handle.
- Point the tool upward at a 45deg angle (with the floor).
- <u>Slowly</u> pull with the tool until the handle unlatches (use a "J" motion, do not pull straight).
- Take this measurement twice to make sure readings are consistent. Take note of the average pull weight.

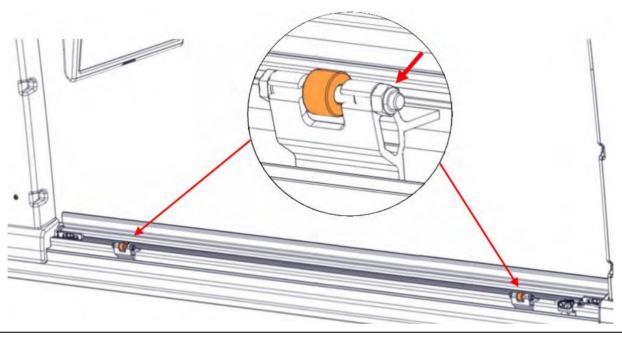
- 2. Pull weight should <u>not exceed **20LB** (90N)</u> If the pull weight is over the limit, the two handle rollers must be replaced.
 - Rollers are located on both sides under the handles.
 - To remove the roller, simply unscrew the retaining nut and slide the screw acting as a roller shaft.
 - Clean the screw and reinstall new supplied 290576 low tension roller (smaller diameter).
 - Put a light coat of red synthetic grease on the new roller (Prevost 683652 recommended).

- 3. Cycle the handle a few times to break in the new rollers and make sure the mechanism operate properly.
- 4. Measure again the tension required to lift the handle.
