SAFETY RECALL BULLETIN

NHTSA RECALL 23V373

AUTOCAR, LLC SAFETY RECALL ACX-2306

Autocar, LLC has determined that certain ACX models may have improperly assembled right door latches.

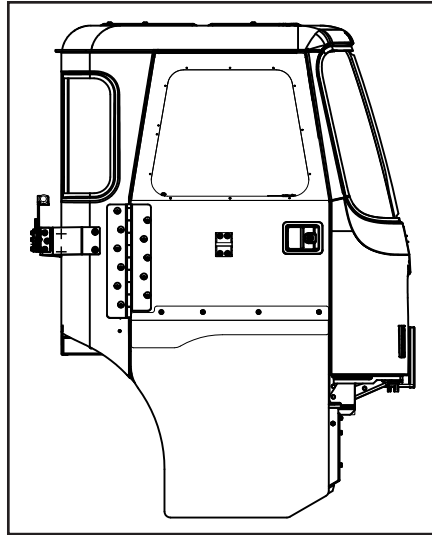
Figure 1

1. Follow all lockout/tagout procedures and verify the battery disconnect switch is in the “OFF” position. If the unit is not equipped with a battery disconnect switch, disconnect the battery cables beginning with the negative cables, followed by the positive cables.
2. Unlock and open the right door (see *Figure 1*).

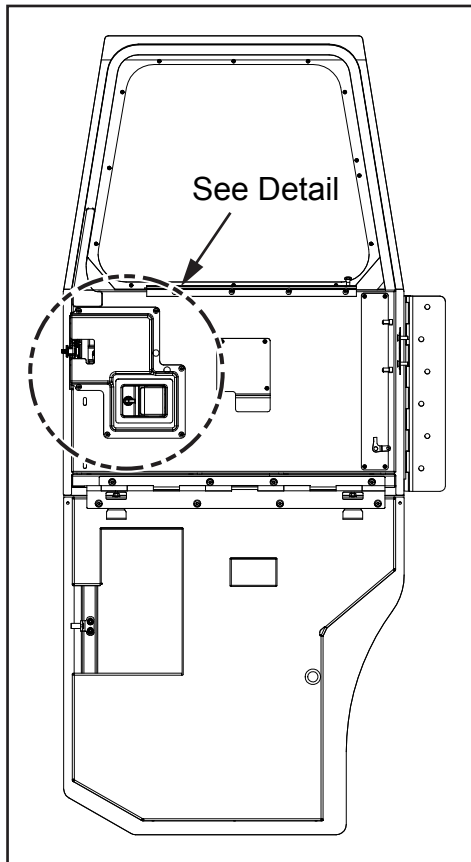
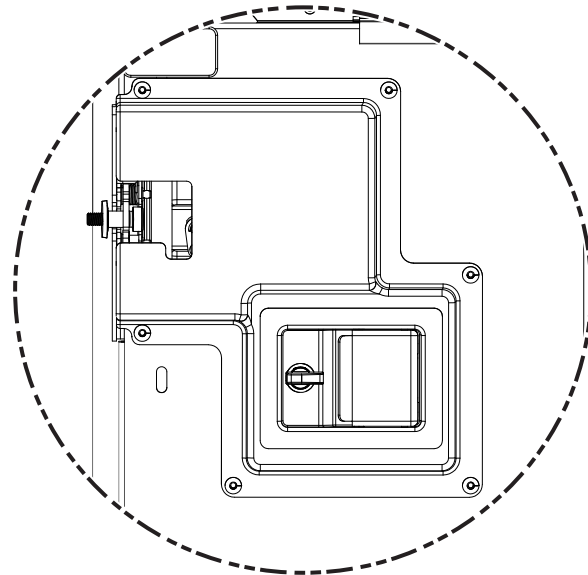
Figure 2

3. Remove the interior panel fasteners and the interior panel and set aside for reinstallation (see Figure 2).

5. Reinstall the interior panel and the fasteners set aside in Step 3 (see *Figure 2*).
6. Perform a functional test of the door and door lock.
7. Turn on the battery disconnect switch or re-connect the battery cables beginning with the positive connections followed by the negative connections.
8. Repairs are complete.

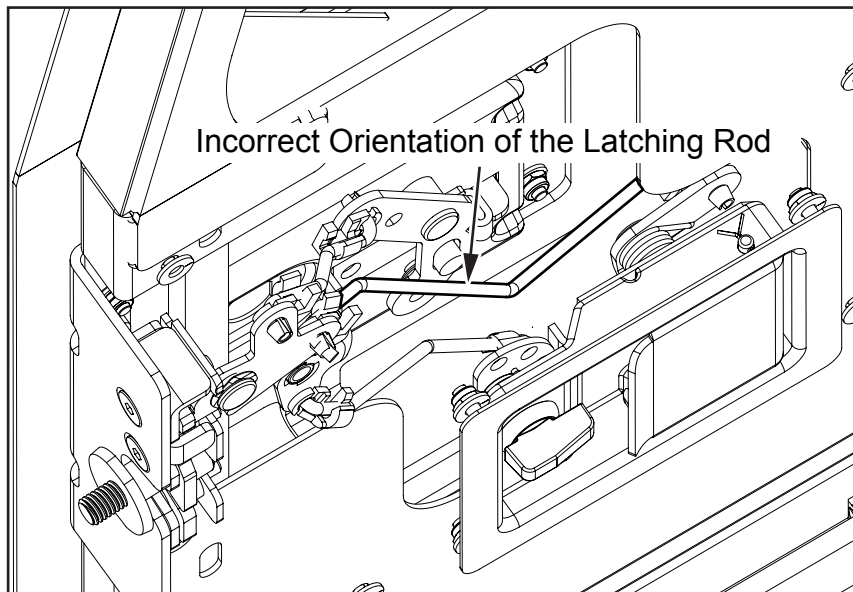
Figure 3, Incorrect Orientation

4. Locate the latching rod and verify its orientation. If the orientation of the latching rod is as shown in Figure 3, the installation is incorrect. Remove the latching rod and reinstall in the correct orientation as shown in Figure 4 (see *Figures 3 and 4*).
