PREVOST

**SAFETY
RECALL**

SR23-19B

DATE :	August 2023	SECTION :	06 ELECTRICAL
SUBJECT:	FRONT RH TURN SIGNAL MALFUNCTION – ADDITION OF A RESISTOR HARNESS

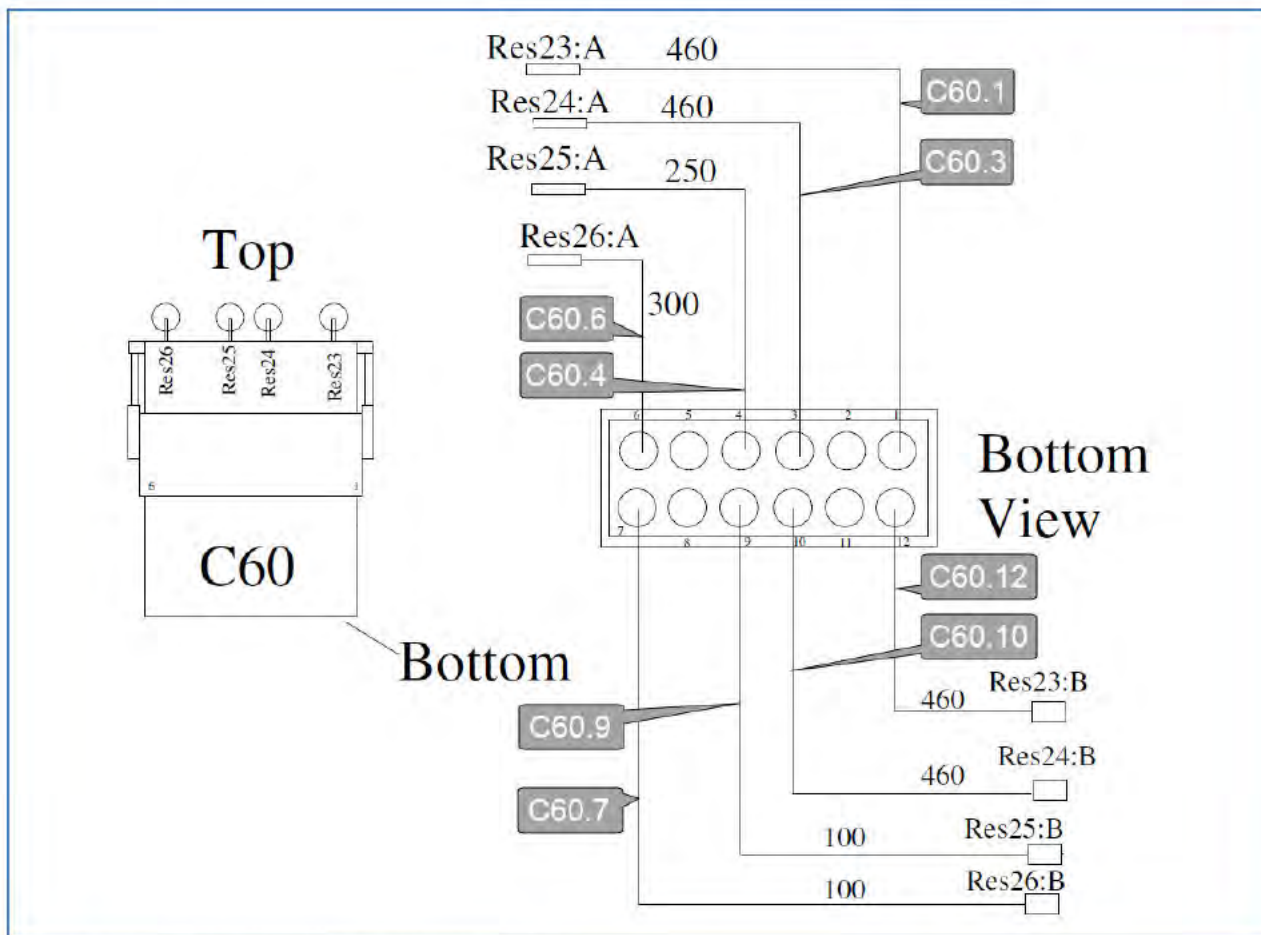
FIGURE 1: 0600179 RESISTOR HARNESS (CONNECTOR C60)

Part No.	Description	Qty
0600179	RESISTOR, HARNESS (connector C60)	1
562286	TERMINAL, DEUTSCH TYPE 16 PIN 20-16AWG	2

4. Detach connector RES4 from its support and secure on nearby harness using a nylon tie.
5. Secure connector C60 of *resistor harness 0600179* on the support in place of connector RES4.

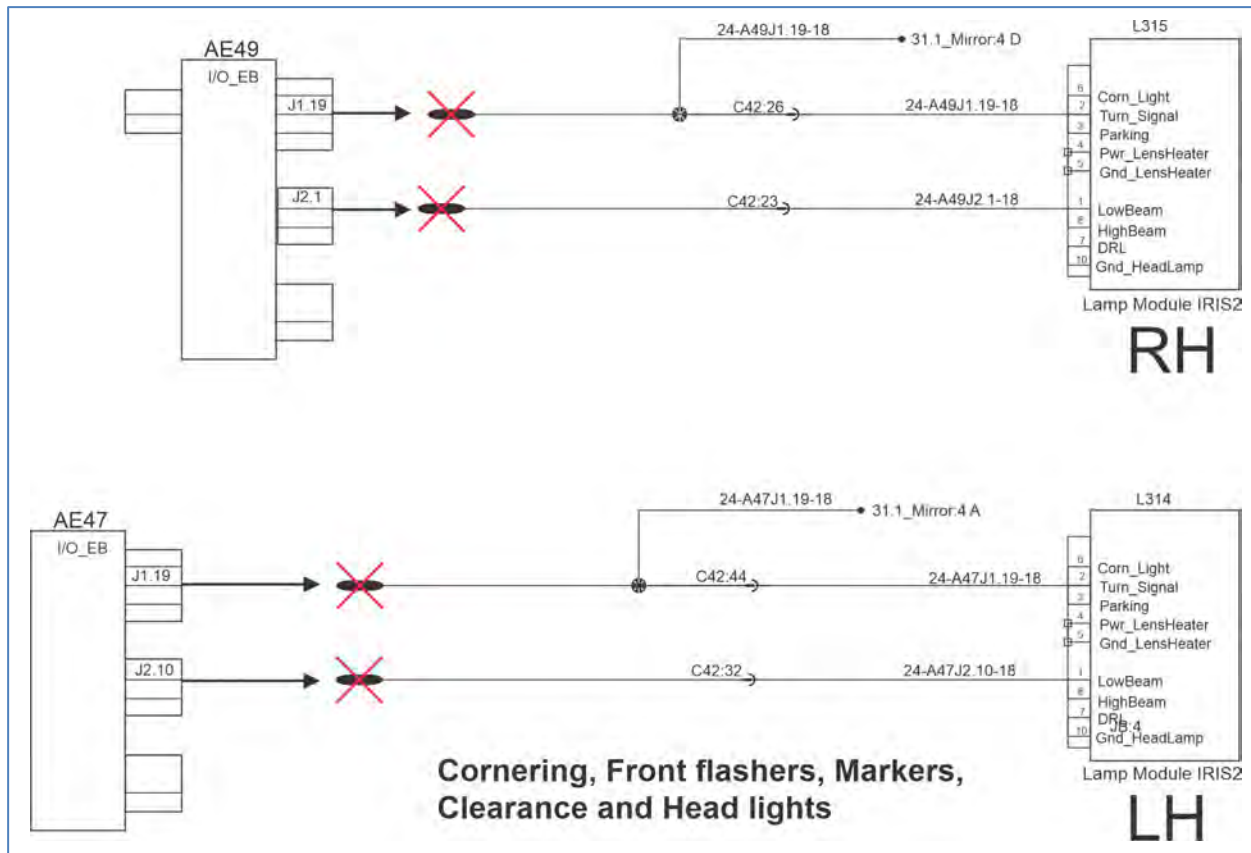
FIGURE 9

6. Disconnect the RH turn signal circuit (A49J1.19) from MUX module AE49 at J1.19. Cut and discard the terminal (Figure 9).

7. Disconnect the RH low beam circuit (A49J2.1) from MUX module AE49 at J2.1. Cut and discard the terminal (Figure 9).
8. Disconnect the LH turn signal circuit (A47J1.19) from MUX module AE47 at J1.19. Cut terminal and discard (Figure 9).
9. Disconnect the LH low beam circuit (A47J2.10) from MUX module AE47 at J2.10. Cut terminal and discard (Figure 9).

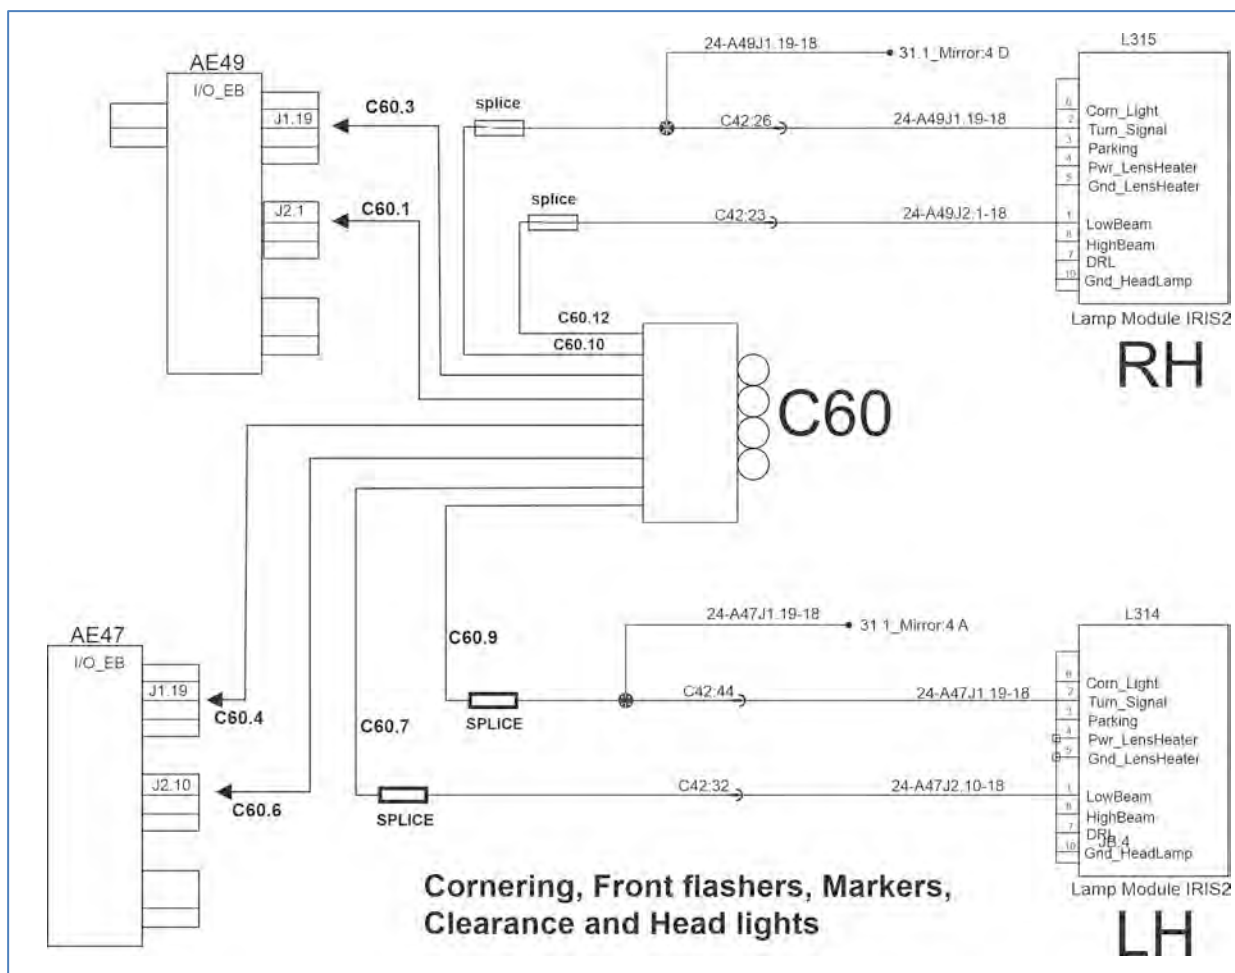
FIGURE 10

10. Insert wire C60.3 from C60 into AE49J1.19.
11. Insert wire C60.1 from C60 into AE49J2.1.
12. Insert wire C60.4 from C60 into AE47J1.19.
13. Insert wire C60.6 from C60 into AE47J2.10
14. Splice RH turn signal circuit A49J1.19 from RH lamp module to C60.10 wire from C60.
15. Splice RH low beam circuit A49J2.1 from RH lamp module to C60.12 wire from C60.
16. Splice LH turn signal circuit A47J1.19 from LH lamp module to C60.9 wire from C60.
17. Splice LH low beam circuit A47J2.10 from LH lamp module to C60.7 wire from C60.

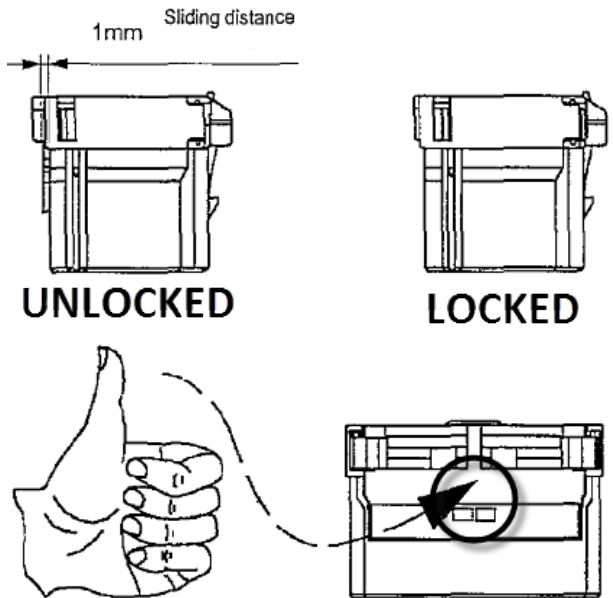
Locking the secondary lock

Delivery state of the secondary lock is the open position. In this position the AMP MCP2.8 contacts can be loaded. After that the secondary lock is moved into the final locking position by hand.

At a sufficient large surface a perpendicular force is initiated by (preferably) the thumb of one hand. Proper final position is reached a click noise can be heard. Make sure that both sides are locked.
