June 12, 2025

Version 9

## Safety Recall: 2018–19 Odyssey Connecting Rod Bearing

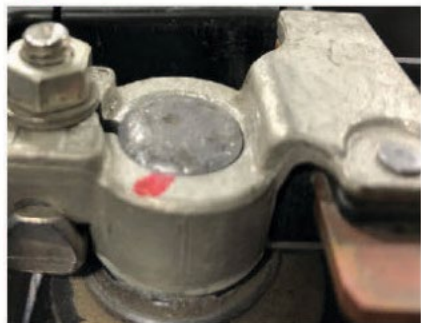
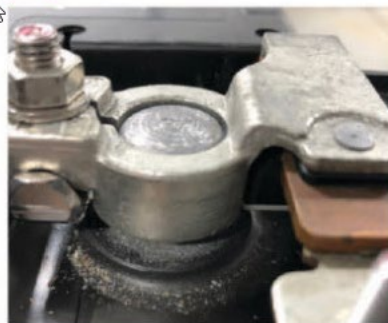
- Battery terminal installation on this vehicle is critical. Failure to follow the terminal installation or inspection procedures could cause electrical problems, stalling, and/or DTCs to set. Do not over torque the terminals, and do not use an impact gun.
- Battery terminal installation must be level or below the post.
