# SOP10393 QAAR 10323 Recall Wire Check at Truma Junction Box

Department: 32  
 People Required: 1  
 Time to Complete: 30min  
 Date Created: 6-01-23  
 Date Revised: Rev #:  
 Created by Initial: GK Verified: BH

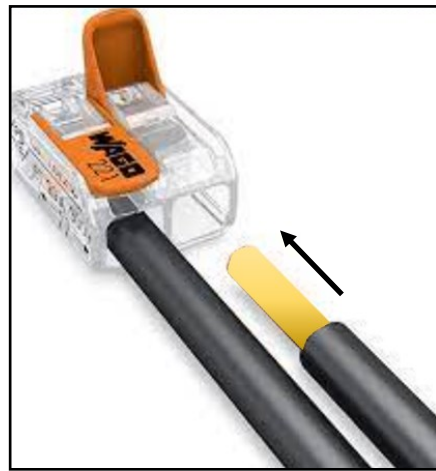
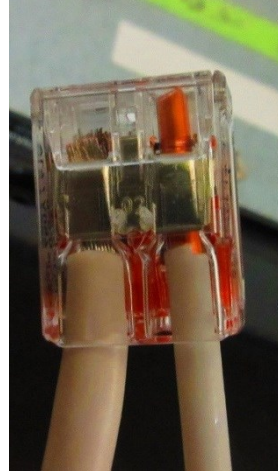
Insert each stripped wire fully into the Wago connector.  
 Push the orange tab down and pull test the connection.  
 Wrap each reassembled Wago in electrical tape.

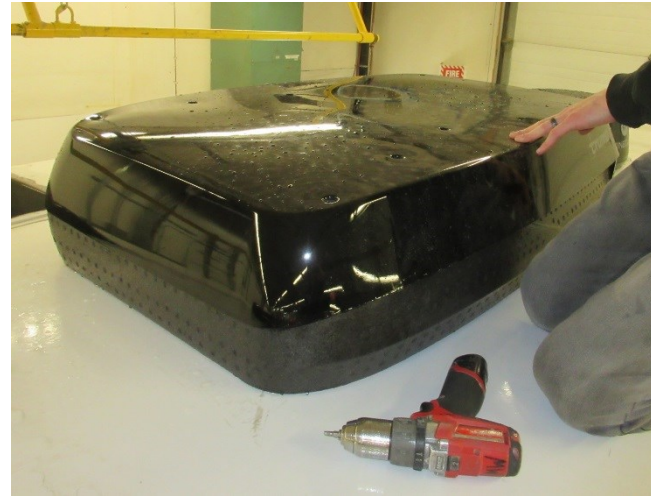
10

Reassemble the junction box and air conditioner shroud.

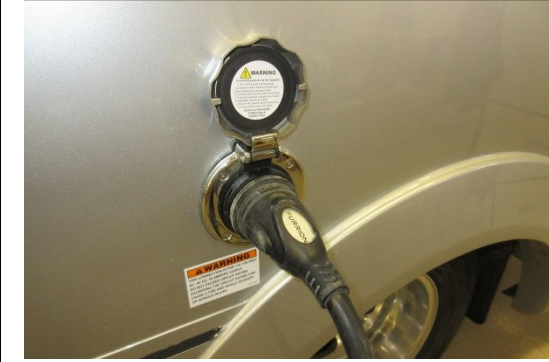
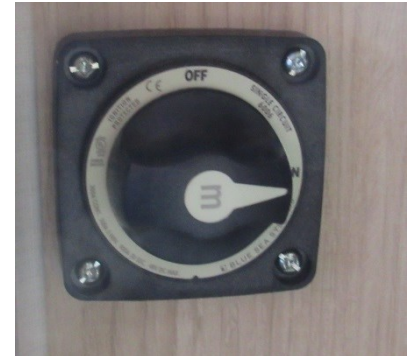
11

Plug coach into shore power and turn battery disconnect ON.

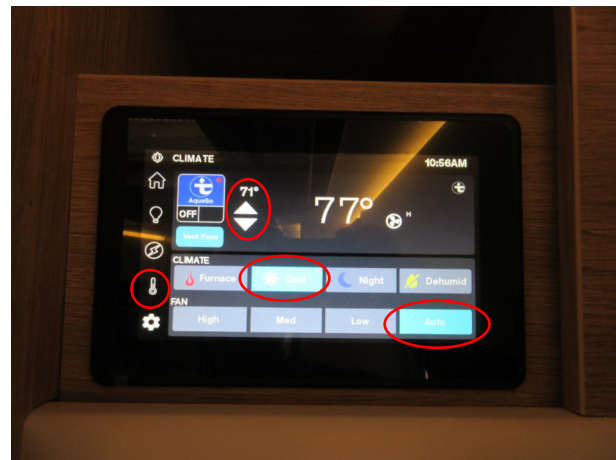
12

In the climate screen of the multiplex system, turn the air conditioner on and confirm that it is functioning.
