SOP12388

Recall QAAR 10438 Truma Air Conditioner Power Supply Grommet

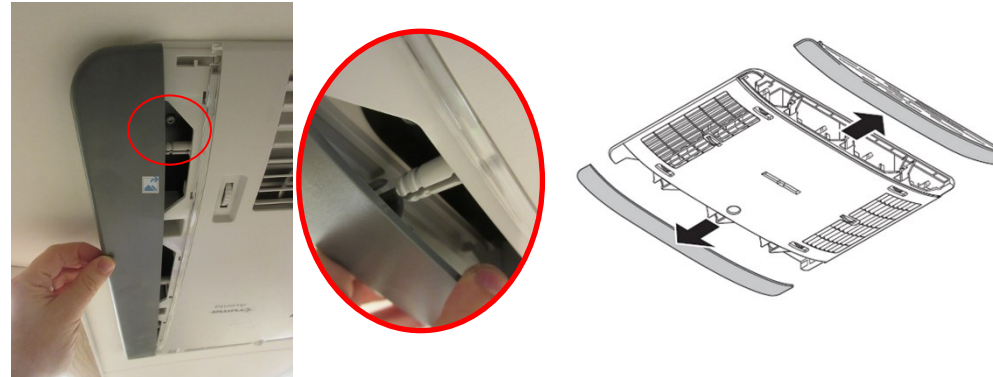
1

Remove both side panels on the air conditioner diffuser housing by sliding sideways.

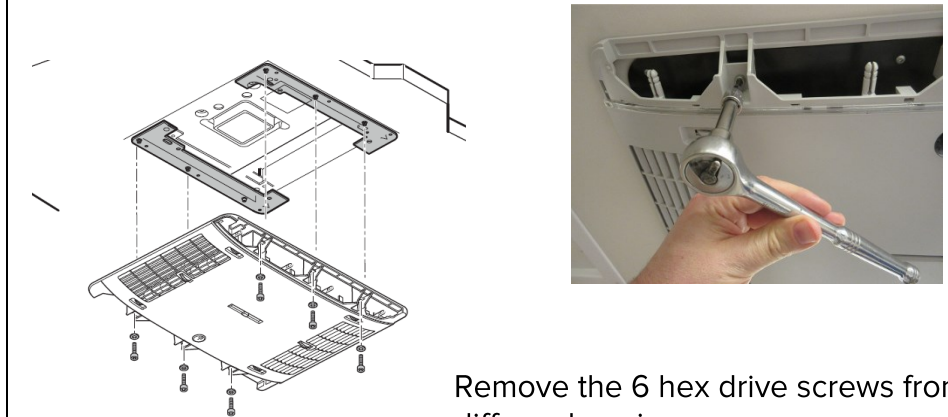
3

Remove the 6 hex drive screws from the diffuser housing.

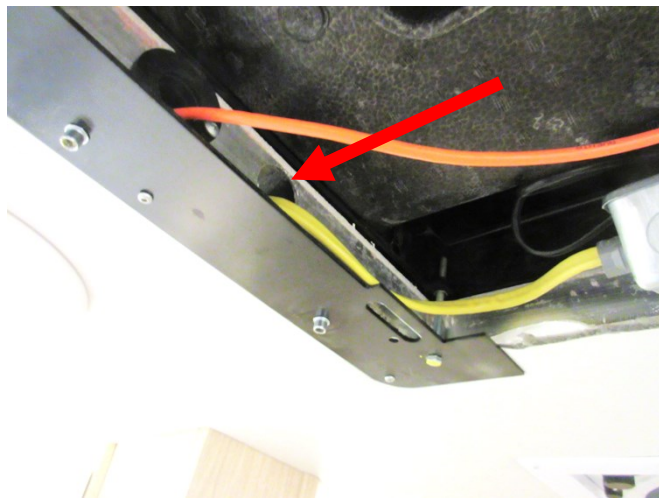
4

Verify the yellow 12/2 NMD wire is missing a grommet where it runs into the roof frame.
 If grommet is present no corrective action is required, proceed to step #7.

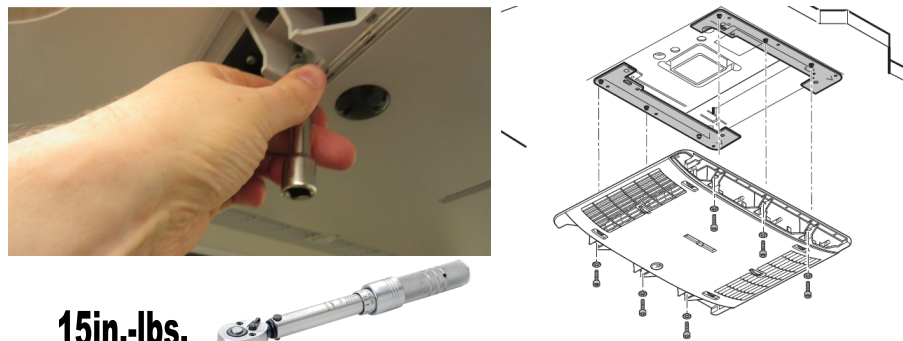
7

15in.-lbs.

Reinstall the diffuser housing starting all the hex drive screws by hand to prevent cross threading.
 Torque each hex head to 15inch lbs.
